**BEECH HOUSE FARM, 3 ROCKLEY LANE,  
BIRDWELL.**

**BAT SURVEY.**

**Ref No:- 130340 REV1.**

**Date: 25<sup>th</sup> March 2013.**

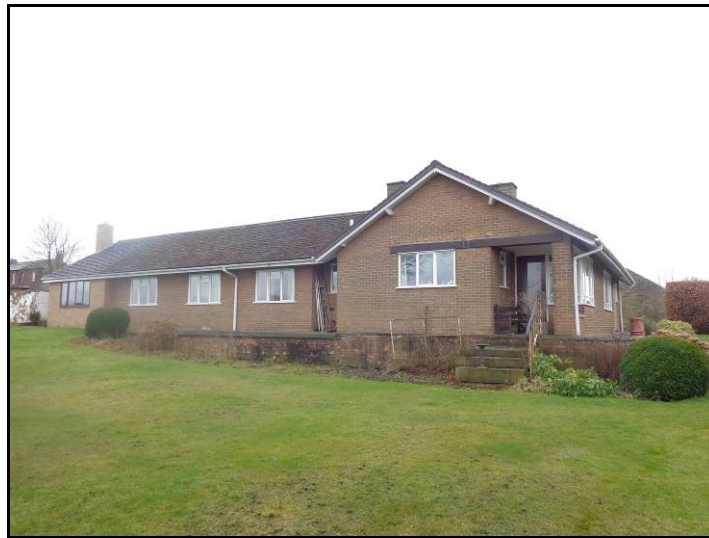
3.3.1.1. **Building 1** is a single storey residential bungalow comprising cavity brick walls and a pitched roof with three gable ends. The cavity walls have recently been thoroughly filled with spray insulation and the brickwork is well pointed with no gaps or crevices. There are doors and windows in all elevations of the building which are all tightly sealed with no gaps or crevices. The pitched roof is covered with tight fitting concrete roof tiles and well pointed tight fitting ridge tiles. The fascias and

soffit boards around the building are all tight fitting with no gaps or crevices. There are three chimneys on the building which are all tightly sealed to the roof tiles with lead flashings. Internally there are three loft spaces all comprising a simple rafter and purlin design from with a tight fitting hessian and bitumen felt underneath the tiles.

3.3.1.2. There were no bat field signs or suitable bat roosting potential identified during the internal or the external inspection.

3.3.1.3. The photograph below shows the northern elevation of Building 1.

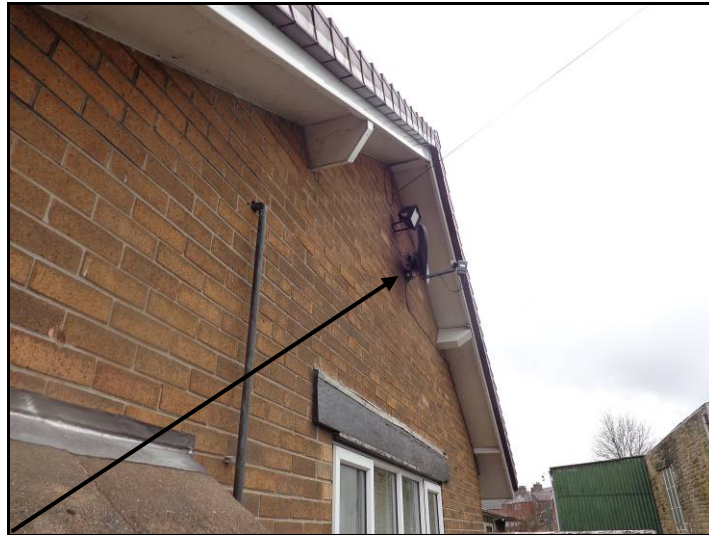
3.3.1.4. A bird nest was identified on top of the satellite dish mounting bracket on the eastern elevation of the building. The nest was not currently occupied during this survey.

3.3.1.5. The photograph below shows the birds nest located on top of the satellite dish mounting bracket.

5.2. Any demolition or vegetation clearance works should be carried out outside the nesting bird season. The nesting bird season extends from March to September weather dependant. If the works are required during this period a thorough nesting bird survey should be carried out by a suitably knowledgeable person prior to works commencing.

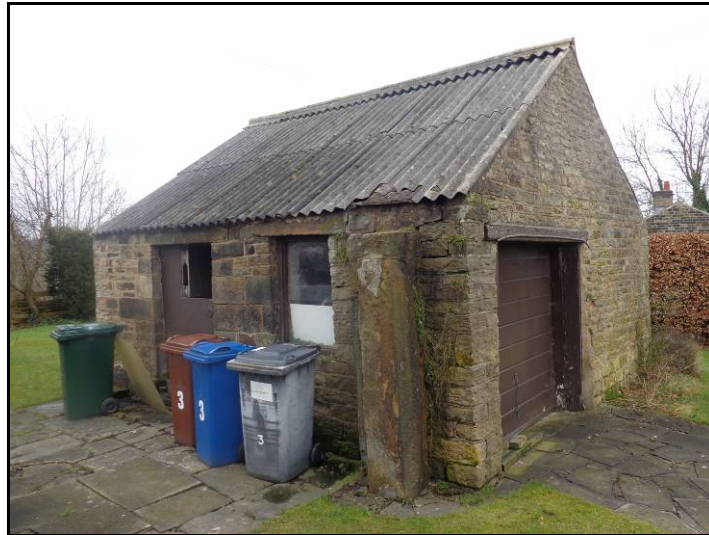
3.3.2.1. **Building 2** is a single storey cow shed which comprises stone rubble filled walls with a pitched roof and two gable ends which is currently used for storage. There are some gaps and crevices within the external elevation of the stone work. However, these could be examined during this survey and no suitable gaps or crevices were identified. There are doors and windows on the northern and eastern elevations of the building which are all tightly sealed with no gaps or crevices. The internal elevation is pointed and rendered with no gaps or crevices. The pitched roof is covered with corrugated cement sheeting and the ridge is covered with cement sheet ridge sections. Internally there is one room which is open to the rafters and there is no lining between the king post design timbers and the corrugated cement sheet roof covering.

3.3.2.2. There were no bat field signs or suitable bat roosting potential identified during the internal or the external inspection.

3.3.2.3. The photograph below shows the north eastern elevation of Building 2.

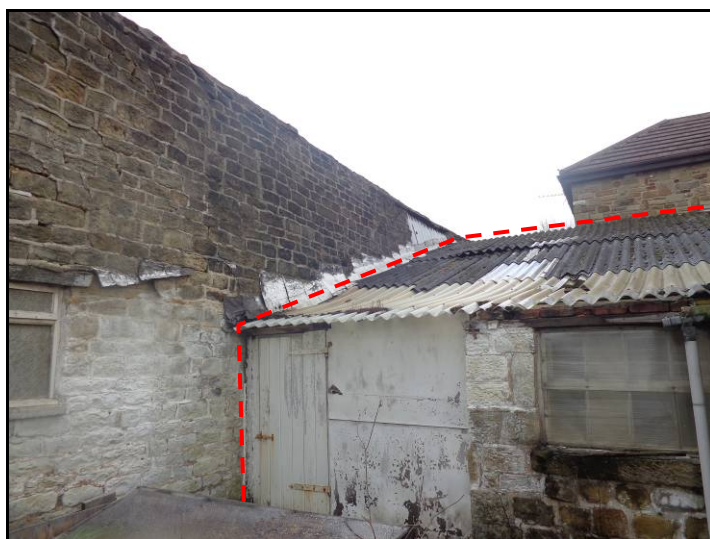
3.3.4.1. **Building 4** is a single storey greenhouse which comprises solid stone walls with a sloping roof which is currently used for storage. Building 4 is attached to the northern elevation Building 3 and the southern elevation of Building 5. There are no gaps or crevice within the stonework. There are doors and windows on the western elevation of the building which are all tightly sealed with no gaps or crevices. The internal elevation is pointed and rendered with no gaps or crevices. The sloping roof is covered with corrugated cement, metal and clear plastic sheeting. Internally there is one room which is open to the rafters.

3.3.4.2. There were no bat field signs or suitable bat roosting potential identified during the internal or the external inspection.

3.3.4.3. The photograph below shows the western elevation of Building 4.

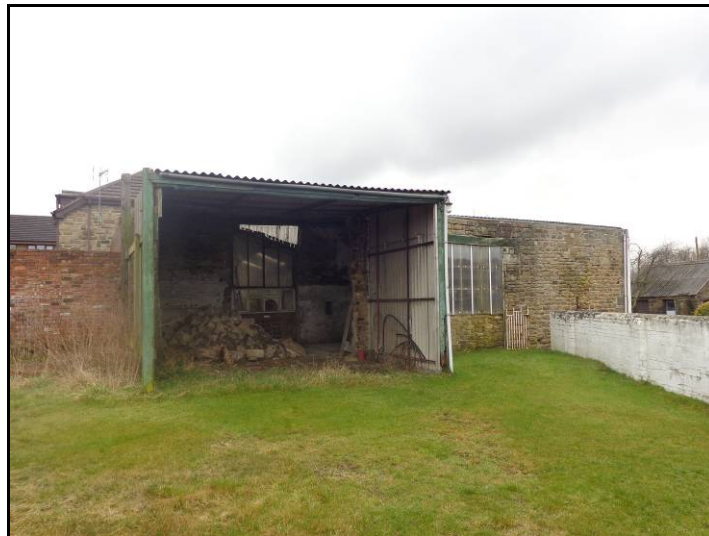
3.3.5.1. **Building 5** is a two storey barn which comprises stone rubble filled walls with a sloping roof which is currently used for storage. Building 5 is attached to the northern elevation of building 4. There are some gaps and crevices within the external elevation of the stone work. These could not be thoroughly examined during this survey. There are doors and windows on the northern elevation of the building which are open providing access into the building. There is an extended shelter protruding from the open barn door comprising wooden lathes, and corrugated cement sheeting. The internal elevation is pointed and rendered in areas leaving gaps and crevices. The sloping roof is covered with corrugated cement sheeting. Internally there is one large room with a smaller room making a mezzanine effect at the western elevation of the building. The roof is open to the rafters and there is no lining between the wooden rafters, metal frame and the corrugated cement sheets.

3.3.5.2. There were no bat field signs. However, suitable bat roosting potential was identified within this building.

3.3.5.3. The photograph below shows the north eastern elevation of Building 5.

4.2. Building 5 will provide a suitable habitat for roosting bats as there are large gaps and crevices from recent movement in the stonework.

5.1. Prior to works commencing a further bat dusk emergence survey should be carried out of Building 5. This should be carried out between May and September when bats are active to check for roosting bats within the building. If bats are found to be roosting within the building a Natural England bat licence including a method statement will be require to accompany the demolition of the building.

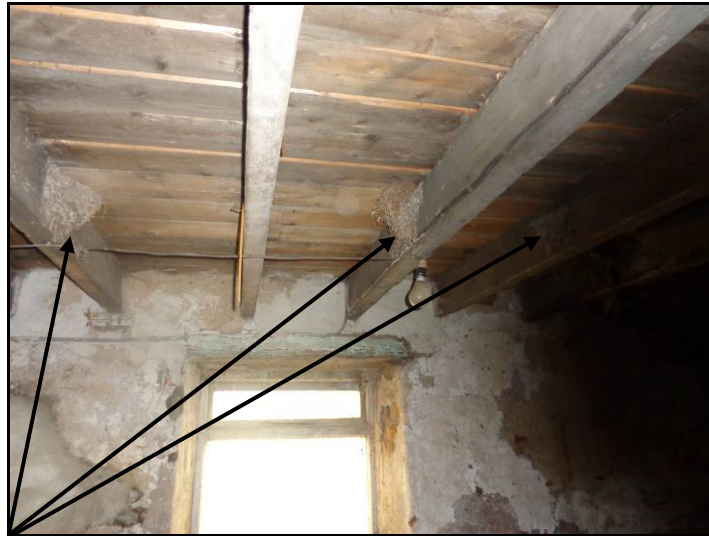
3.3.5.4. Six swallow nests were identified underneath the ceiling of the mezzanine section at the western elevation of the building. Also one nest was identified on the wall top on the southern elevation of the building. The nests were not currently occupied during this survey. Several butterfly wings were identified on top of the mezzanine floor. These were identified near to the swallow nests and will be foraging remains from the resident swallows.

3.3.5.5. The photograph below shows some of the swallow nests identified within the building.

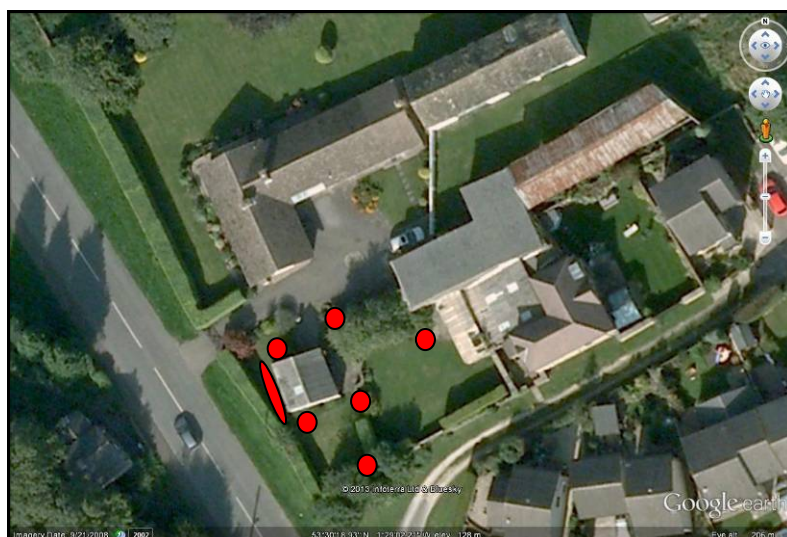
3.3.8. Several areas of cotoneaster were identified around the survey area. These are localised to the southern elevation of the survey area.

3.3.8.1. The aerial photograph below shows the location of the several areas of cotoneaster.

4.7. The areas of cotoneaster identified to the south of the survey area are listed on the Schedule 9 non native invasive plant species list and should not be spread during the vegetation clearance or demolition works.

5.3. It is recommended that the cotoneaster plants are excavated prior to vegetation works and demolition works commencing. The materials should be bagged and taken off site and disposed of as contaminated waste.
