REPORT SDS2544
June 2014

**COMPLETION REPORT FOR THE DRILLING AND GROUTING
TREATMENT OF MINEWORKINGS**

at land off
BARNBURGH LANE, GOLDTHORPE (PHASE 1)

prepared for
GLEESON HOMES AND REGENERATION

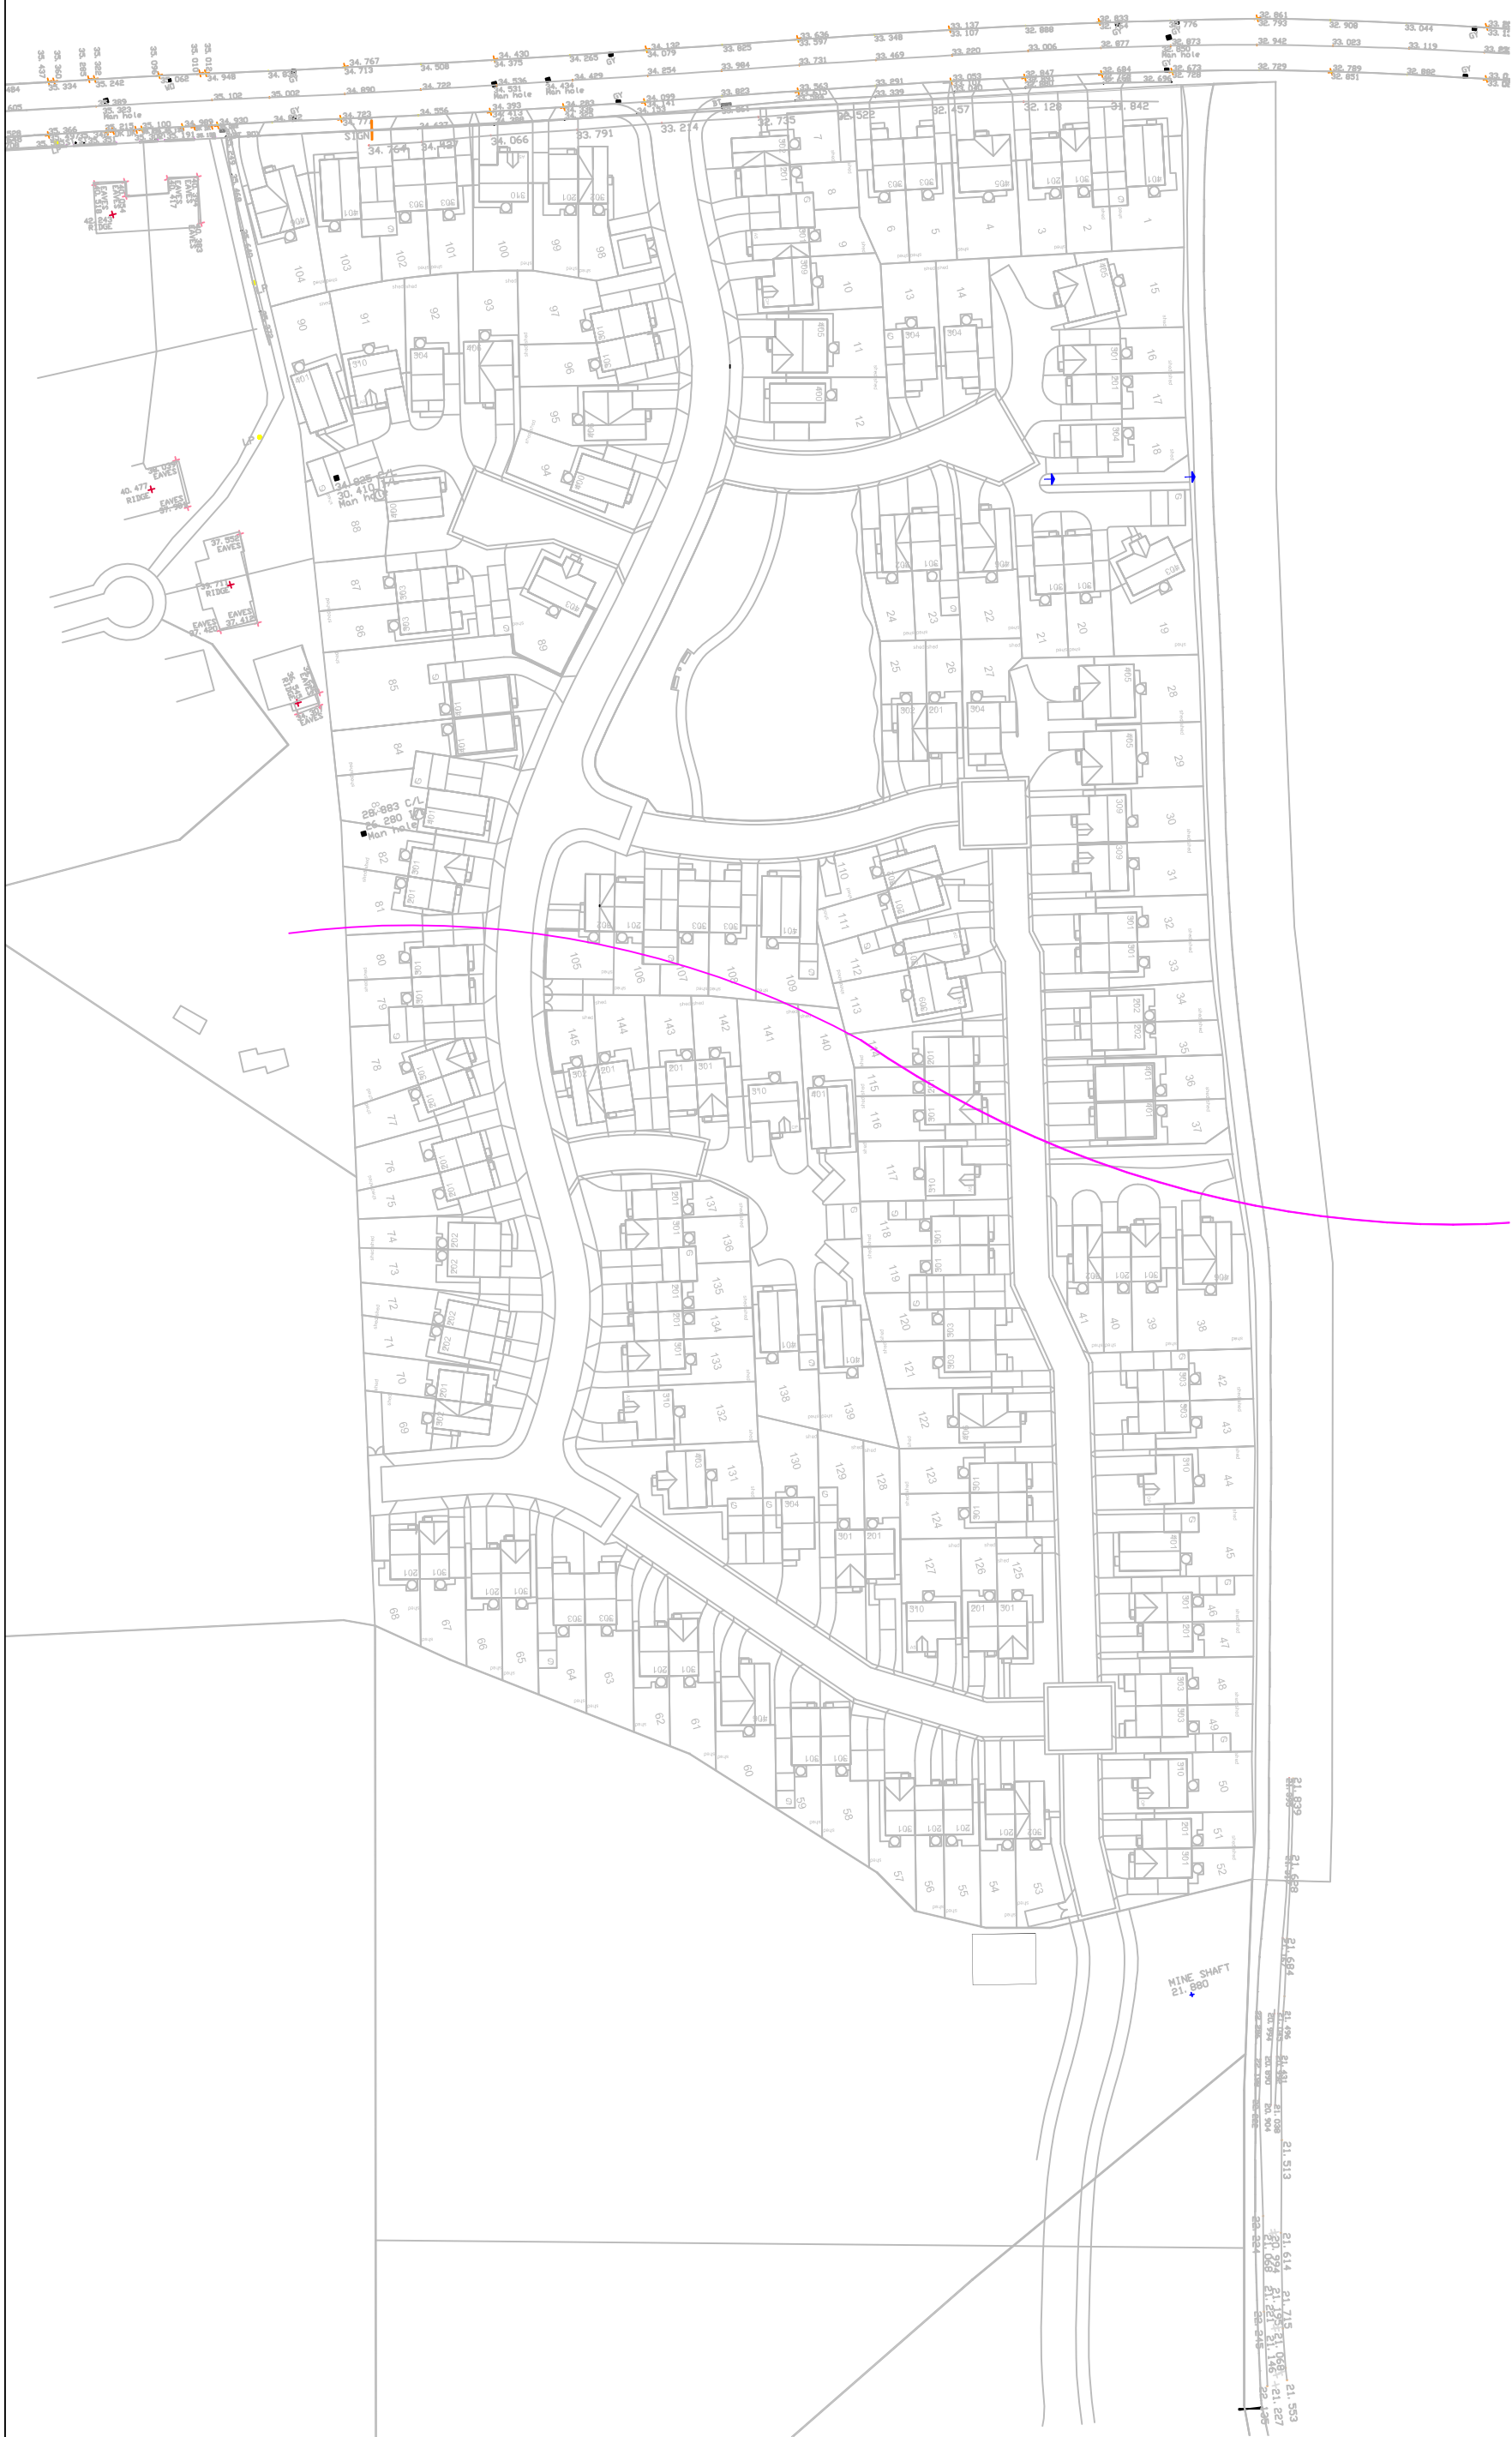
DRAWING NO. SDS2544/CS/02	REVISION NO. 0
DRAWN BY MB	APPROVED BY JCC
DATE June 2014	SCALE 1:1000
	PAPER SIZE A3

Gleeson Homes and Regeneration (Gleeson) are in the process of developing land off Barnburgh Lane, Goldthorpe for residential housing with private gardens and associated infrastructure. A proposed layout plan is presented within Appendix A as Drawing No. SDS2544/CS/02.
