## Heritage Statement

Extension and Alterations to a Grade II Listed Building within a Grade I Parkland setting

Queen Anne's Lodge  
Off Rockley Lane  
Worsbrough  
Barnsley  
S75 3DS

Date July 2014  
Project No 2013/05

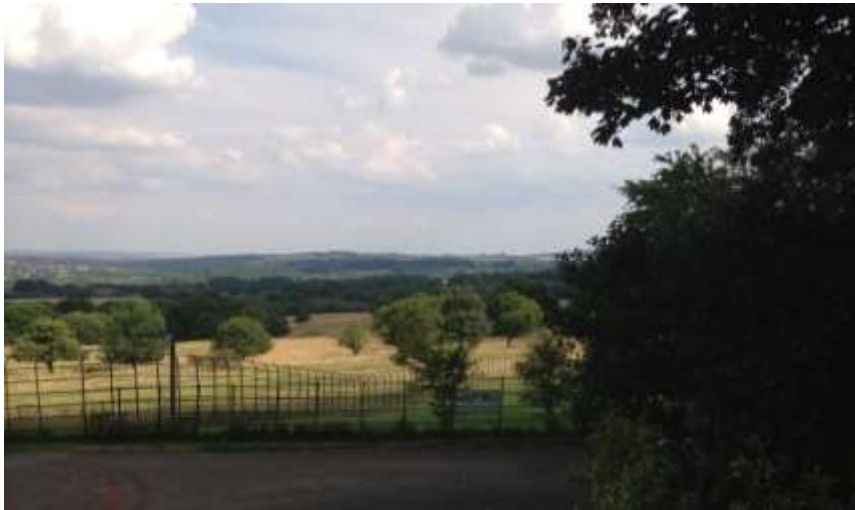
It has been found that, while the Lodge is visible from the House and the Visitors' Centre, the Lodge is significantly far away (1.25km) and it is very hard to identify the Lodge within the landscape. It is strongly masked by the surrounding trees and vegetation. Image 1 has been taken from the seating area outside the café and it demonstrates that it is very hard to identify the Obelisk and Lodge from this distance, strongly suggesting that the impact on the House and visitors to the house will be negligible. Image 2 has zoomed in on the location of the Lodge, where the Obelisk is just about identifiable, but the Lodge remains camouflaged by the surrounding landscape.

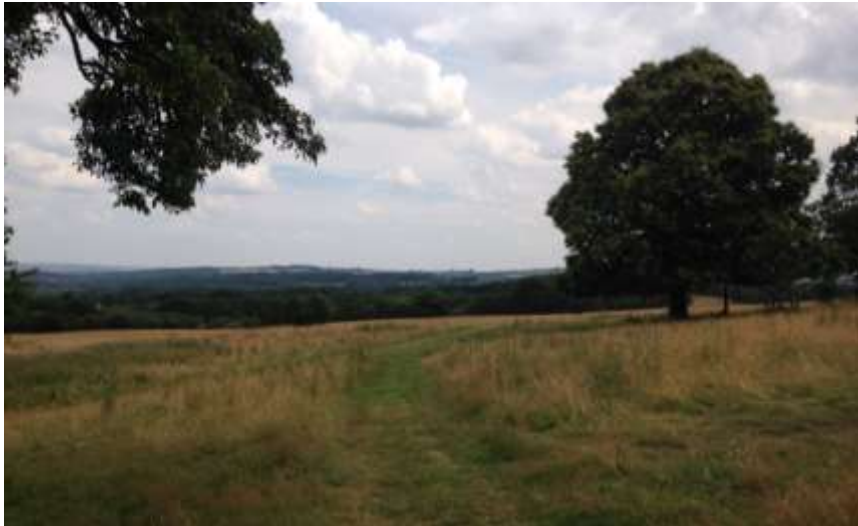
Image 3

The Obelisk and Lodge beyond are only visible once you approach the Obelisk through the recently planted Ivas Wood. The Obelisk and Lodge are not directly visible from any other location within the wood, except along the path shown.

There are various walks around the park, dictated by the landscape (woodland and Serpentine Lake). The Lodge is not visible from the vast majority of these walks because of the landscape, including hills, woodland and the undulation of the land. Image three has been taken along the shortcut to the Visitor Centre (See Appendix A) and the Obelisk and Lodge are fully obscured by the wood at the southern end of the Serpentine Lake and the mature trees that line the edge of the Lake. The Obelisk and Lodge beyond are only visible once you approach the Obelisk through the recently planted Ivas Wood

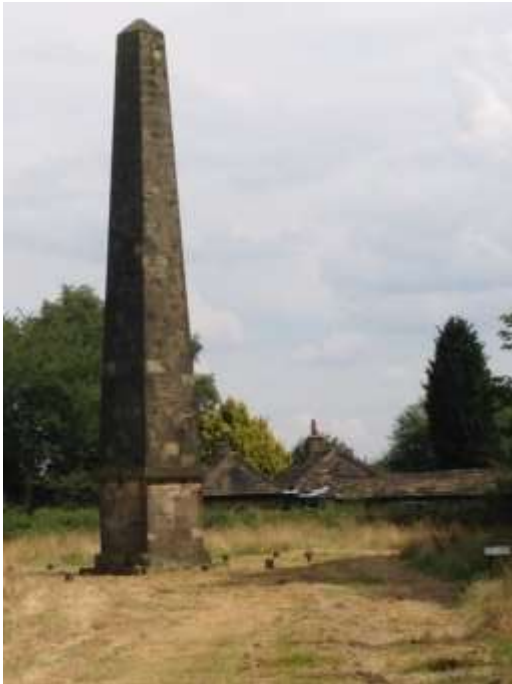
Image 5

View of existing dwelling when approaching the Obelisk

The lay of the land and the vegetation means that the house is very unobtrusive.

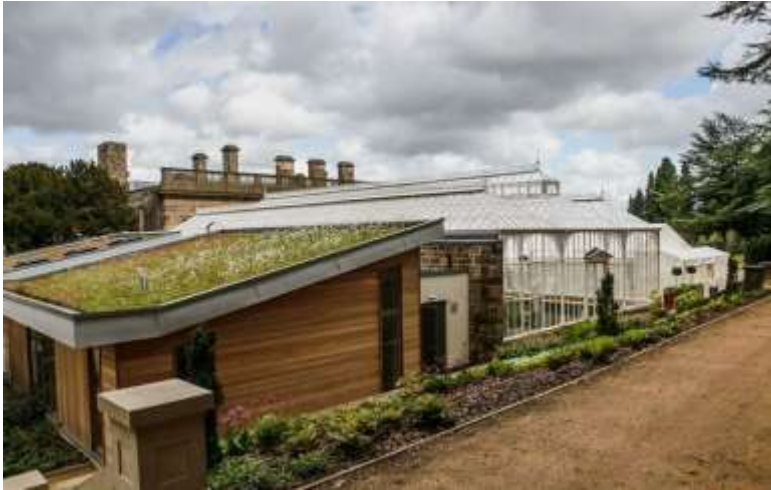
Image 9

Restored Victorian Conservatory from the side and rear showing the modern extension

In 2013, the Grade I Listed Conservatory at Wentworth Castle was restored and extended, with a modern extension attached to it. The mix of old and new presents a very strong precedent to the more modest proposals at Queen Anne Lodge.

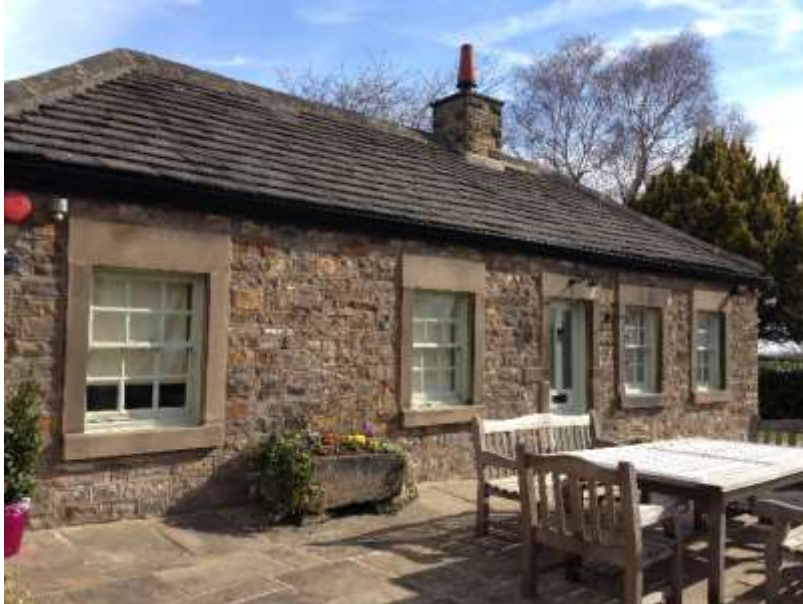
Image 10

Image showing front elevation of main lodge.

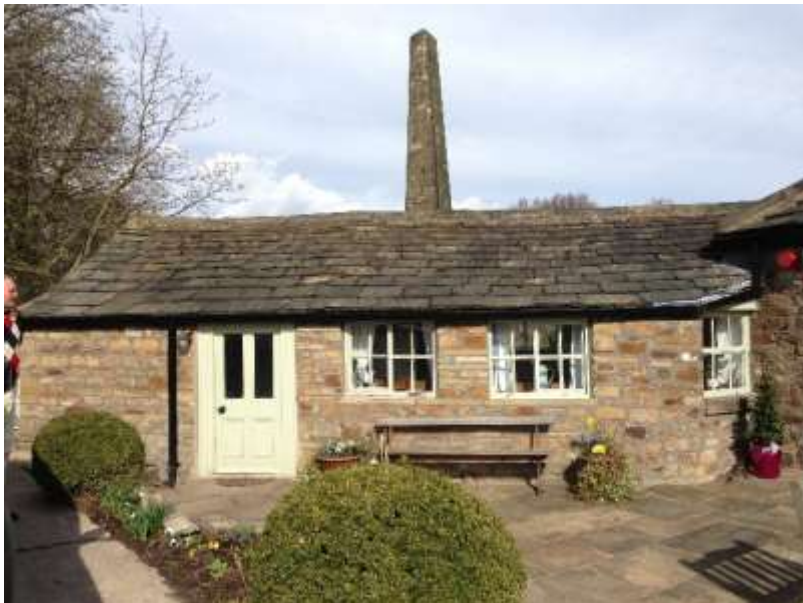
Image 11

Image showing front elevation of annex extension. Obelisk in the background.

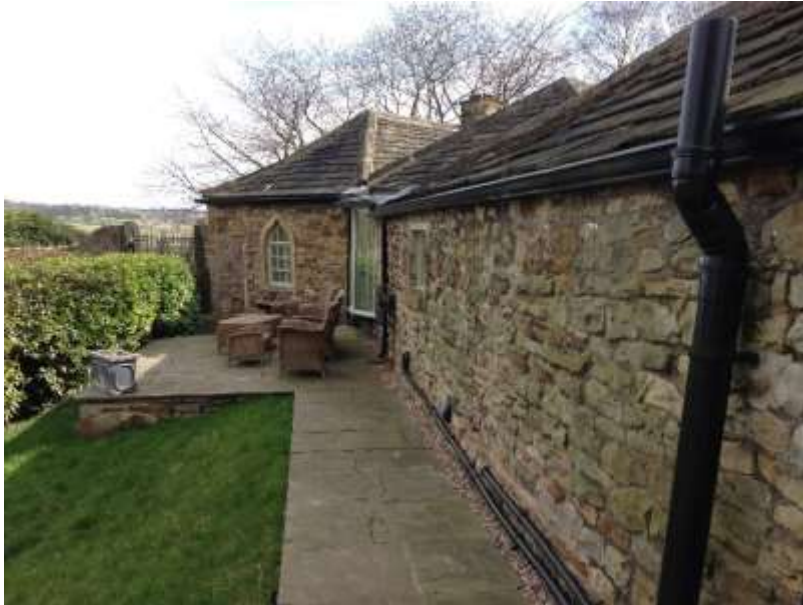
Image 12

Image showing rear elevation annex extension adjoining the main lodge.

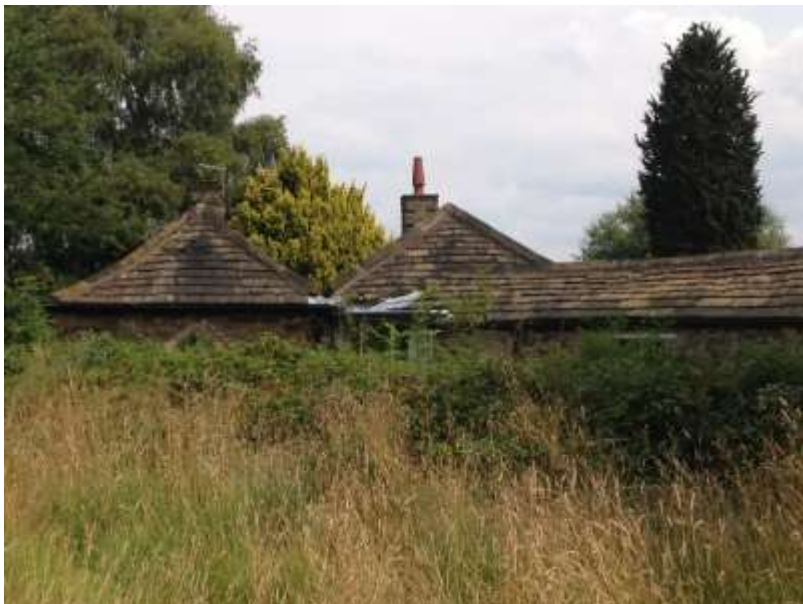
Image 13

Image showing rear side of junction between annex extension and the main lodge.

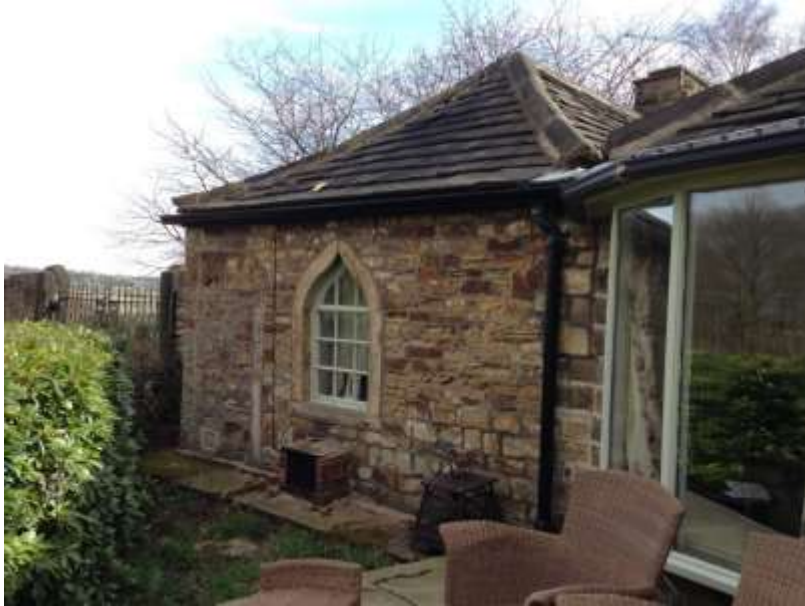
Image 14

Image showing bay window at rear

It is proposed that the existing bay window which overlooks the Parkland is removed and a stone extension with windows extension be built. This will provide space for a private sitting room.

- **Visual impact of the extension:** The extension is replacing a bay window which is of poor construction and design. The extension represents an increase in volume but has been visually reduced by orienting the extension so that only one face is visible along the vista from the Castle. Also, the roof of the extension has been designed so it is camouflaged by the original roof beyond it and the stonework and ashlar will be of a high standard to reflect the status of the Lodge. The heads of the windows will be a double ogee to match the existing windows.

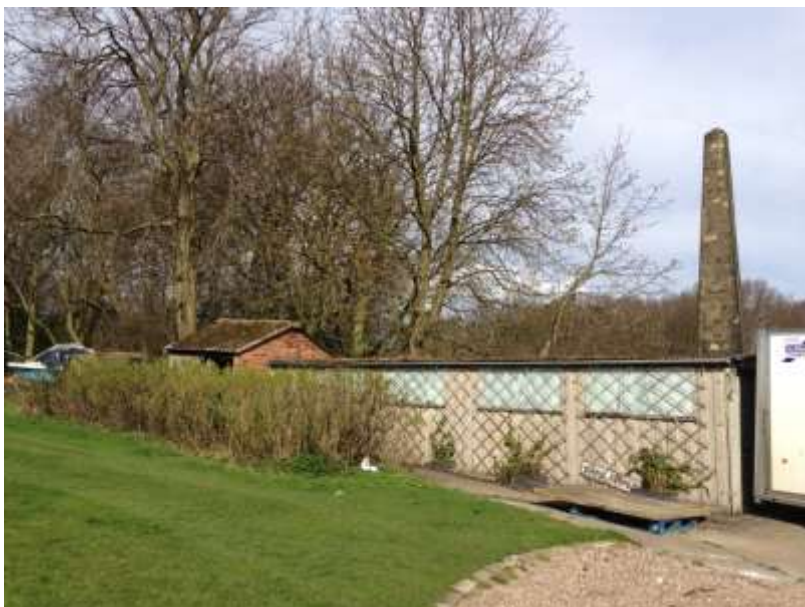
Image 15

Image showing pebbledash garage

Regarding the impact of the changes on the Lodge, the dwelling has been altered and extended previously, but the workmanship appears to be of a poor standard. The extension and alterations have been of poor quality and construction. It appears that the previous owners have not carried out the maintenance and repairs to the property as has been necessary. The existing pebble dash garage is particularly incongruous and its removal and replacement with a more traditional agricultural style garage will be a great improvement.

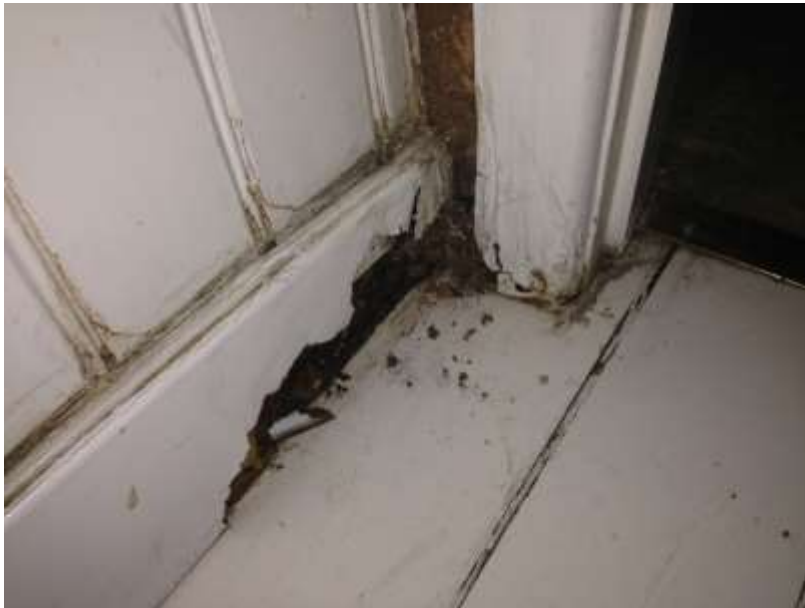
Image 16

Example of rotten joinery work

As well as protecting the fabric of the existing building, the maintenance of the building is required to provide a suitable and safe environment in which to raise a family. There is no insulation to any of the thermal elements. The existing building is cold and damp and would present a possible health risk for young children. Many of the windows and joiner elements are rotten and require replacement. See image 16.

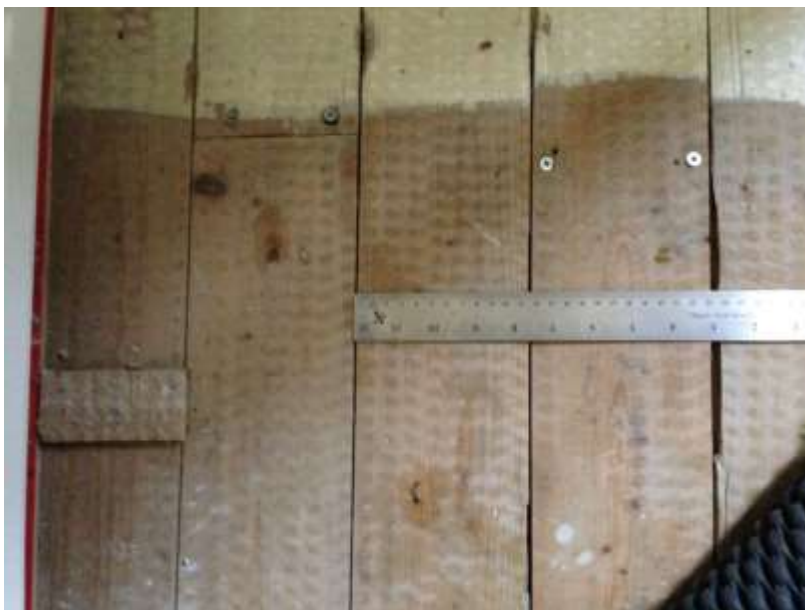
Typical floor board throughout

- The GSHP system will be more economic to run in the long term and will reduce the carbon footprint of the building.
- There is ample garden for the loop to be laid within.
- Following the works the land will be returned to the original appearance so there will be no visible indication of the loop.
- The GSHP lends itself to underfloor heating. This would be a 20mm board can be laid top of the joists. The existing modern floor boards can be taken up and re-laid on top of the underfloor heating boards. (See Image 17 and 18)
- Modern radiators can be removed.

- Alterations **may** be required to the doors, architraves and skirting boards. These can be carefully removed, altered and replaced, subject to agreement with Conservation. Inspection has confirmed that the floor boards are modern pine and have no architectural merit. See Photographic study, images 17 and 18.
- Insulation levels to the roof, walls and floors will need to be upgraded in line with current building regulations. It is proposed that insulated plasterboard is applied to the internal face of the external walls.
- Air tightness of the structure will need to be improved.
- High costs in the short term for the installation of the pump and the ground loop.

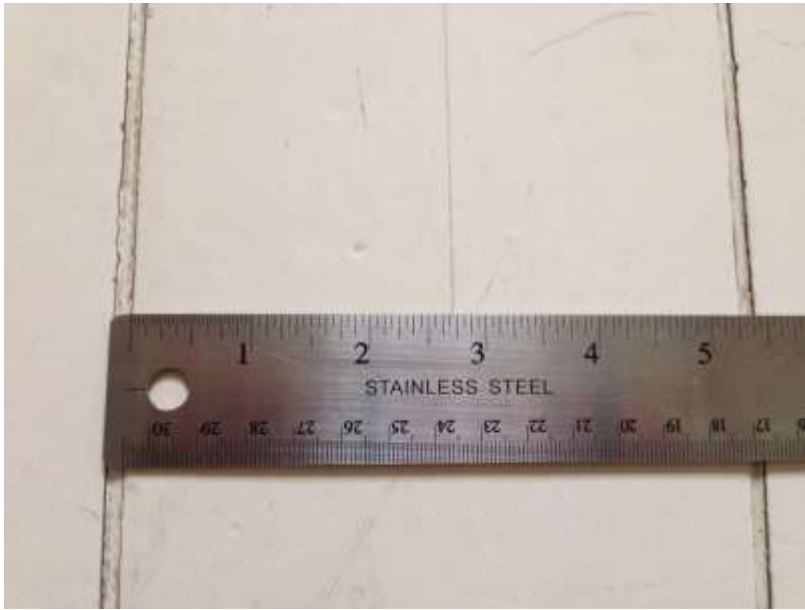
Image 18

Painted bathroom floorboards
