# **Land and building at Scout Dyke. Preliminary Ecological Site Appraisal**

**2<sup>nd</sup> April 2014**

**Middleton Ecological Consultancy, 33 Wilthorpe Road, Barnsley S75 1JA**

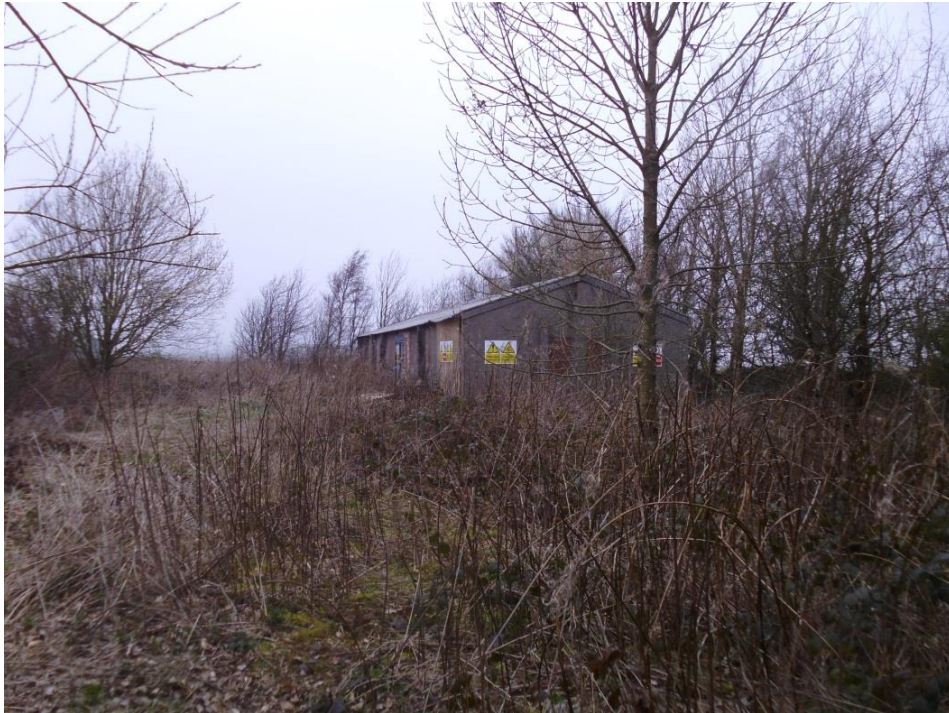
**Plate 1**

- 2.1 The site is immediately adjacent to the A629 and at the boundary of a Local Authority Local Wildlife Site. The proposed development plot consists mostly of a deciduous plantation, and although there are some naturally colonised trees, these make up not more than 20%. Tall ruderal herbs dominated by Rosebay *Chamerion angustifolium* and nettle *Urtica dioica* constitute around a third of the site and there are also patches of Bramble *Rubus fruticosus* within the tall ruderal but it is not abundant. The small area between the existing building and the boundary adjacent to the road is more heavily planted with deciduous trees including Silver birch *Betula pendula* and Cherry Plum *Prunus cerasifera*. The existing building on site is single storey, rectangular in shape and is built of brick and covered in render. It has a single ridge roof with gables and is covered with corrugated asbestos sheets (see plate 1).

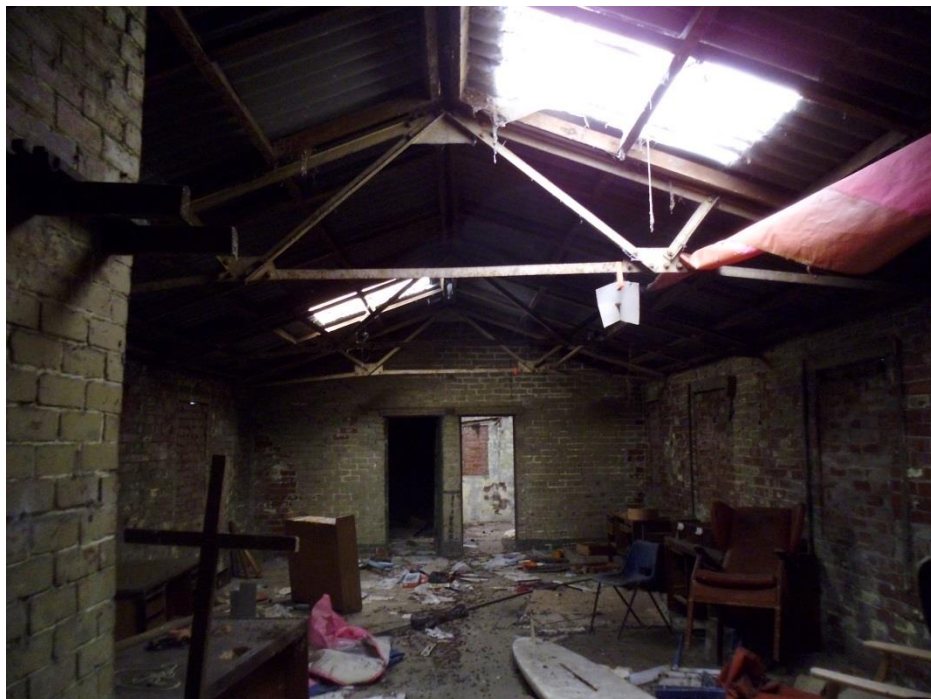
- 4.4.2 The building was assessed for its potential to accommodate a bat roost. The structure is built of brick and rendered except where the windows have been 'bricked up', consequently, therefore there are no opportunities for bats to roost in the outside walls. On the inside the asbestos roof is supported by a steel frame and wooden purlins. The brick walls have no suitable gaps or crevices and no signs of bats could be found; the building was therefore assessed as having only negligible bat roost potential. However, two Blackbird *Turdus merula* nests were located inside the building.

**Plate 2** Inside of building showing steel frame supporting asbestos roof

- 8.4 Demolition of the existing building should preferably be undertaken outside of the bird nesting season (March to August). Otherwise, the building should be searched for the presence of nests by a suitably experienced ecologist prior to demolition. Demolition works should also proceed with caution and vigilance for unexpected bat presence, as single bats can roost almost anywhere. If bats are subsequently discovered, work should be stopped and further advice sought without delay.

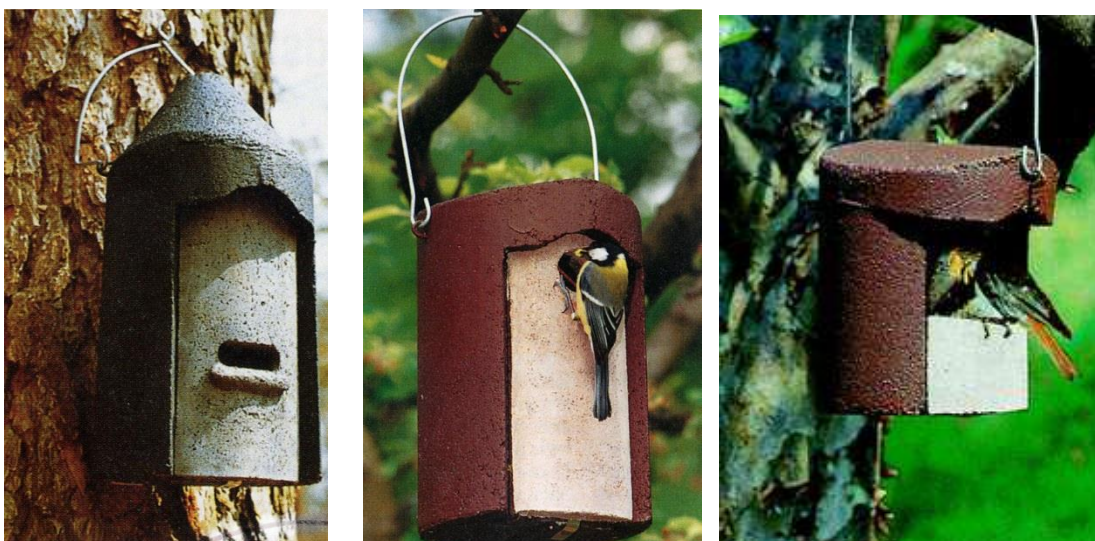
**Bird and bat boxes** – these boxes are made of woodcrete and last 25 years, two of each can be located on site and the wider area.

**Figure 2** Schwegler Bat and bird boxes

- 7.5 Schwegler woodcrete boxes for bats and birds can be placed at various locations within the site and wider area with species targeted informed by the desk study. The trees on site are not old enough to have any features that can accommodate a bat roost or indeed bird's nest's, therefore this initiative is a worthwhile inclusion among a package of enhancements. Furthermore,

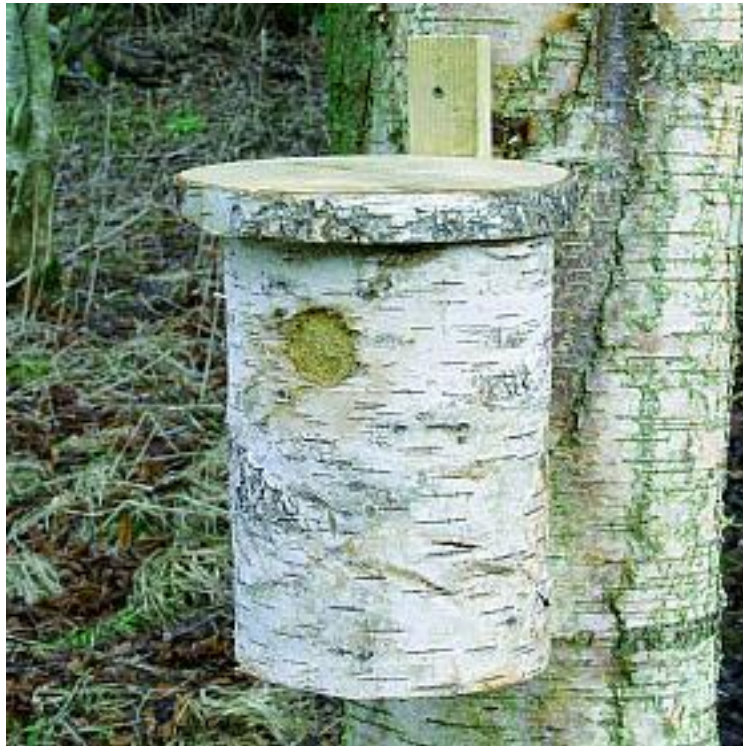
**Willow Tit Box** – The boxes can be made from the trees felled that are extremely close to the existing building. The boxes are made from birch and packed with sawdust so that the Willow Tits can excavate their own nest site. Two or three can be placed on site and the wider area.

**Fig 3** Wooden bird box for Willow Tit

Willow Tit is both a Red Listed species of conservation concern and a UK BAP species and it is present in the wider area, therefore can be targeted for practical conservation by providing a specific nest box for this species (see Appendix 2).

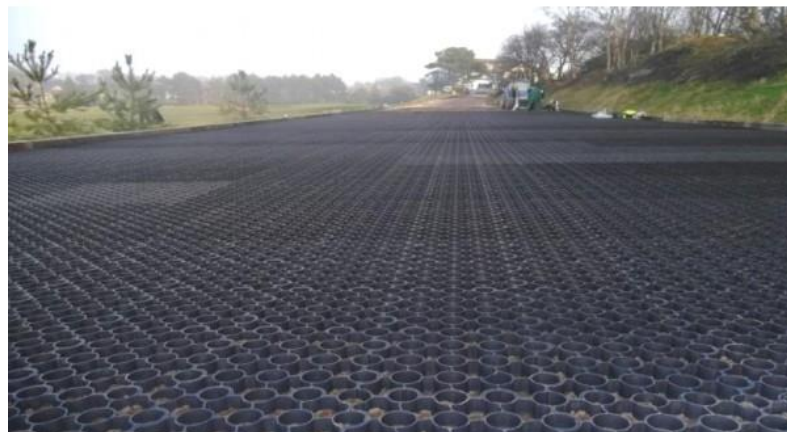
**Figure 4**

**Permeable Ground Protection Reinforcement Grid** – The permeable ground reinforcement grid is a modular paving solution offering a cost-effective and practical solution for reinforcing unstable ground. The product is Sustainable Drainage System (SUDS) compliant allowing unimpeded permeation of surface water through its open-grid design. A variety of infill materials can be used including gravel, soil, chippings, rubber crumb and many more. The module has been designed to encourage healthy grass growth whilst protecting roots. The role of this product is to transfer loads from the surface to a porous base course underneath, and to provide a stable and even ground surface which facilitates natural drainage. This can lead to significant cost-savings over traditional drainage systems on non-porous ground surfaces. This product is manufactured from 95-100% recycled mixed plastic waste from UK household waste collections, and is fully recyclable. Resistant against acid, oil, alcohol, petrol, strewing salt and ammonia and is UV stable giving the

product an expected lifespan of over 10 years. The load bearing capacity when used on a compacted sub-base is 250-320 tonnes/sqm, making it suitable for heavy goods vehicles.

- 7.4 A permeable grass grid will be used as a link between the existing concrete driveway and the proposed new building, including the turning point. Once laid, the surface can be left to colonise naturally or be planted with the appropriate wildflower mix. If seeded with wildflowers it will need mowing in July. For design and advice on how to created wildflower meadows; contact Middleton Ecological Consultancy.
