Ref: CLE20196.005.001  
Date: 25<sup>th</sup> March 2015

**RE: Daytime Bat Survey, Three Garages at Norcroft Cottages, Cawthorne S75 4DY**

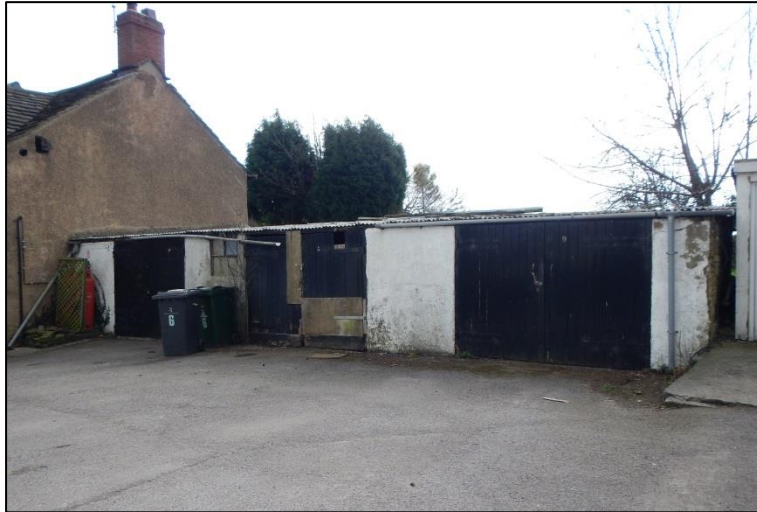
The building was a single storey, part brick, part stone built structure which was rendered on the north facing aspect. The roof was mono-pitched and comprised single skin corrugated material sheeting supported by wooden beams. Four single pane, wooden framed windows were present, one of which was boarded up. Potential access points for bats were observed at the top of some of the window frames and top of the wall plate leading into the interior of the building on the south and

west facing aspect, although following a detailed inspection of these features no evidence of bat usage was identified. The wooden doors on the north facing aspect had large gaps at the top which also could provide open access for bats into the interior of the building. Small areas of missing mortar were present between the stonework on the south facing aspect although following a detailed inspection no evidence of bat use was observed.

**Figure 1: North facing aspect of the garage building**

The garage building was assessed for its potential to support roosting bats and was deemed to have 'negligible' potential. The roof structure, well-lit interior of the building and absence of bat evidence indicate that the building is unlikely to be utilised by roosting bats. Some potential roosting features were identified in the exterior of the building however these features were thoroughly inspected with a high powered torch and endoscope where necessary and no evidence of bat usage was identified within the cavity. It is considered due to the sheltered nature of the cavities that if bats had utilised these features in the past evidence would have been observed. No further survey effort is therefore considered necessary for this building.

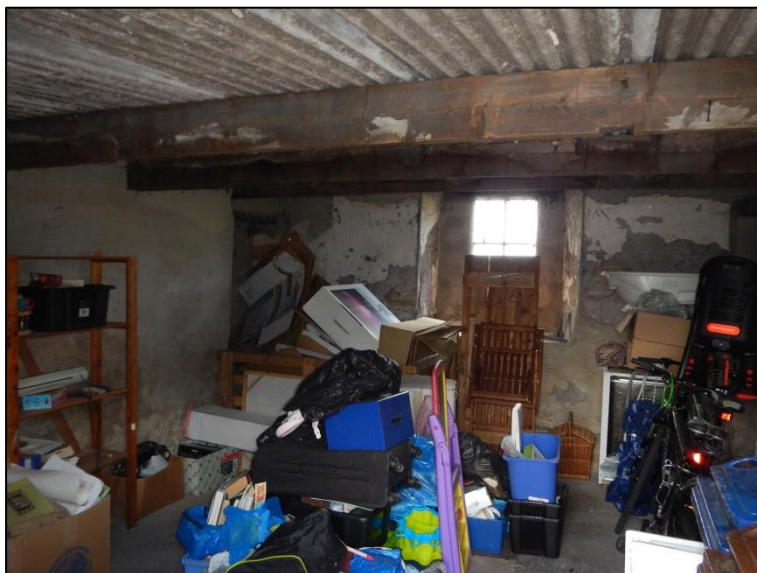
Internally the building was divided into three separate garages all of which were used for storage of household items. No loft space was present within the building and each section had a window resulting in a well-lit interior. The underside of the corrugating roof sheeting and the supporting wooden beams were visible and cobwebbed. Although during the external assessment access points were identified leading into the interior of the building, no features suitable for roosting bats were noted within the interior during the survey. Furthermore no evidence of bats, such as droppings was identified during the survey (although mouse dropping were recorded).

**Figure 2: Internal view of a garage compartment**
