**Whitcher Wildlife Ltd.
Ecological Consultants.**

8 CLIFF LANE, BRIERLEY.

BAT SURVEY REPORT.

Ref No: 250668.

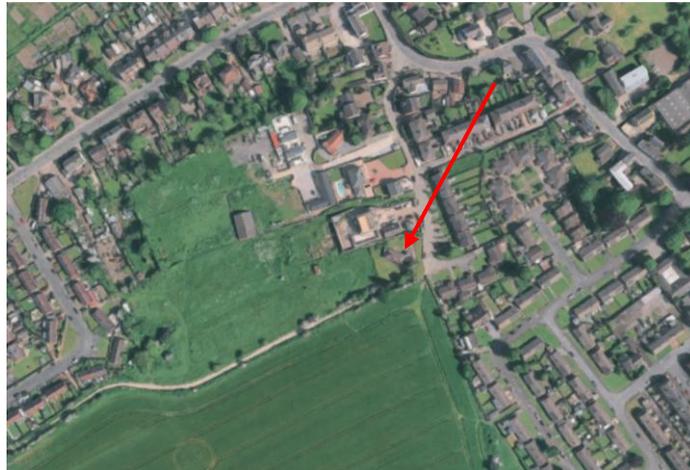
3.1.1. The surveyed area is a corner plot on Cliff Lane, Brierley, as shown by the red arrow on the aerial photograph below.

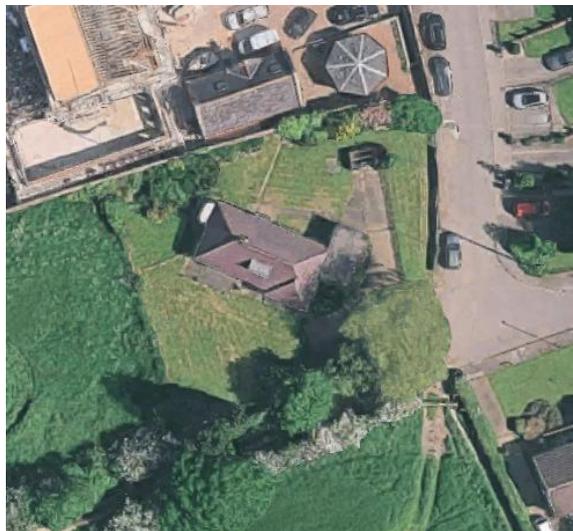
3.1.2. The site comprises a bungalow and an area of bare ground and grassland around that bungalow. The close up aerial photograph below shows the bungalow.

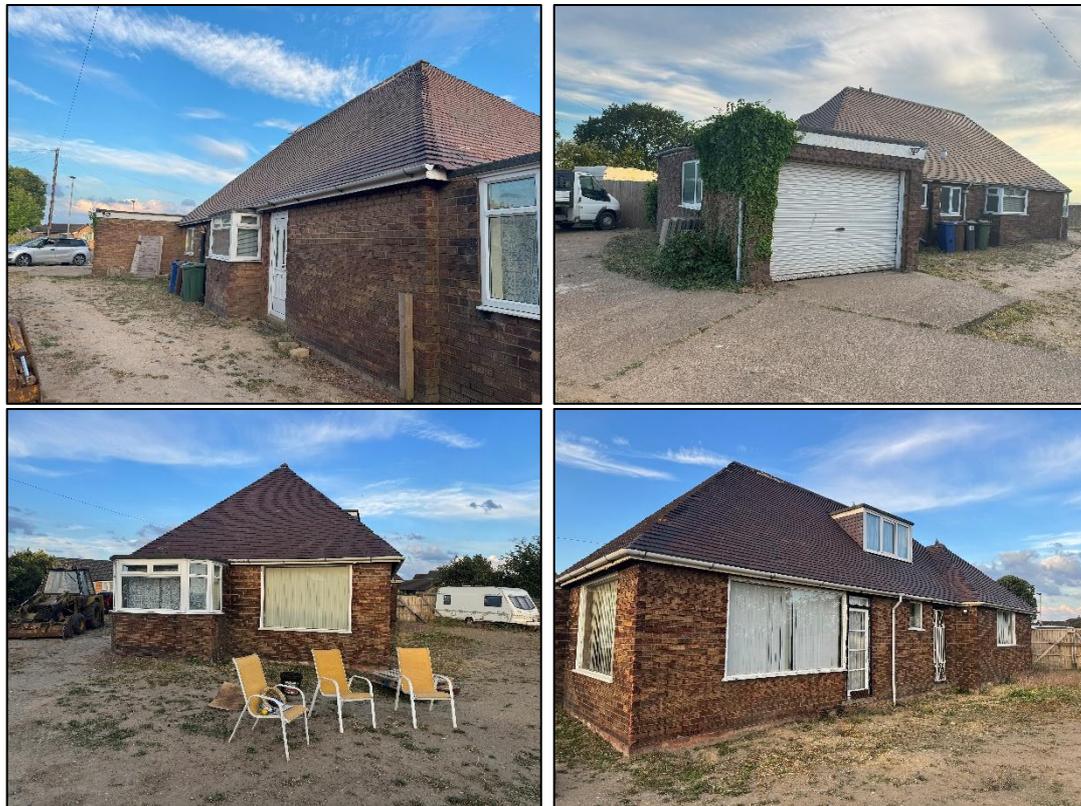
3.1.4. The site presently contains the bungalow and attached garage, as shown in the photographs below. The bungalow is a brick building with a hipped and pitched roof covered with Rosemary tiles and with a dormer window.

3.1.5. The garage is brick built with a flat timber and felt roof and with a timber fascia board. This latter is in poor condition and there is a clump of ivy over one corner.

3.1.6. The walls are all sound with no opportunities for roosting bats.

3.1.7. The bungalow roof is generally in good condition although there are some misplaced tiles at the western end of the ridge.

3.1.8. There are also gaps at the eaves where asbestos soffit boards have been removed.

3.1.12. When assessed in accordance with the Bat Conservation Trust Good Practice Guidelines, Edition 4, the bungalow and garage were assessed to have a low potential for roosting bats.

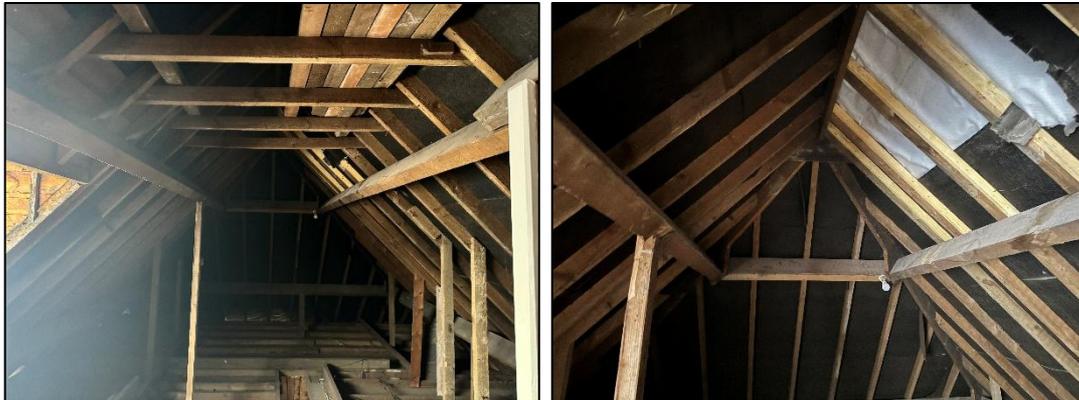
3.1.10. The loft space is open and has been stripped out, as shown in the photographs below. This was also done to remove asbestos.

3.1.11. The roof lining is all in place and there were no bat field signs present anywhere within the loft space.

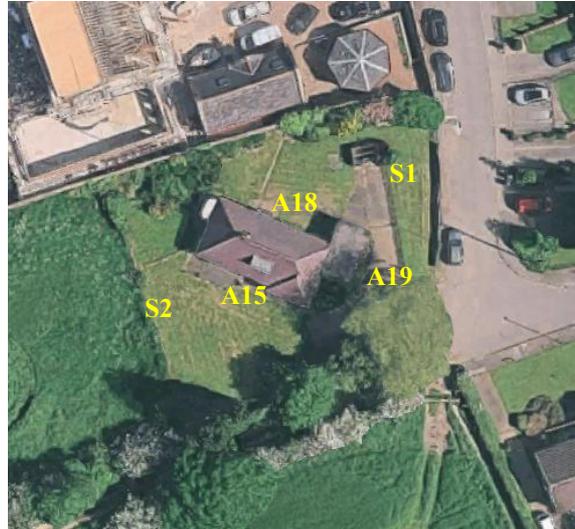
3.2.3. The position of the surveyors and the static Anabats are shown on the aerial photograph below where S is a surveyor and A is an Anabat.

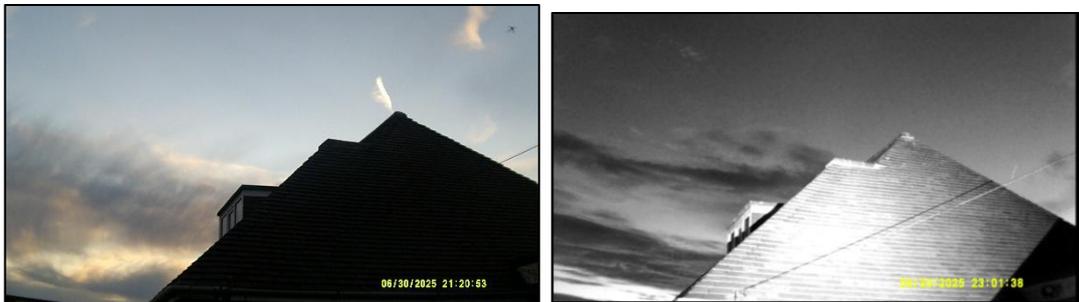
C1.

3.2.4. Three infra-red cameras and infra-red torches were also set up around the building, ensuring that all suitable features were covered. The photographs below show the view of each camera at both the start and towards the end of the survey when it was darkest.

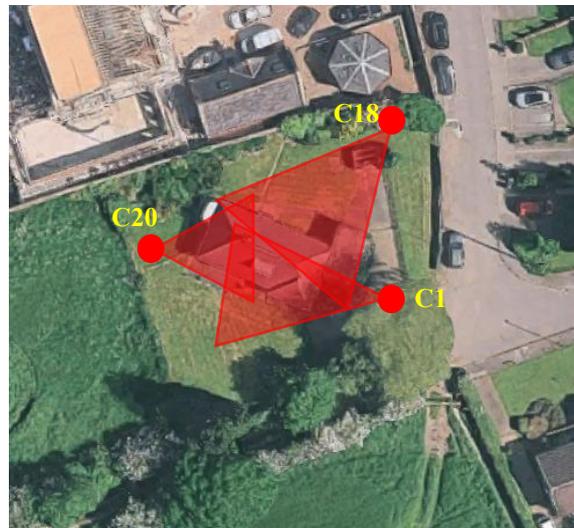
3.2.5. The aerial photograph below shows where the cameras were positioned along with their approximate field of view.
