**Whitcher Wildlife Ltd.
Ecological Consultants.**

**35A & 37A WASHINGTON ROAD,
GOLDTHORPE.**

BAT SURVEY.

Ref No:- 150739/1.

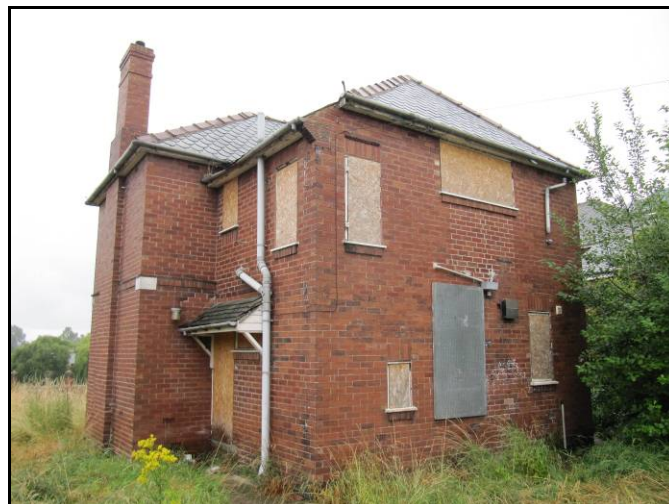
Fig. 2

3.2.2.1. 35A Washington Road is of brick construction and has a slate-tile hip and valley roof; see Figure 2. The brickwork is in a good condition, with the mortar present throughout and no damage apparently visible. The arrangement of the bricks indicates that a wall cavity is present.

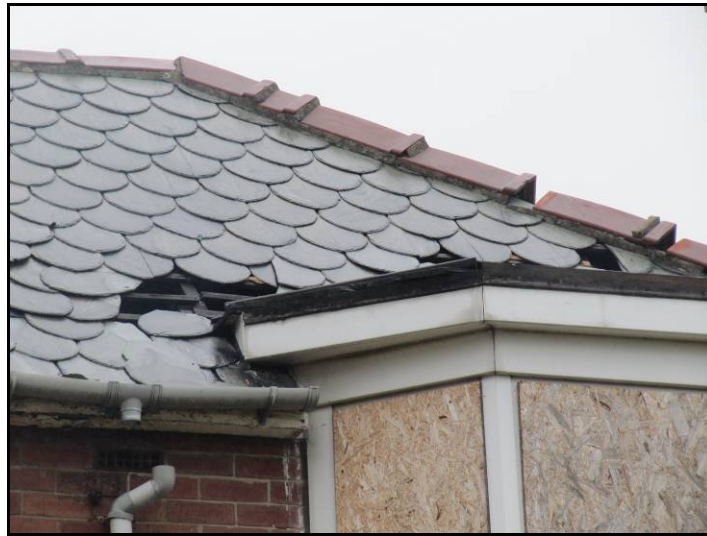
Fig. 3

3.2.2.2. The roof of building is damaged, with large areas of missing tiles discovered, as well as gaps between the ridge tiles; see Figure 3.

3.3.1. Gaps within the roofs and between slipped tiles of these two buildings could potentially allow bats to access into the interiors of the buildings. Crevices discovered between roof timbers could be potentially be utilised as roosting spots. No lining was present beneath the tiles of either of these buildings, and as such, the roofs themselves offer no roosting opportunities. No bats or bat field signs were discovered within either 35A or 37A Washington Road.

5.4. Nevertheless, individual bats can seek temporary refuge almost anywhere so it is recommended that the roof, lead flashing and fascia boards are all removed with care. In the unlikely event a bat is found, the bat should be covered and protected, work should cease at that location and Whitcher Wildlife Ltd immediately contacted for further advice.

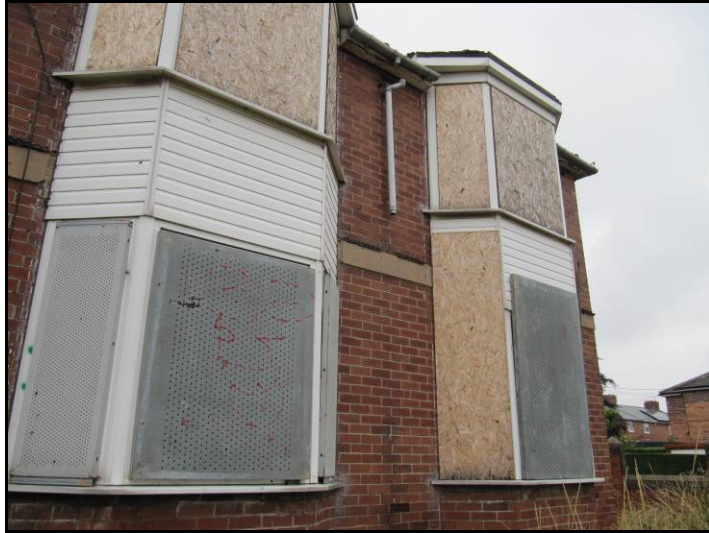
Fig. 5

3.2.2.4. uPVC clad bay windows are located on the southern elevation of the building; see Figure 5.

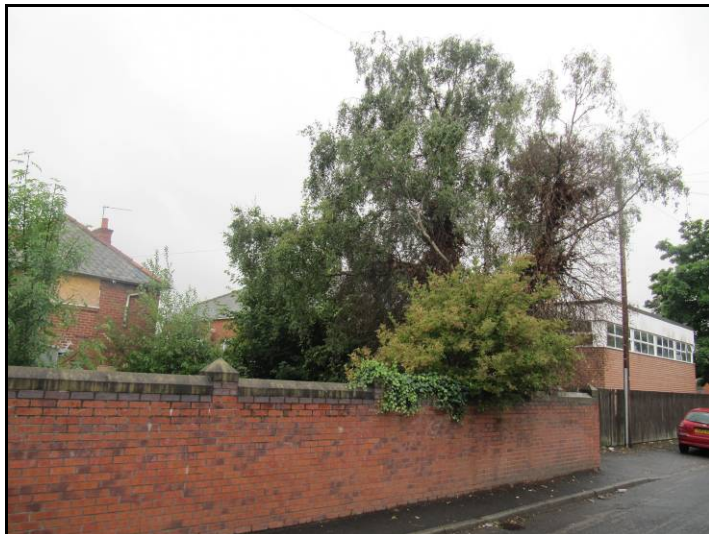
Fig. 6

3.2.2.5. Semi-mature trees are located within the north-west of the site; see Figure 6.

5.5. It is recommended that all works to the buildings or vegetation at the site take place outside of the bird nesting season, which extends from March to September. If vegetation clearance must take place within this period, works must be preceded by a bird nesting survey. If any active nests are discovered during this survey, they, and the surrounding structure or vegetation, must be left in place until the young have fledged.

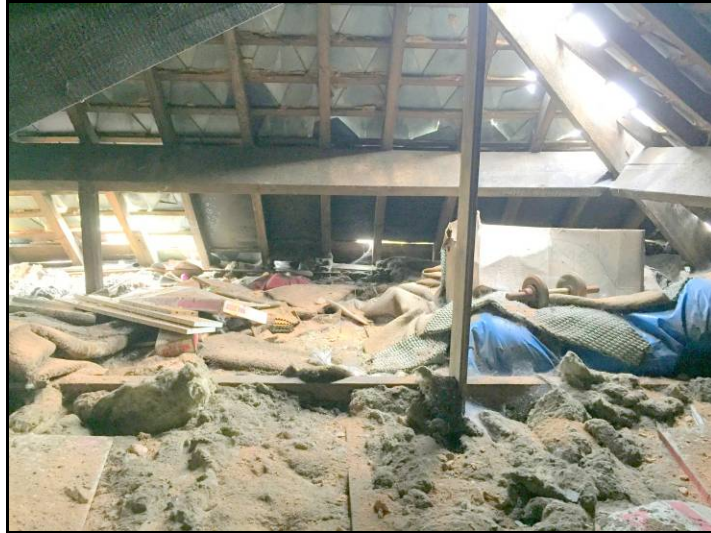
Fig. 7

3.2.2.6. Internally, this building has a vacant loft space. There is no lining beneath the tiles, with the underside of the roof open to the room beneath. The roof is of wooden rafter and purlin construction; see Figure 7.

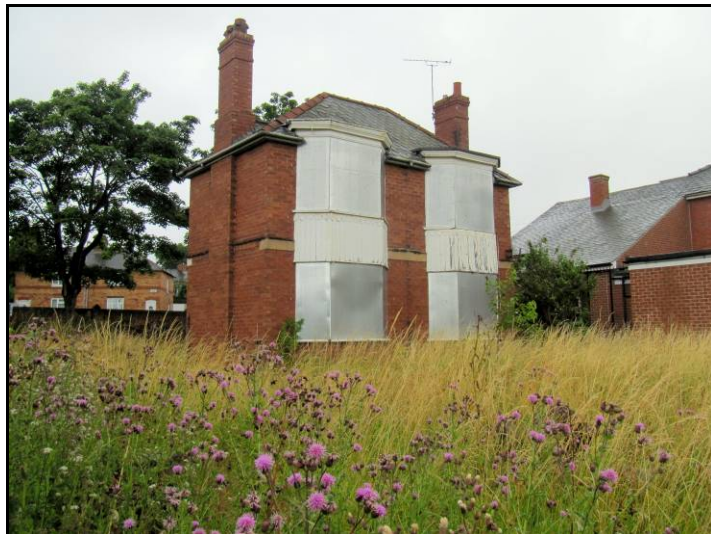
Fig. 8

3.2.3.1. 37A Washington Road is of brick construction and has a slate-tile hip and valley roof; see Figure 8. The brickwork is in a good condition, with the mortar present throughout and no damage apparently visible. The arrangement of the bricks indicates that a wall cavity is present. Wood-clad bay windows are located on the southern elevation of the building.

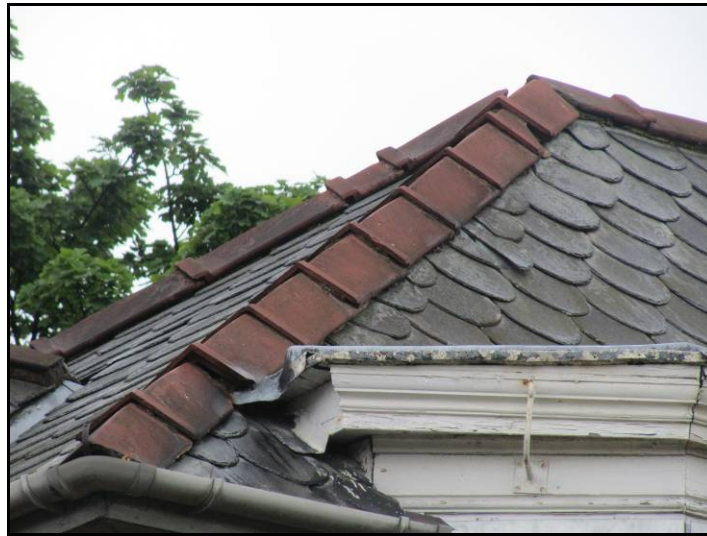
Fig. 9

3.2.3.2. The roof appeared to be in a reasonable condition; however, open lead flashing, slipped tiles and gaps between ridge tiles were discovered; see Figure 9.

3.3.2. Features around the exteriors of the buildings, such as open lead flashing, wooden fascias and open ridge tiles, are potentially suitable habitat for roosting bats. These features are small in extent, offering roosting potential for a low number of crevice-dwelling bats.

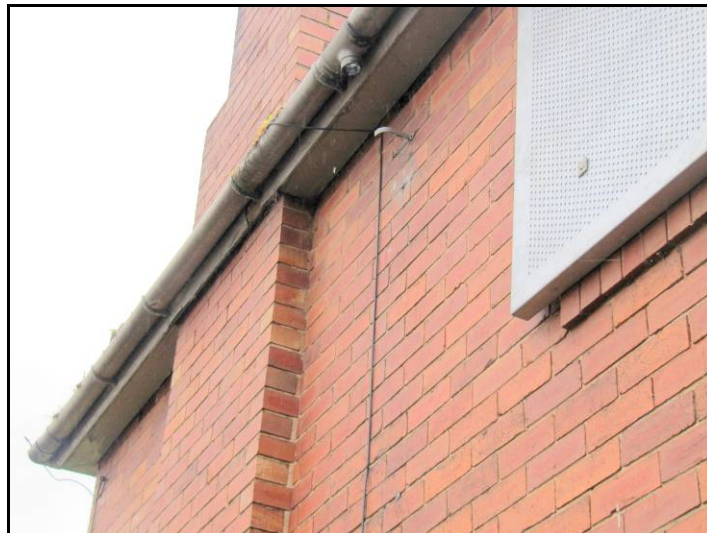
Fig. 10

3.2.3.3. Wooden soffits are located around the building; see Figure 10.

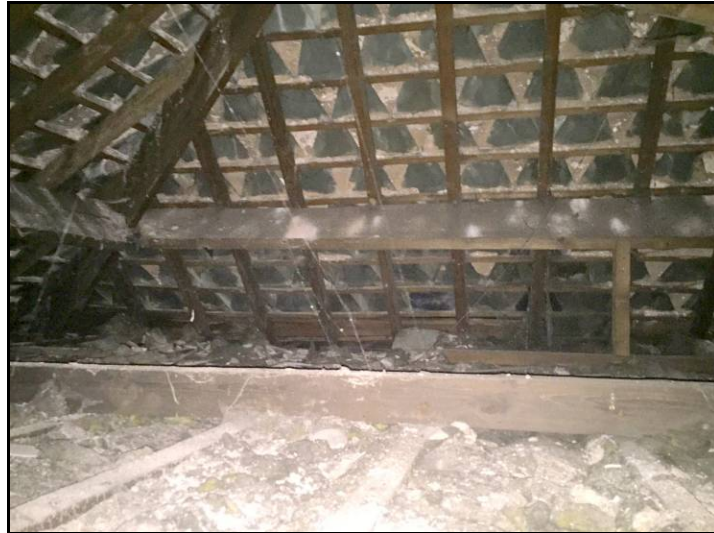
Fig. 11

3.2.3.4. Internally, this building has a vacant loft space. There is no lining beneath the tiles, with the underside of the roof open to the room beneath. The roof is of wooden rafter and purlin construction; see Figure 11.

3.3.3. A vacated pigeon's nest was discovered between timber joints within the loft of 37A Washington Road. Nesting opportunities were discovered throughout both buildings and within garden vegetation.

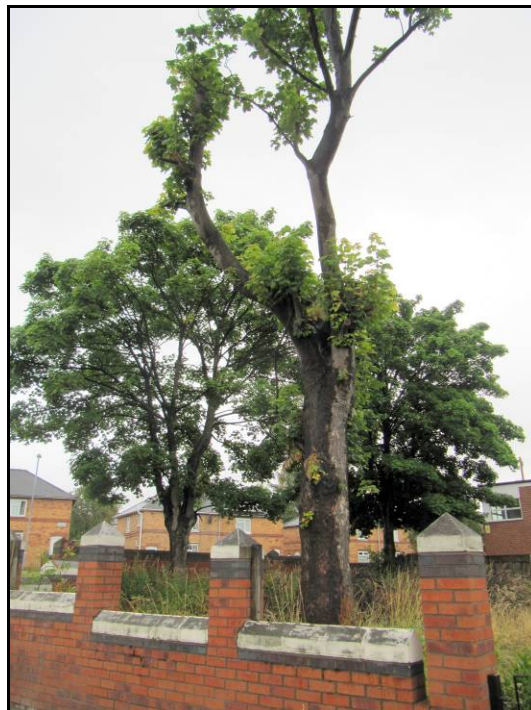
Fig. 12

3.2.3.5. Semi-mature trees are located along the northern and western extents of the site; see Figure 12.

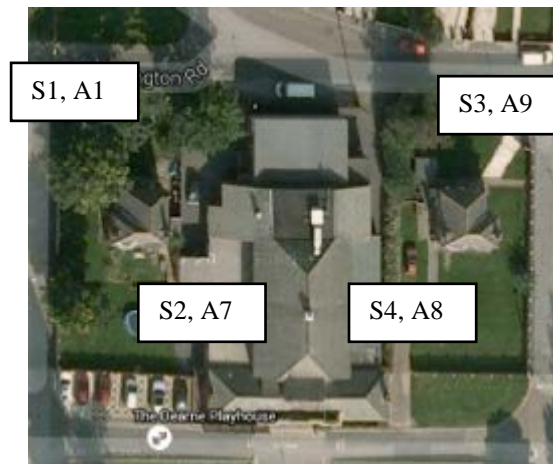
3.4.2. Four surveyors were positioned so as to be able to view all sides of the building simultaneously. Each surveyor (S) was equipped with a Batbox Duet detector and a two way radio and static Anabats (A) were placed with each surveyor, as shown below.
