# **Preliminary Environmental Risk Assessment**

Trinity Academy, Barnsley

July 2020

**Client Name:** Waterman Building Services  
**Document Reference:** WIE17125-100-R-1.2.1-RJM  
**Project Number:** WIE17125

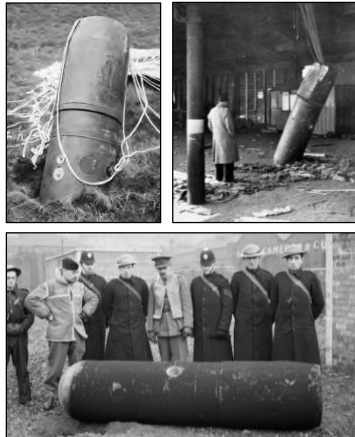
*‘118. Planning policies and decisions should:*

*c) give substantial weight to the value of using suitable brownfield land within settlements for homes and other identified needs, and support appropriate opportunities to remediate despoiled, degraded, derelict, contaminated or unstable land;*

*170. Planning policies and decisions should contribute to and enhance the natural and local environment by:*

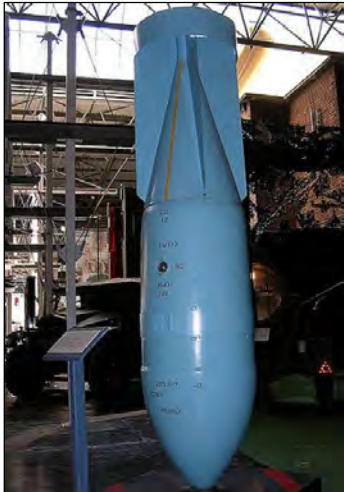
179. Where a site is affected by contamination or land stability issues, responsibility for securing a safe development rests with the developer and/or landowner.

183. The focus of planning policies and decisions should be on whether proposed development is an acceptable use of land, rather than the control of processes or emissions (where these are subject to separate pollution control regimes). Planning decisions should assume that these regimes will operate effectively. Equally, where a planning decision has been made on a particular development, the planning issues should not be revisited through the permitting regimes operated by pollution control authorities.

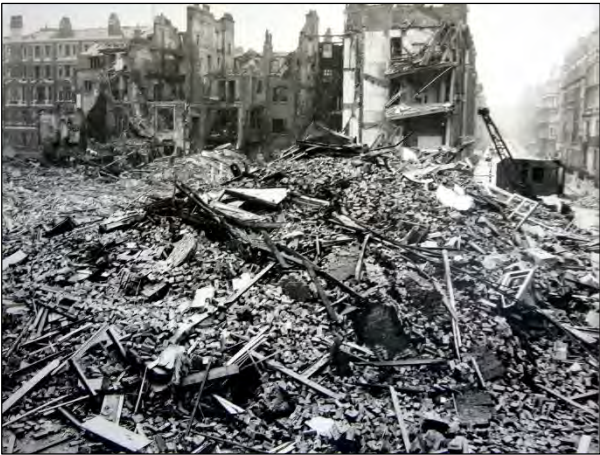
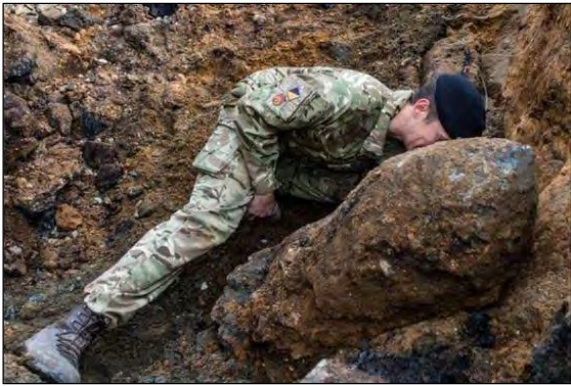
A review of historical maps obtained from Landmark Information Group has been undertaken. Figure 2

Figure 2: Historical Site Use
