**REPORT NO: D8947/02**

**GEOENVIRONMENTAL APPRAISAL FOR LAND AT  
NANNY MARR ROAD, DARFIELD – PHASE TWO  
PREPARED FOR:  
PARTNER CONSTRUCTION AND PERVERIL  
SECURITIES LTD**

| <b>Job Name</b> | Nanny Marr Road, Darfield – Phase 2 |

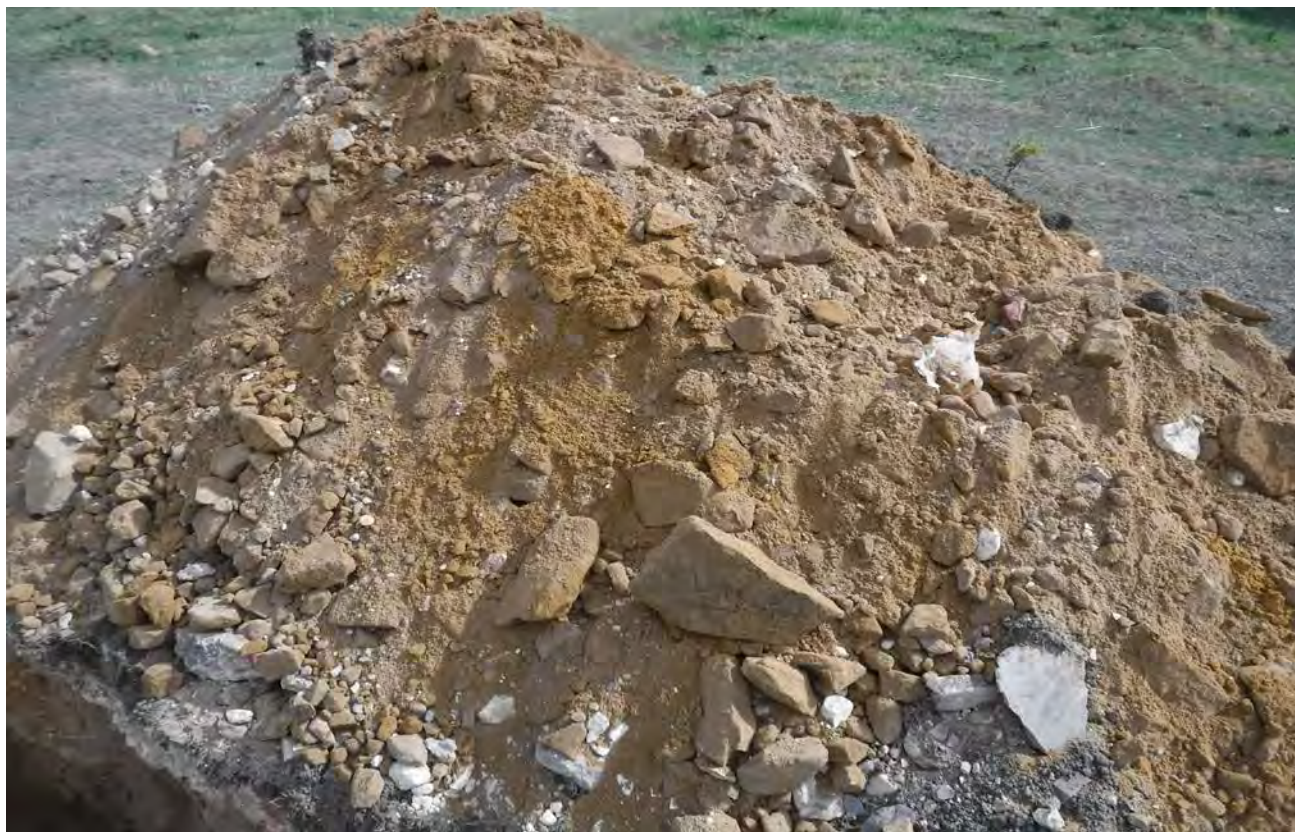
SA1 - 1

During excavation of the trial pits, the side walls were observed to be generally stable, some instability was noted within the soakaway trial pits below 1.70m.
