Bat Assessment  
Preliminary Roost Assessment

Saville Lane  
Thurlstone  
Barnsley  
South Yorkshire

Nationwide Structures Ltd

(15<sup>th</sup> February 2018)

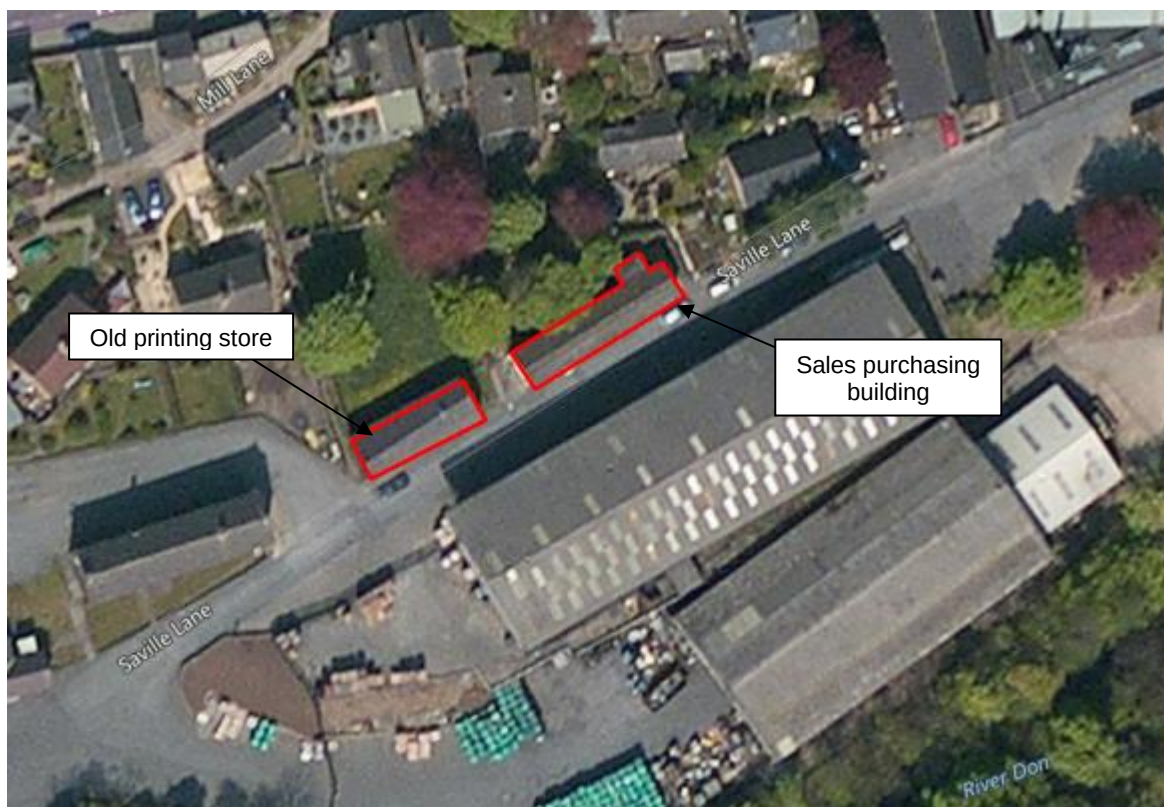
Figure 1: Survey boundary

The Site (grid reference SE 230 033) was located off Saville Lane in Thurlstone, South Yorkshire. The Site included two buildings: the sales purchasing office building and old printing store.

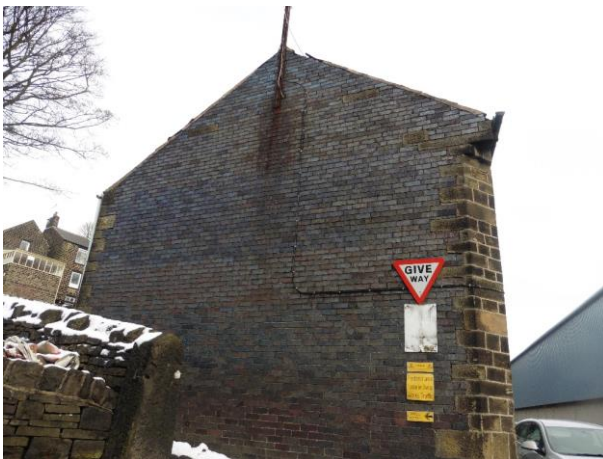
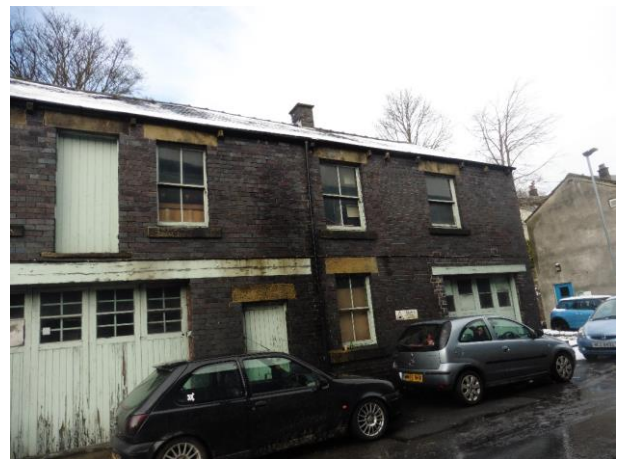
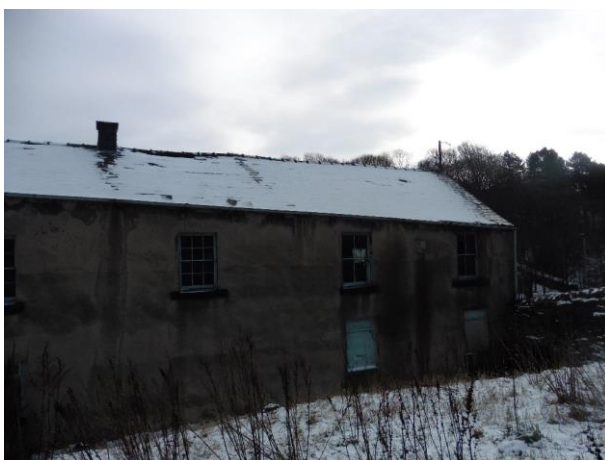
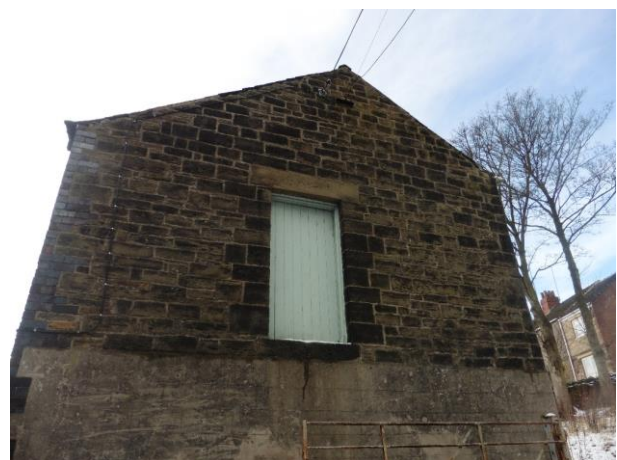
The old printing store was a two-storey gabled building, which was in a state of disrepair and was unused except for storage. The eastern gable wall was stonework, with the remainder of the building constructed in brickwork, with render on the northern elevation. The roof was finished in slate tiles with concrete ridge tiles and open eaves. The roof was unlined, and a large roof void extended across two thirds of the roof, with the eastern third open to the roof with no separate void. There were numerous large holes in the roof, allowing wind and rain into the building and the wooden ceiling under the roof void was rotting.

Western elevation

Southern elevation

Northern elevation

Eastern elevation

The licensed bat worker will inspect all suitable gaps in the brickwork and timbers in the old printing store with an endoscope immediately prior to disturbing works. The licensed bat worker will then supervise the removal of tiles at the ridge, gable ends and eaves. If evidence of bats, including droppings, is found works will stop while Natural England are contacted for advice on how to proceed.

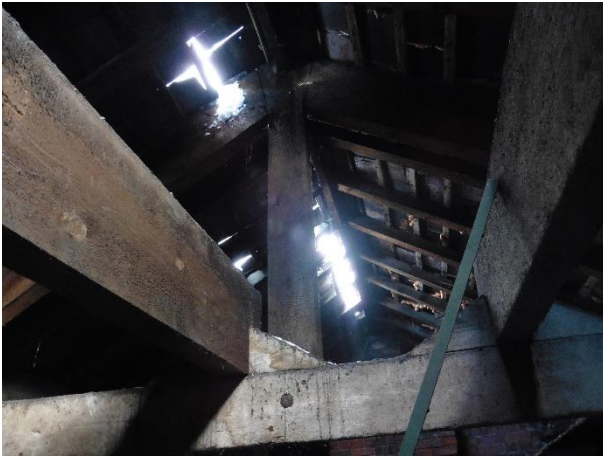
The roof was unlined and the numerous holes in the roof, windows and doors offered multiple opportunities for bats to enter the building, where they could fly through and access every room. However, the gaps also allowed in water

and light and resulted in a cold, draughty and lit interior, which was likely to be changeable in different weather conditions, reducing its suitability for roosting bats.

Large holes in roof allowing light and water into void

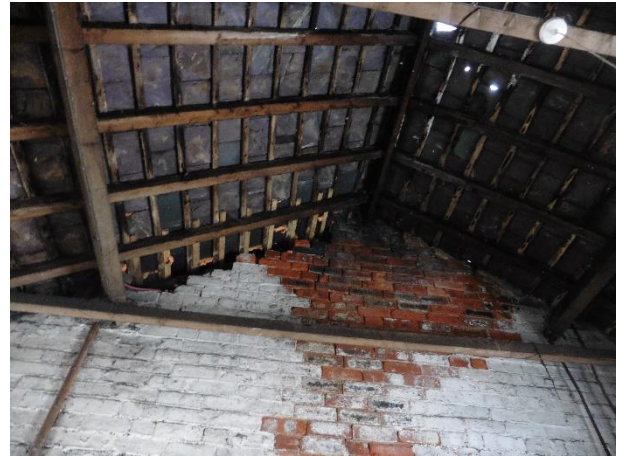
Eastern section open to roof and unlined

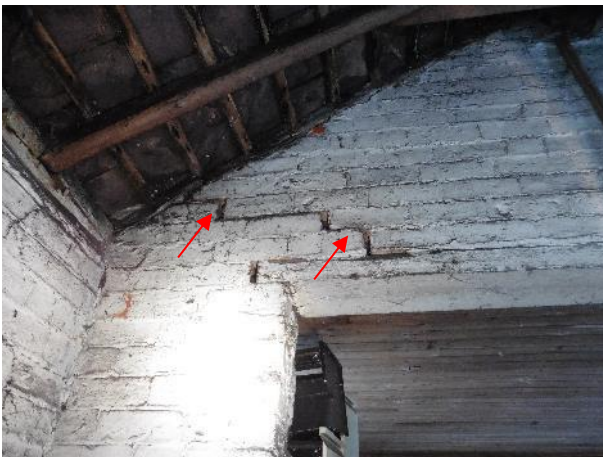
Internally, small gaps were present at the joins between ceiling joists and purlins and the walls and there were small cracks in the brickwork in places, which all provided shallow crevices suitable for roosting bats. All of the gaps found were inspected with a torch and found to be very heavily cobwebbed, suggesting that they had not been used by bats recently. Whilst the cold, damp conditions of the building would be favourable for hibernating bats, all of the gaps found internally were considered too exposed to the external conditions to provide a stable environment for hibernation.

Cracks in brickwork filled with cobwebs

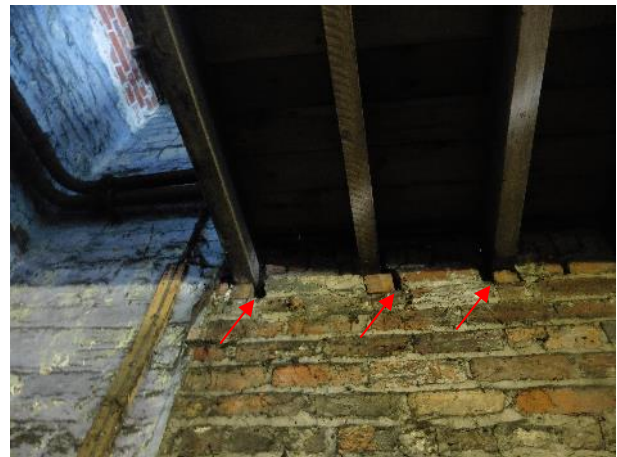
Gaps around joists filled with cobwebs

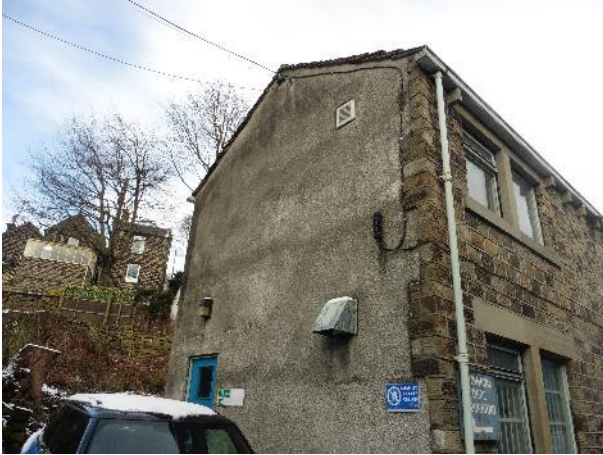
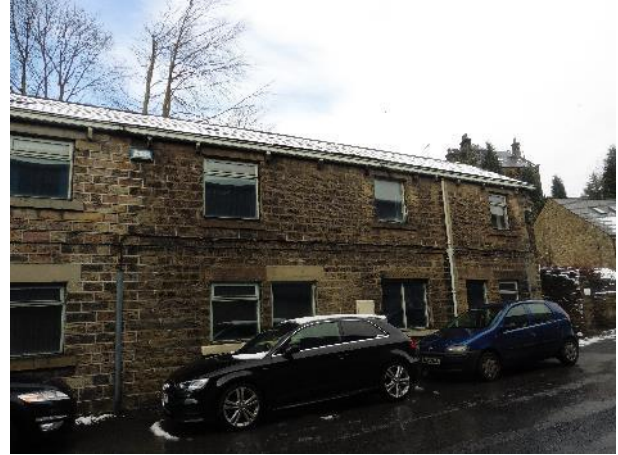
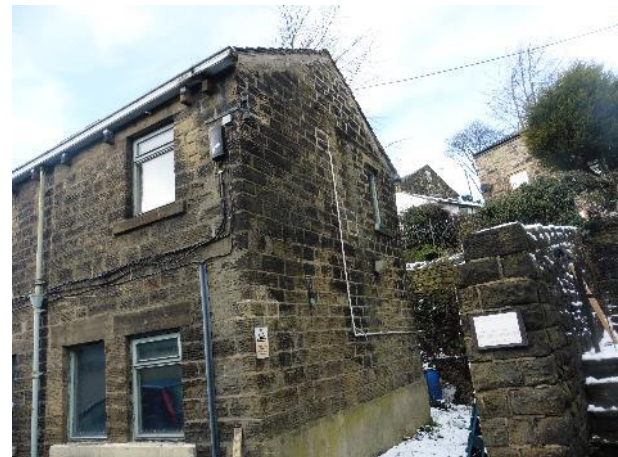
This building was a two-storey gabled building with a flat-roofed stairwell extension on the northern elevation. It had previously been used as offices but had been redundant for some time. The walls were constructed in a mix of stonework and brickwork with render on the northern elevation. The roof was finished in slate tiles with concrete ridge tiles. The flat-roofed extension was finished in bitumen felt. The roof was split into two separate voids, with a maximum of 1m height between ceiling and apex. The voids were supported with modern attic trusses, creating a cluttered internal space, with bituminous felt lining to the underside of the roof and rockwool-type insulation at ceiling level.

Western elevation

Southern elevation

Eastern elevation

The previous survey identified a single gap beneath a lifted tile on the southern elevation, with the building otherwise considered to be well-sealed. This updated survey found the building to be well-sealed, although it was possible, given the snow cover, that gaps between the tiles and lining could have been missed. However, the lining was noted to be tightly fitting to the underside of the roof, with no sagging or torn areas, which reduced the likelihood of any gaps between the slates and the lining being big enough for bats to use for sustained roosting.

The window and door frames, eaves and gable verges all appeared to be well-sealed or blocked by guttering, offering no apparent access points for bats.

The licensed bat worker will supervise the removal of tiles at the ridge, gable ends and eaves and any areas of raised tiles providing access to a gap between the tiles and lining. If evidence of bats, including droppings, is found works will stop while Natural England are contacted for advice on how to proceed.

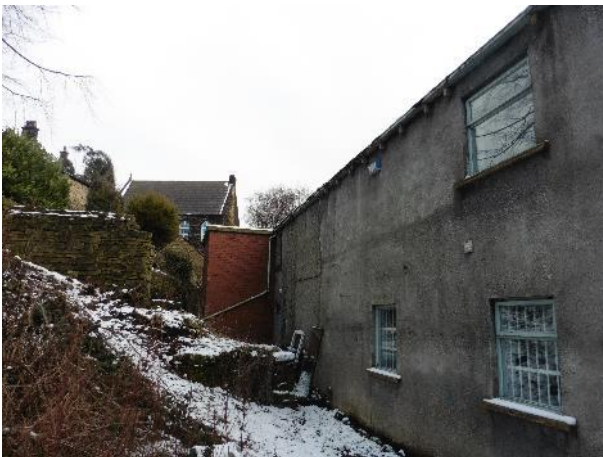
Northern elevation with flat-roofed extension

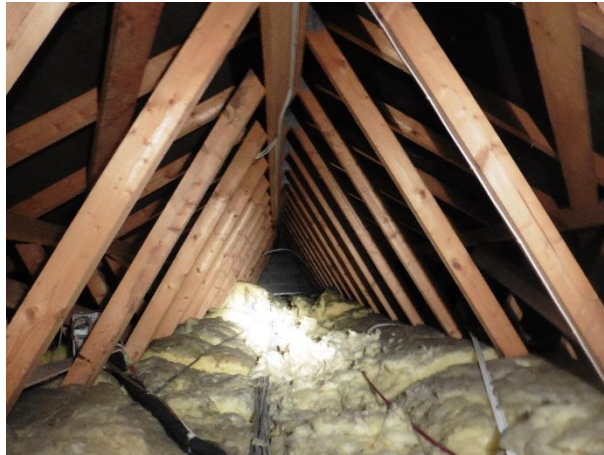
Internally, the office rooms offered no opportunities for roosting bats and there were no apparent gaps providing access into the roof voids, which were thoroughly searched.

Small, well-sealed roof void

No evidence of roosting bats or nesting birds was found in this building during the survey.
