# Darley Cliffe Hall, Worsbrough Assessment of Significance

**Darley Cliffe Hall  
Assessment of Significance**

**Prepared for Mark Ludlam**

**Jenny Wetton Conservation**

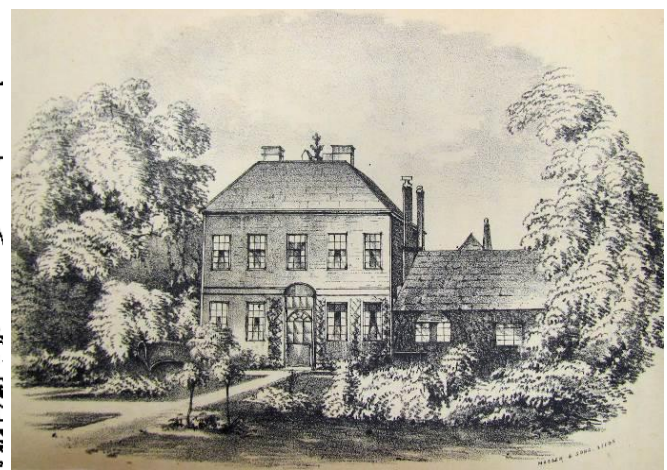
**Darley Cliffe Hall, 1872 (Wilkinson)**

Wilkinson includes an illustration of Darley Cliffe Hall in his book, *Worsborough: its historical associations and rural attractions*. Although this shows the front of the Hall, much of the remainder appears to include some artistic licence as it does not show the Jenny Wetton Conservation

walled garden at the front but a rather stylised garden with pathways and the windows are rather longer than they appear here.

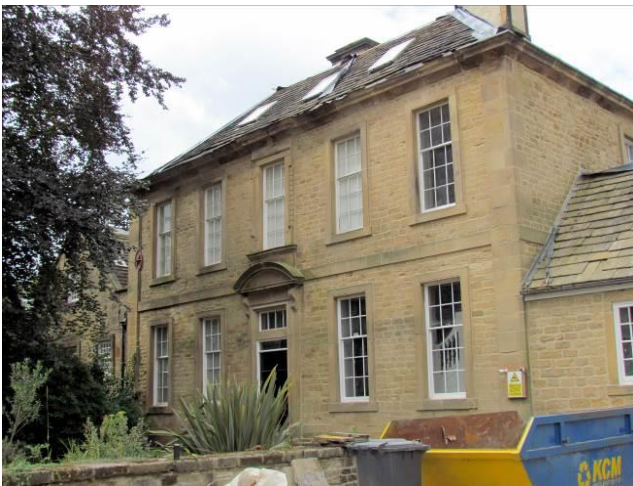
**Front Elevation**

Constructed in yellow sandstone on a stone plinth, Darley Cliffe Hall is two storeys with an attic and a basement. The front elevation is five bays in width and retains ashlar quoins, with the central entrance approached by round steps to the double door with a 4-pane overlight in a bolection-moulded architrave beneath a consoled segmental pediment. The ground and first floor retain unequally-hung 15-pane sashes in raised surrounds with bead-moulded inner arrises. The first floor is separated by a band and retains a central window in a shouldered and eared architrave in a rusticated panel. An eaves cornice breaks forward over the corners and centre. The hipped roof has 3 roof lights and retains 2 corniced stacks set in a roof well. On the right of the main facade is an old single-bay wing with a 3-light casement and capped end stack; a formerly adjoining outbuilding now has consent to be replaced. The rear elevation is similarly fenestrated to the front.

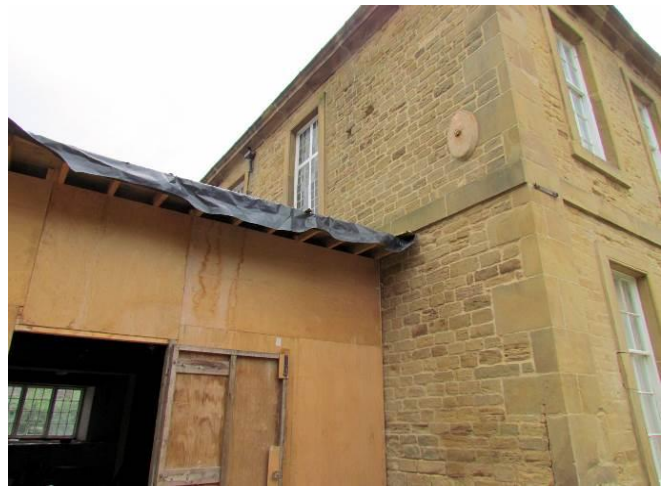
**North Elevation**

The north elevation has an original cross-window with 24 leaded panes to the lower lights and 12 panes above and a 15-pane sash similar to those on the front.

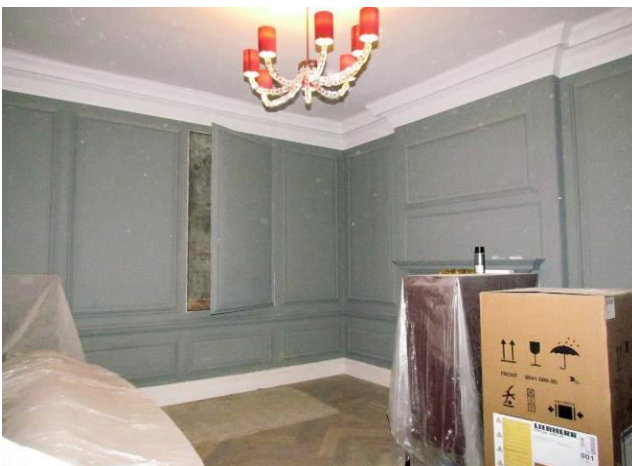
**The Dining Room**

The Dining Room is panelled with large rectangular softwood wall panelling with a chair rail, of which one panel is hinged to allow access to a cupboard formerly fitted into an earlier window behind but the panel below the opening is significantly cracked. As the panelling runs over the external window on this side, it clearly post-dates the 1680s and may date from the early 18<sup>th</sup> century. Behind the opening, the wall can be seen to have been plastered internally and there is a historic stone threshold. The fireplace retains a crinoidal limestone facing set in timber surround with a carved panel of dog on bridge, which Thornborrow assesses to be mid-18<sup>th</sup> century in date<sup>6</sup>. The panelling above the fireplace appears to have been altered, with two panels rather than one large panel, as is the case elsewhere in the house. The doorway into the Drawing Room retains a panelled reveal of a different pattern to the 6-panel door fitted which, although of a standard pattern, is also different to other 6-panel doors on the first floor and may be a later replacement. Other rooms are discussed in Section 4.5.

been replaced and has been dated by Thornborrow to the mid-18<sup>th</sup> century, with resultant change to the pattern of panelling on the chimney breast. There is a standard pattern 6-panel door from the Dining Room to the Drawing Room which does not match with the pattern of panelling on the doorway reveal or other 6-panel doors on the first floor and also appears to be a replacement. There are at least three phases of development represented in the Dining Room, which has been substantially changed.

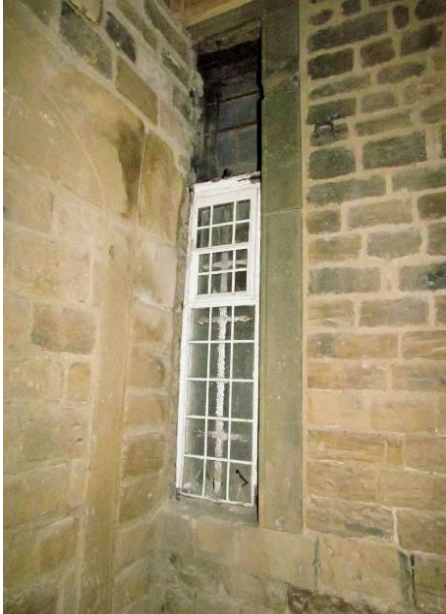
***Formerly Exterior Face of Window***

The WC window can be seen on the formerly exterior north face to be a narrow timber top-opening casement fitted into the space left when an infill wall was added between 1855 and 1890, running across the window on the main range. The window is fitted with stippled glass and probably dates from the mid-20<sup>th</sup> century. Above the window, a section of the historic frame of the 17<sup>th</sup> century cross-window can be seen, with two

metal glazing bars. The stone surround also has a diagonal cut on the right side, possibly evidence of a former lean-to roof.

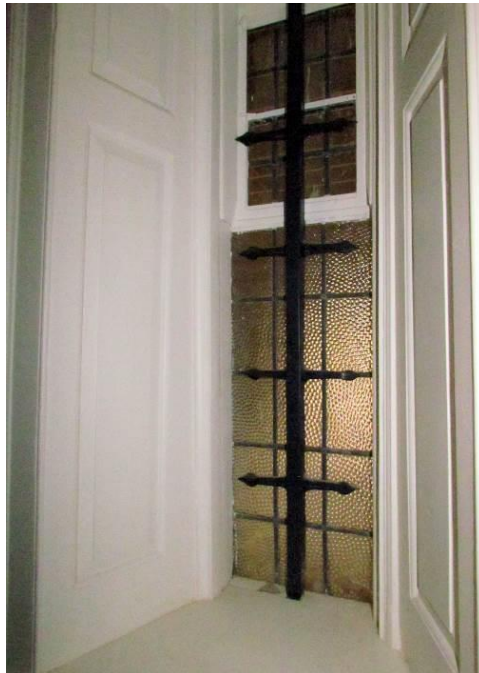
***Interior Face of Window***

Internally, the W.C. retains a panelled reveal and iron window bar which appear to be 19<sup>th</sup> century in date.

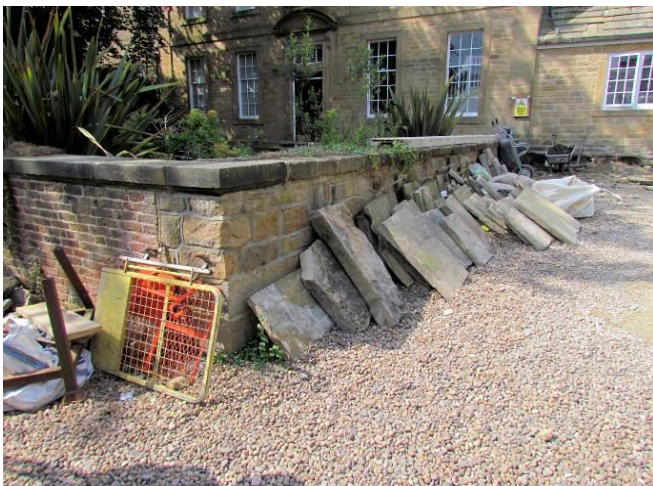
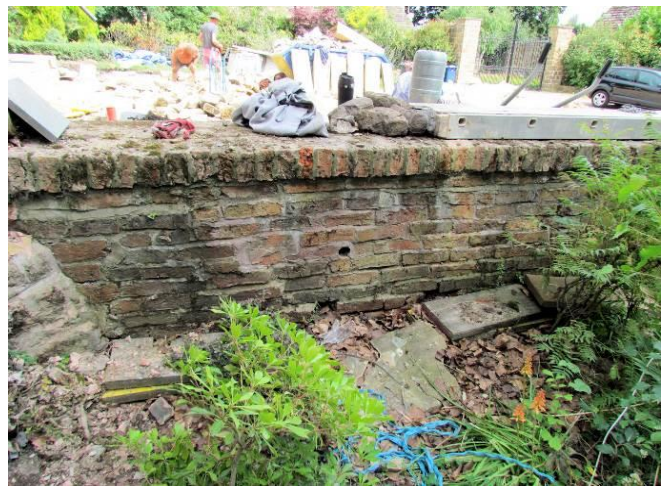
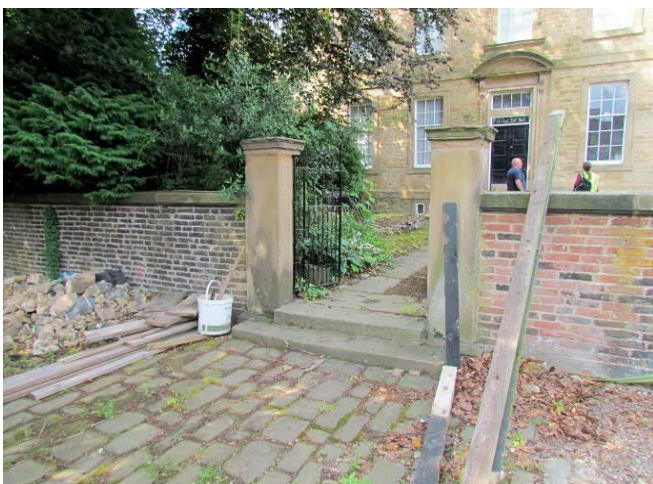
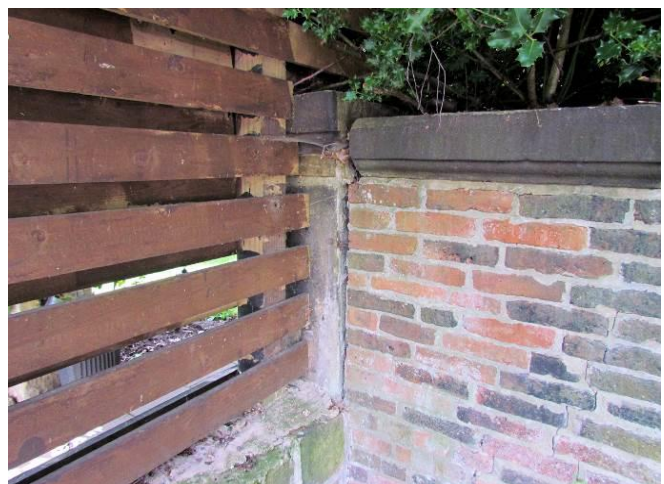
In front of the main elevation is a historic front garden wall which retains a plinth and soffit-moulded copings to the rectangular enclosure, dated by Thornborrow to the 17<sup>th</sup>

century<sup>7</sup>. The listing description of 1986 mentions square end piers which can be seen in a photograph dated 1983 and shown by Elliott but which cannot be reproduced here for copyright reasons. In this photograph, the wall continues northwards, but built in stone, and the piers may have been removed when the stone extension wall was moved to enclose the north side of the garden in front of the Hall, although a stone pier is retained in the south-east corner of the garden. The north wall is lined in historic bricks on the rear face and with brick copings behind the stone copings, although re-pointed in a cement-based mortar. The front wall retains central ashlar gate piers but the flanking consoles, cornices and vase finials reported in the listing description to have been set to each side have also gone. Horse-mounting steps and a platform on the left return of the wall also mentioned in the listing description were not visible at the time of survey for this report. Part of the front wall has been re-built in brick.

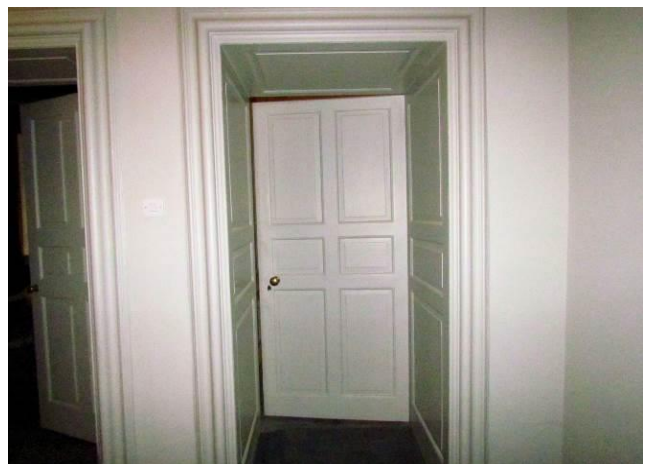
There are 6-panel doors of a non-standard design leading to all three bedrooms but which match the panelled reveals and which therefore appear likely to be historic.

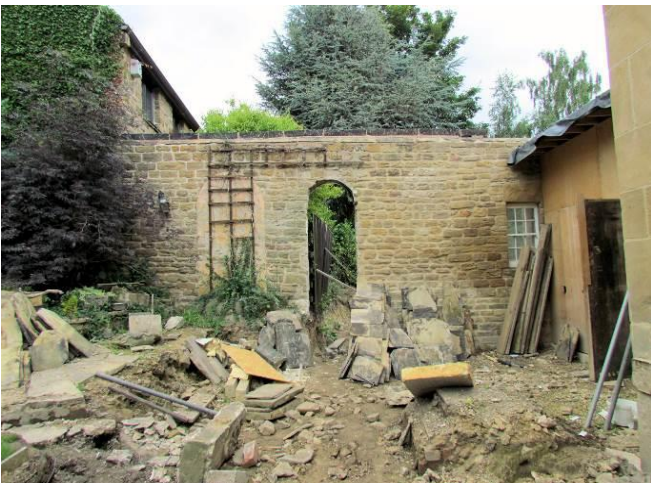
***North Wall of Rear Garden***

A length of a tall stone wall with flat stone copings on the north side of the rear garden was formerly attached to an outbuilding which was itself joined to the Hall by an infill in the mid-19<sup>th</sup> century. There is now consent to replace the outbuilding, thus breaking any link with the listed building and the wall is not considered to be listed, although it does clearly fall within the curtilage of the listed building. A tall arched opening has been inserted to provide access to the side garden and a textured surfacing applied nearby behind a trellis.

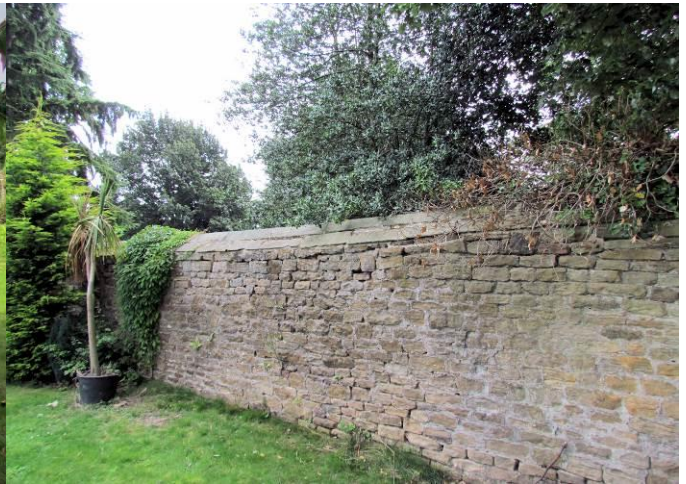
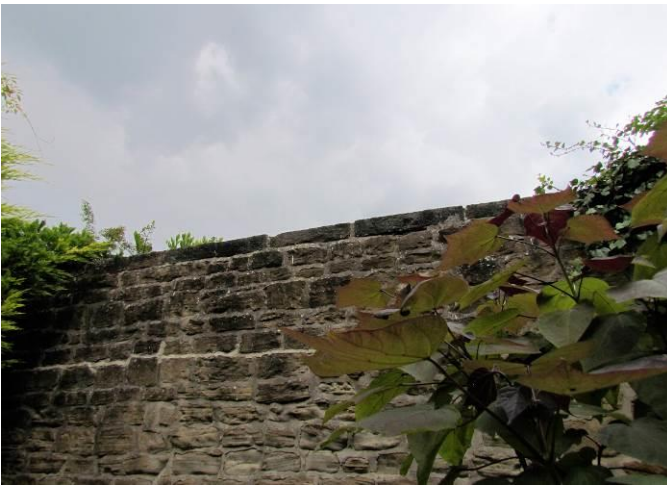
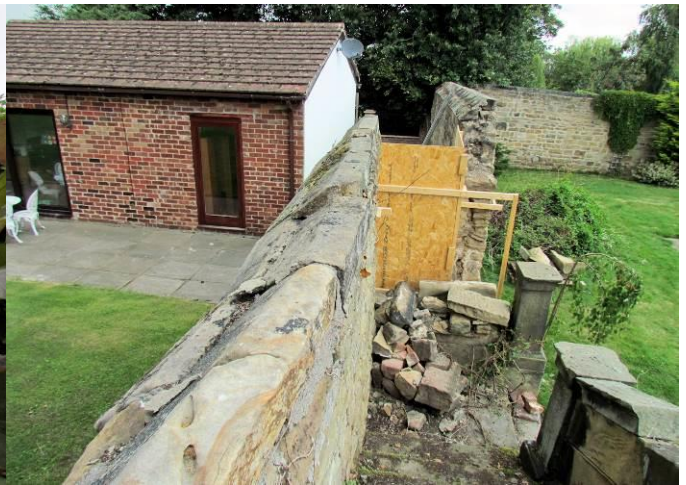
To the west of the rear garden is a walled garden, shown on the 1840 map, which would have provided Darley Cliffe with fruit and vegetables. It is shown on the 1890 map to have had trees, paths in the northern section and glass houses. The garden is accessed via a decorative timber door, now in poor condition and covered with a panel, and set in a stone doorway. The walls show three different phases of construction, with flat copings on the north side, pyramidal copings formed of sections of roofing

slabs on much of the south and the east side and large triangular copings on the west side. The garden is on three levels, with two sets of stone steps which were re-built in 2020, based on Historic England guidance on access for disabled people but which are not finished. A fishpond has been added to the top level, probably in the late 20<sup>th</sup> century or early 21<sup>st</sup> century and in keeping with ponds provided in walled gardens as a source of protein. In the south-west corner is a ruined structure shown on the 1840 map and in a photograph from 1991 by Elliott to have been a two-storey tower roughly square in shape, with quoins, a stone doorway and a square stone window on the ground floor and a rectangular central window on the first floor<sup>16</sup>. To the right is a large set of stone steps which retain an ashlar balustrade, two sections of a moulded handrail and two moulded piers. The west wall is in very poor condition, having collapsed in one section and now propped.

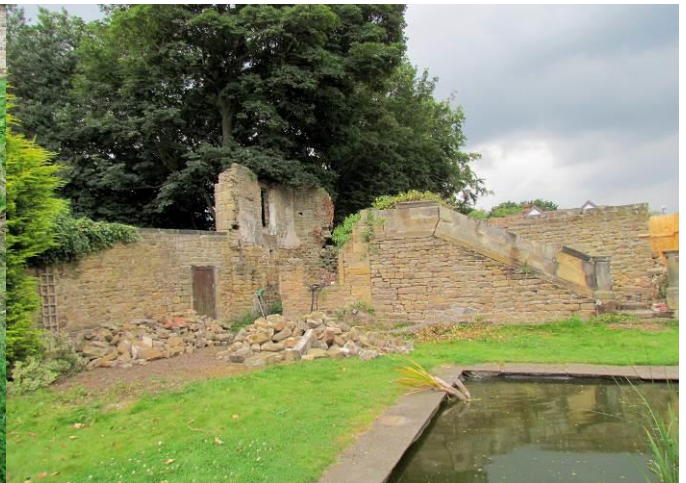
***Ruined Structure***

**The setting is considered to make a positive contribution to the significance of the listed buildings, although the very poor condition of the west end of the walled garden presents a poor aspect to the distinguished nature of the Hall.**
