RESIDENTIAL DEVELOPMENT AT HOYLAND LOWE, PHASE 1

AN ARCHAEOLOGICAL DESK BASED ASSESSMENT  
OSA REPORT No.: OSA16DT24

August 2016

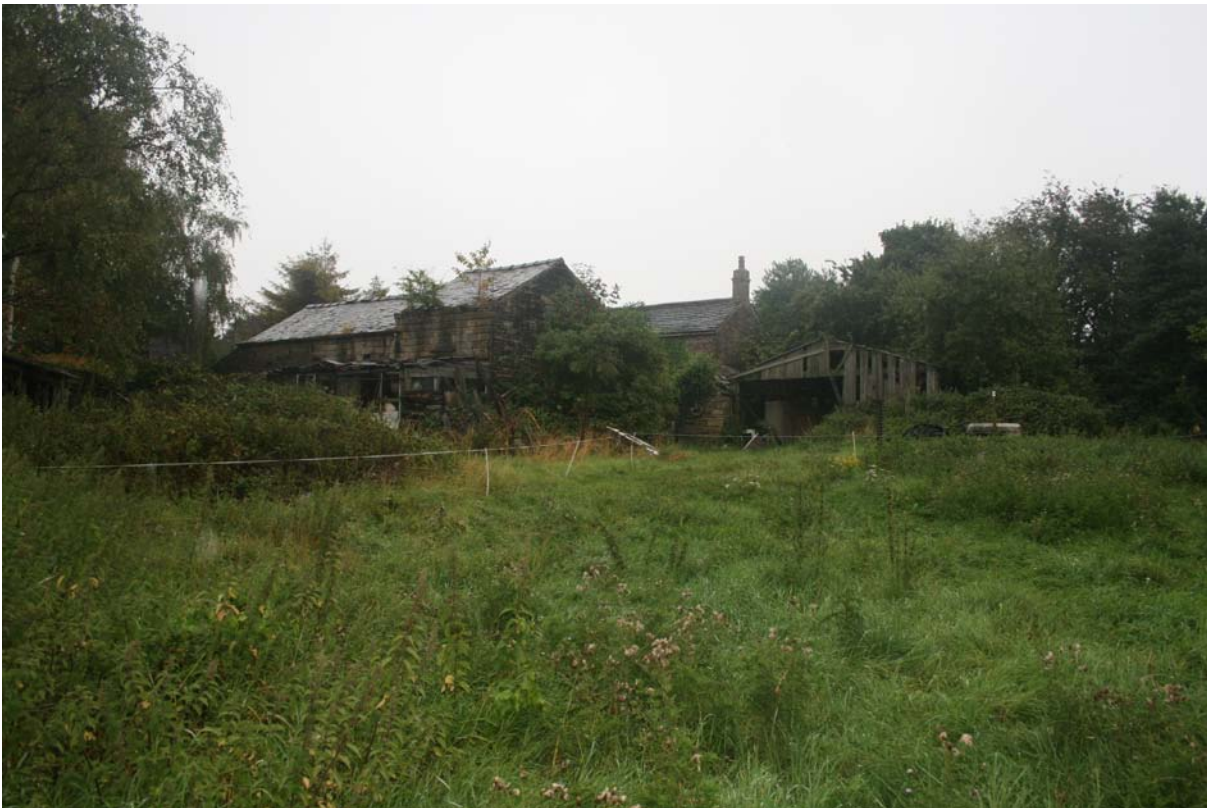
*Plate 4. Farm buildings in southwestern boundary of site, looking S. The stone buildings will be unaffected by the proposed development although the timber lean-to will be demolished*
