COAL MINING INVESTIGATION REPORT

job number	C2812/23/E/5254	date	16.06.2023
site address	Land North of Cooper Lane, Hoylandswaine, Sheffield, S36 7JE		
written by	S. Alexander	checked by	T. Merry
issued by	S. Alexander

Report on a Geotechnical Investigation

Location: Land North of Cooper Lane,
Hoylandswaine, Sheffield, South Yorkshire, S36 7JE

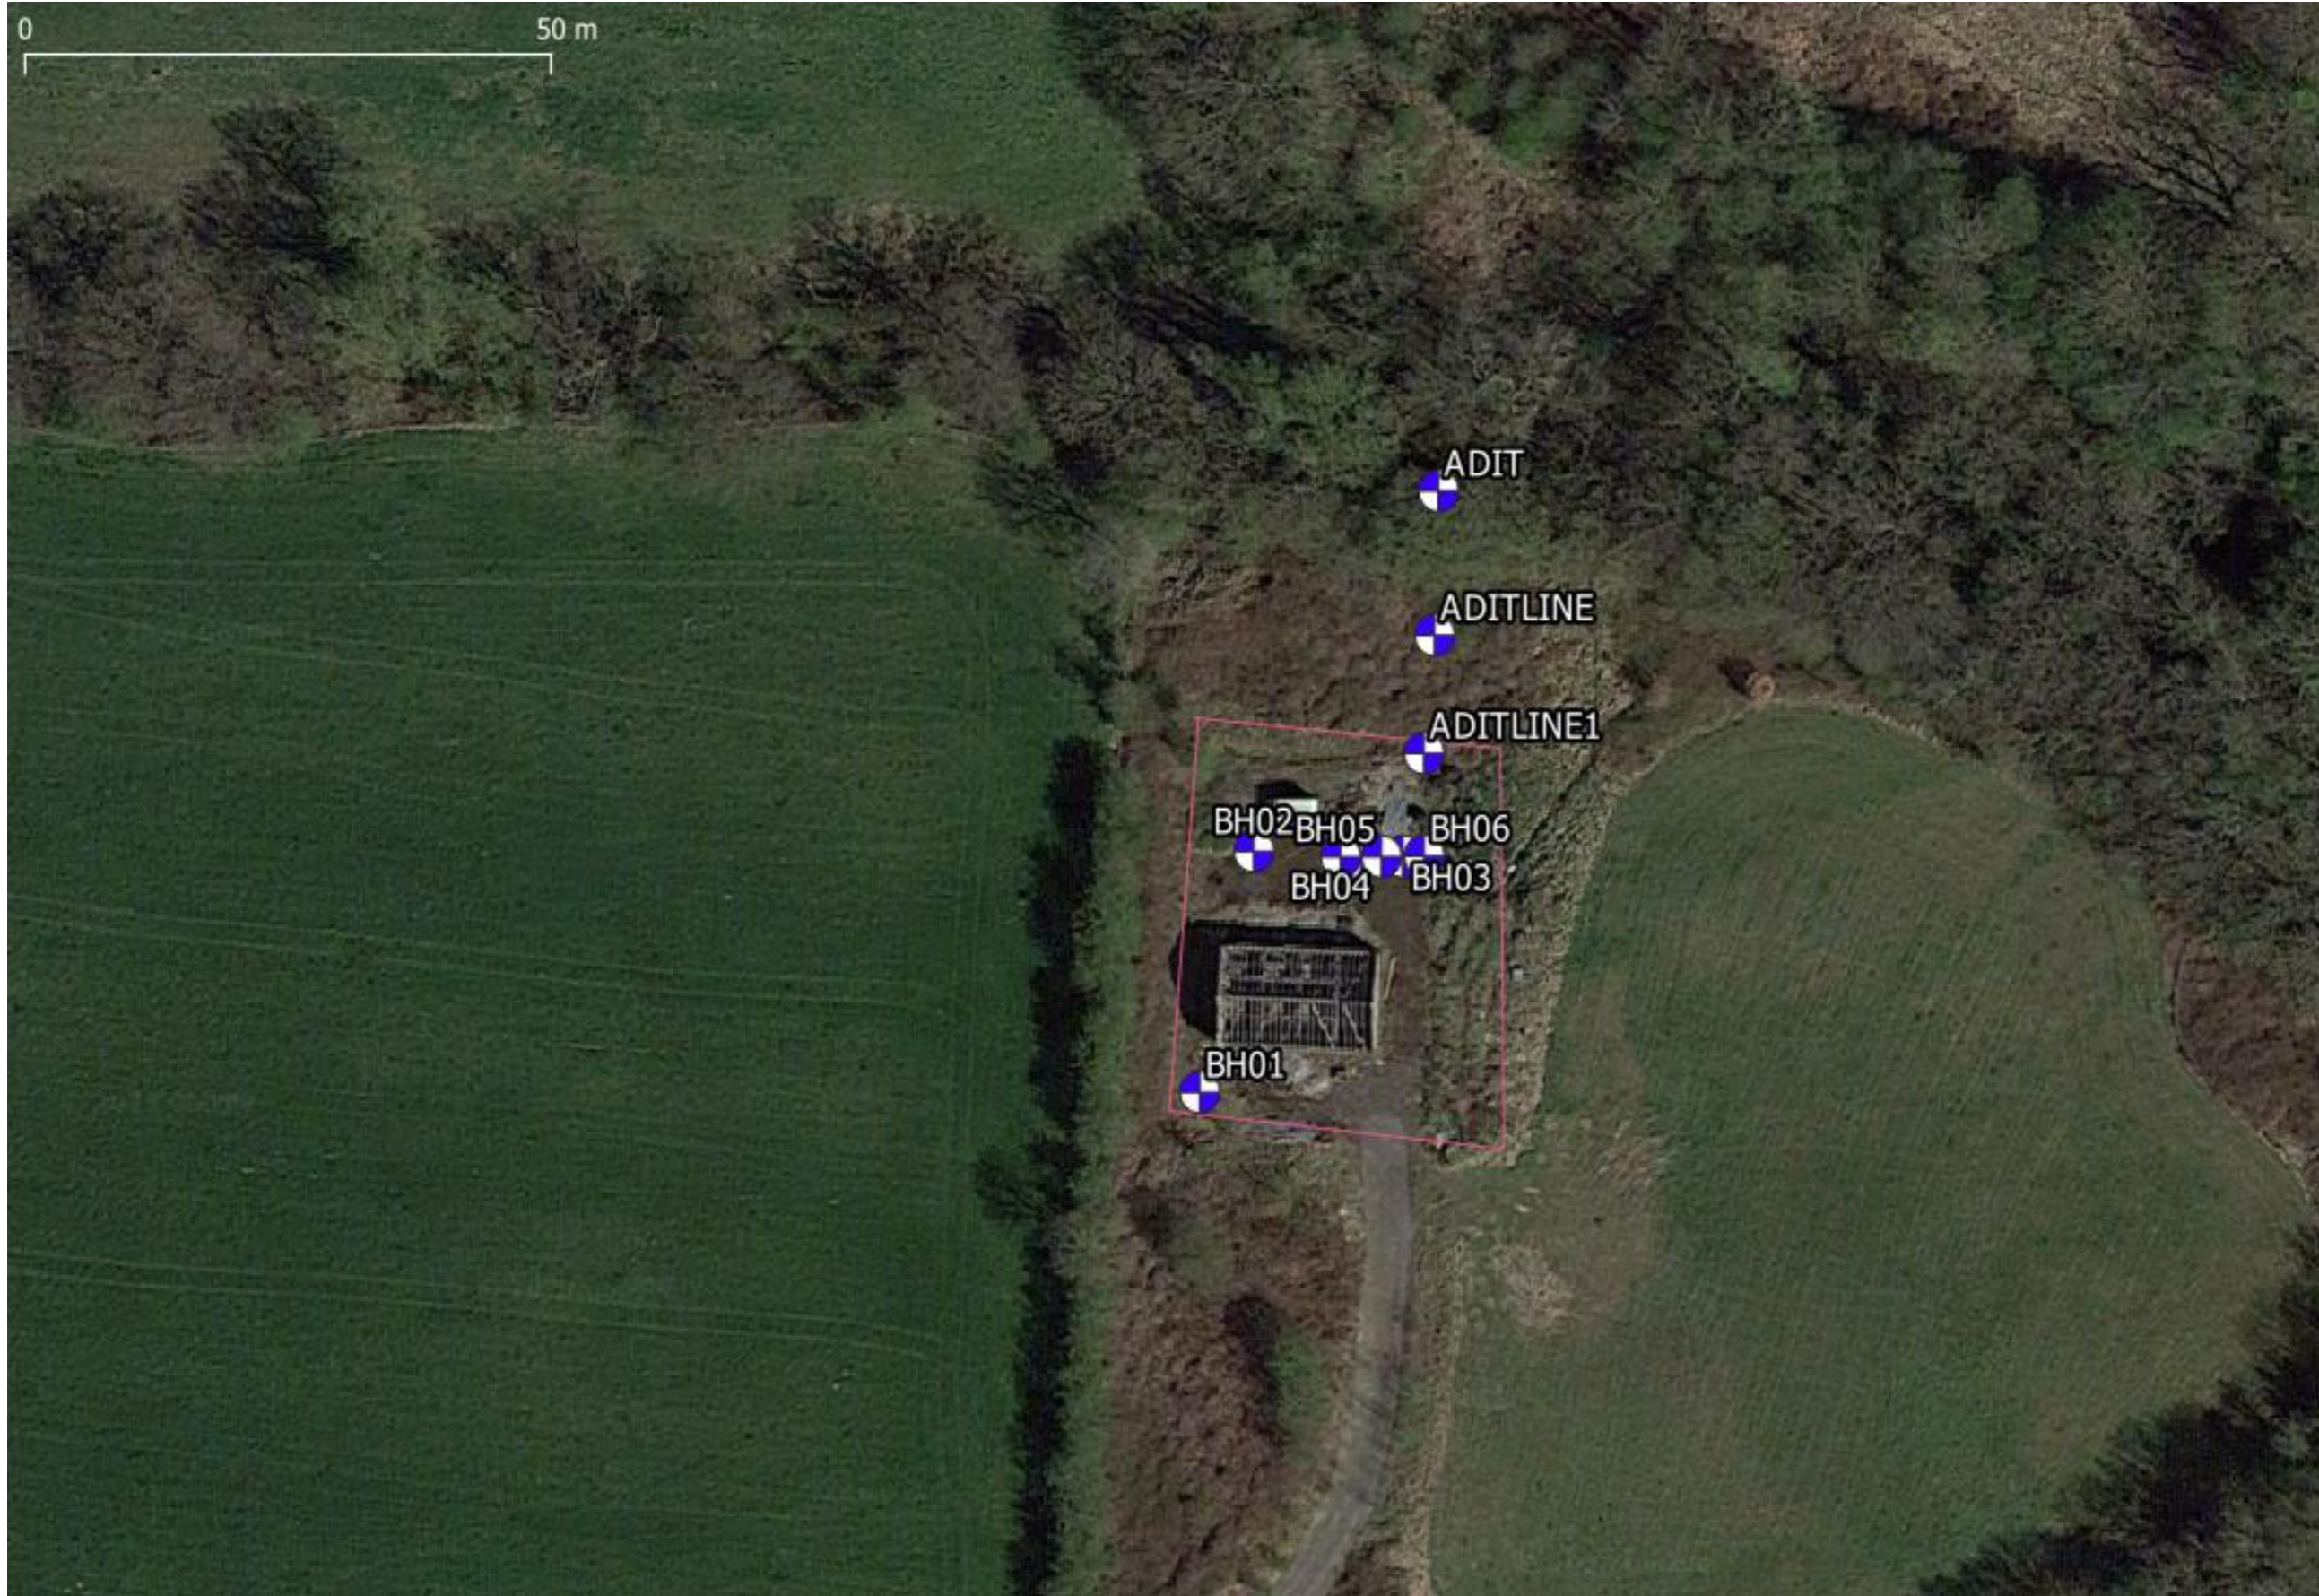
Site Plan

Investigation positions approximated from site operative's notes.

The investigatory locations are shown on the site plan which is presented in Appendix 1 to this report.

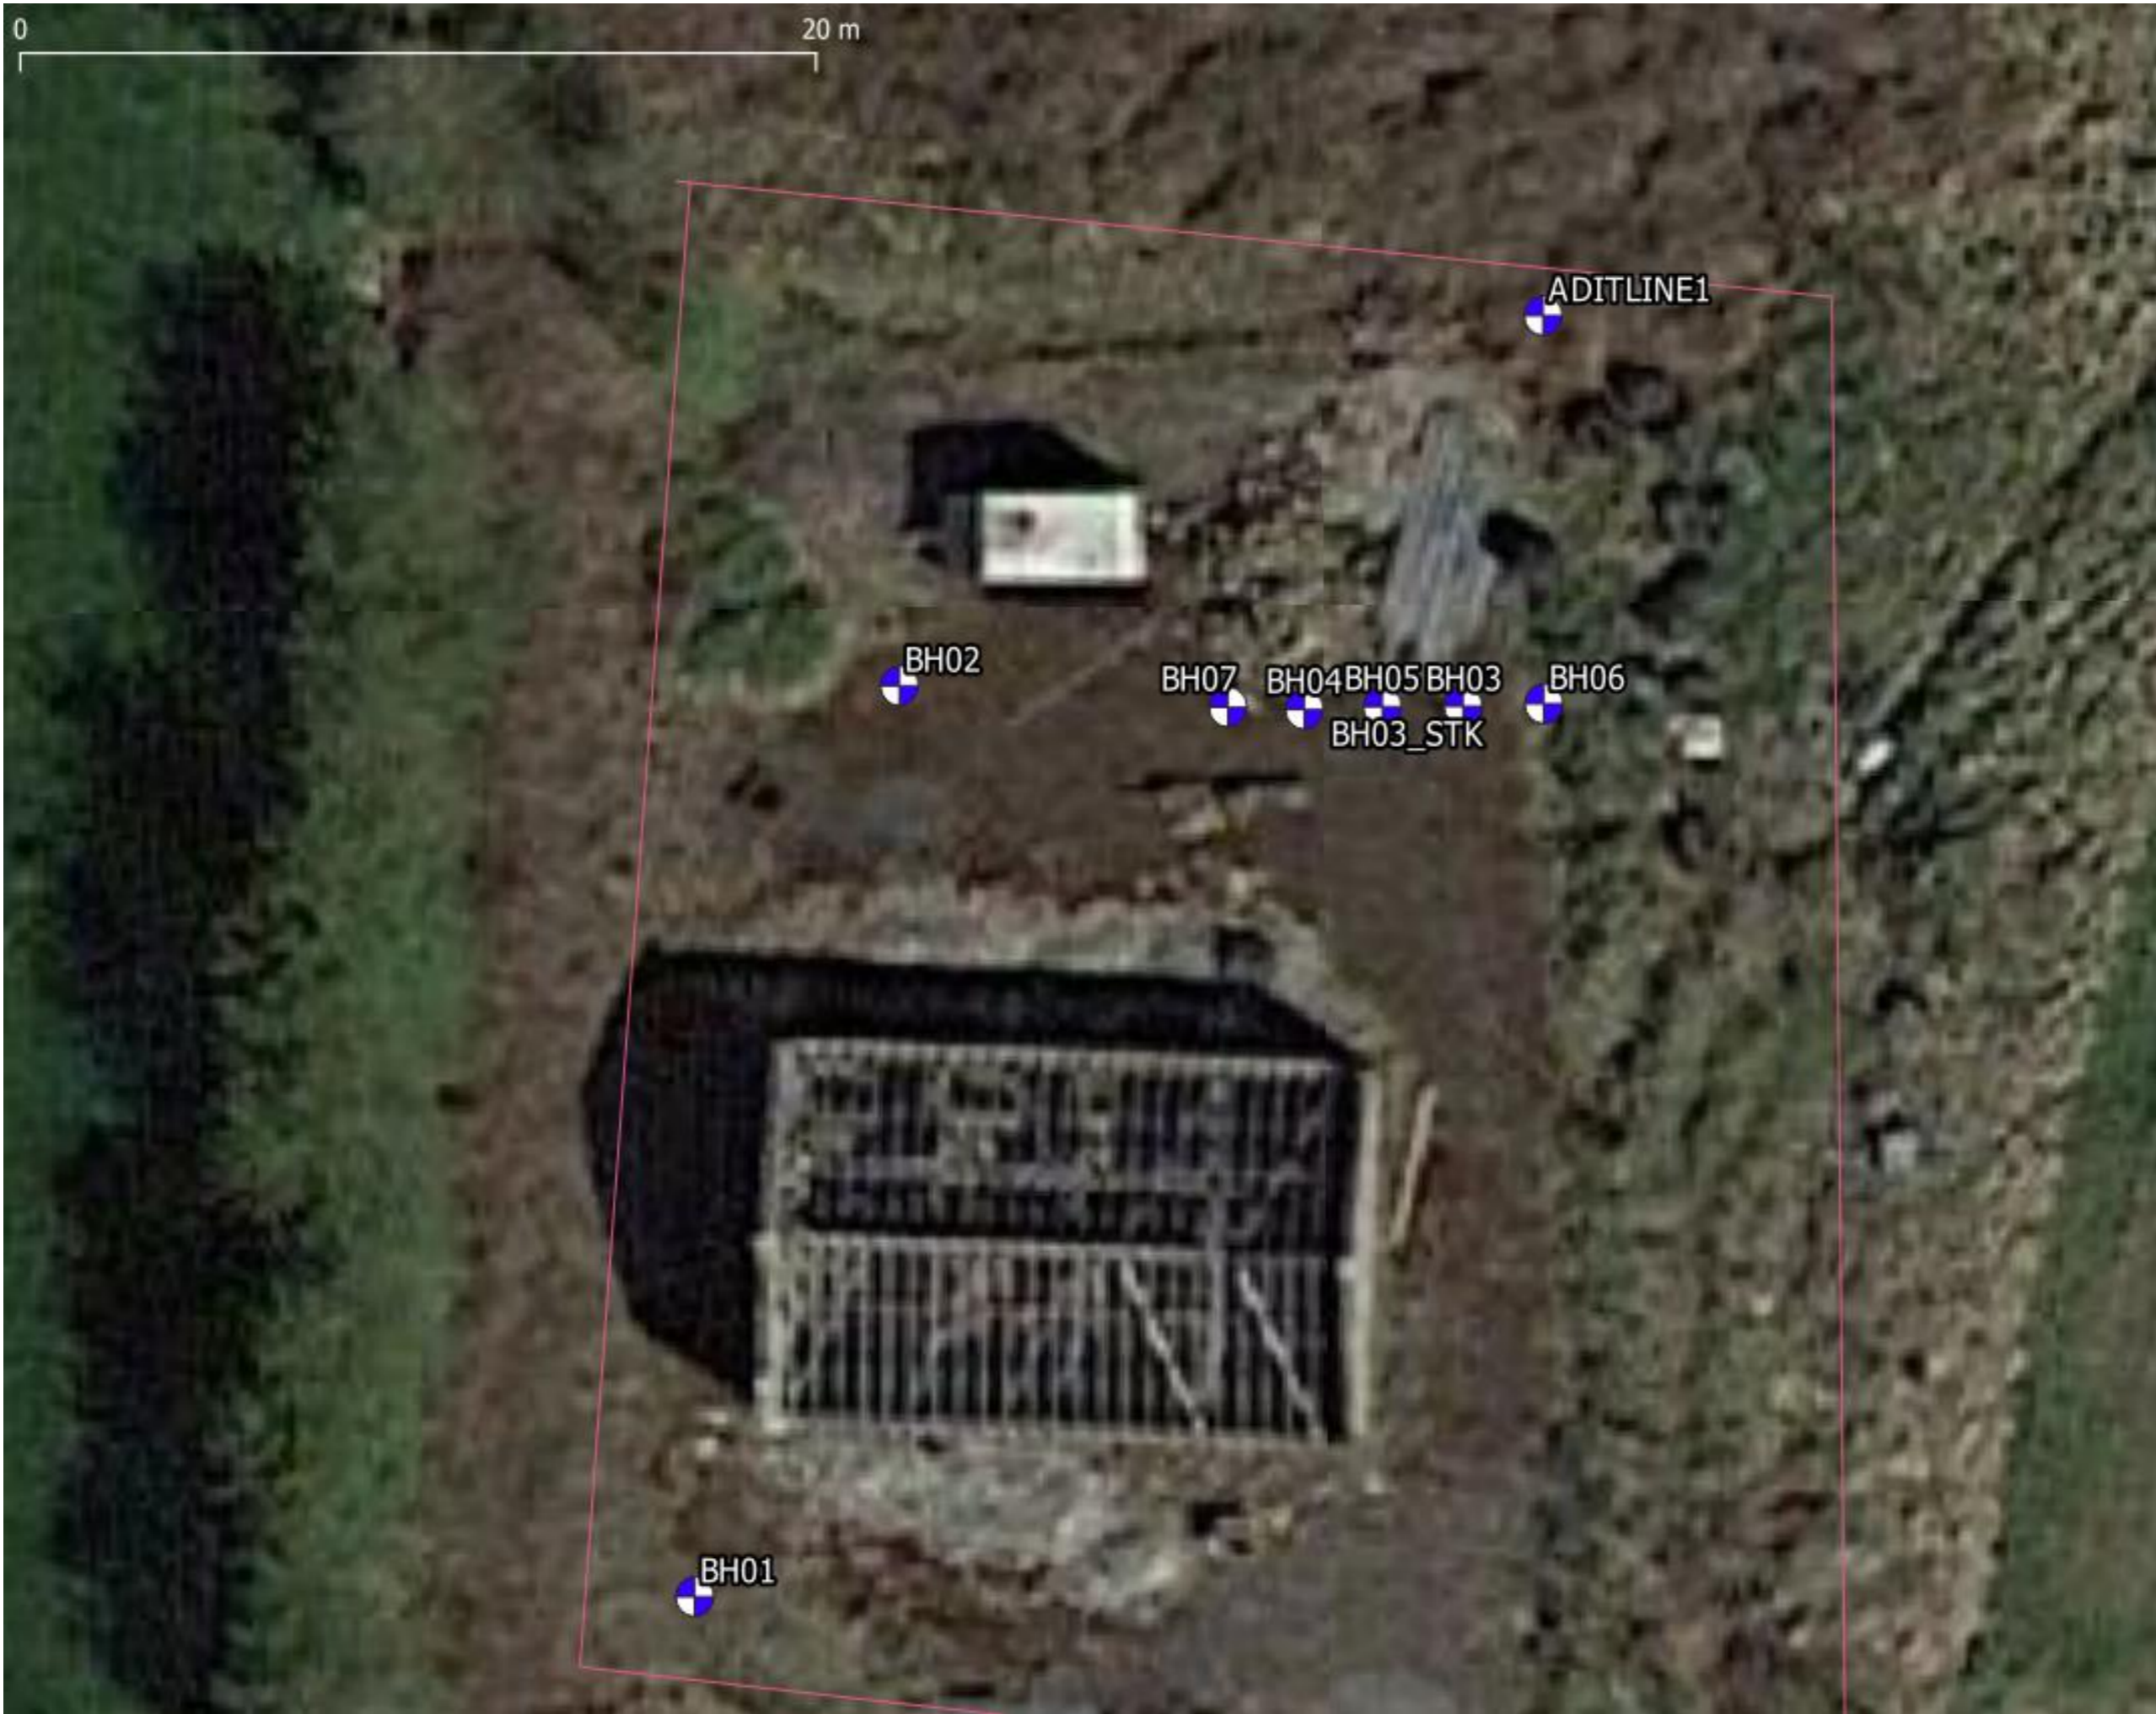
Investigation positions approximated from site operative's notes.

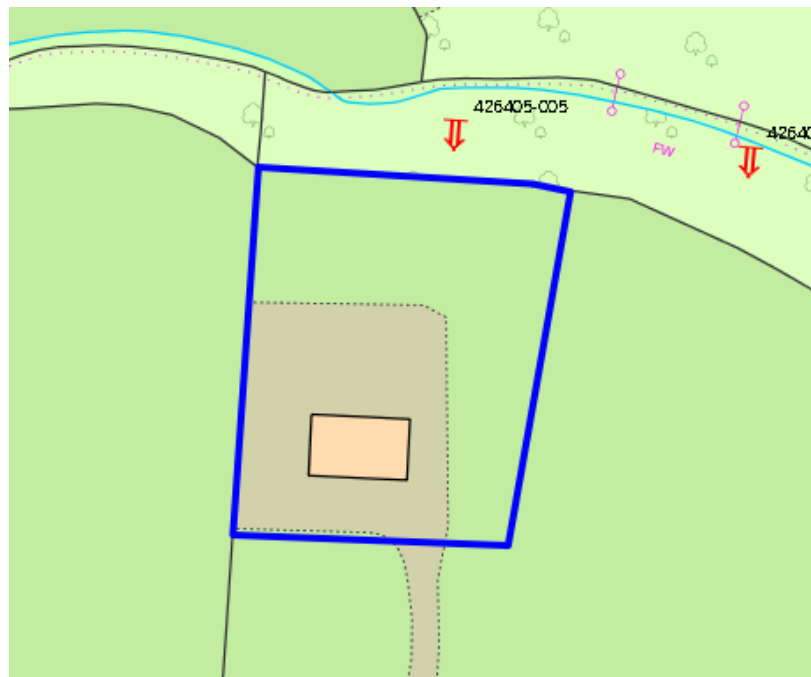
Granted Permit Boundary

Permit Boundary:

In order to undertake this investigation, it was necessary to obtain permission to enter or disturb Coal Authority interests. This permission was granted on the 10th May 2023 as permit reference number 26650, which is presented in Appendix 2 to this report. In accordance with the joint Coal Authority and Health and Safety Executive positioning statement, and under the requirements of the permit, the works were undertaken employing water flush drilling techniques. Furthermore, the drillers wore gas detectors on their person throughout the works.

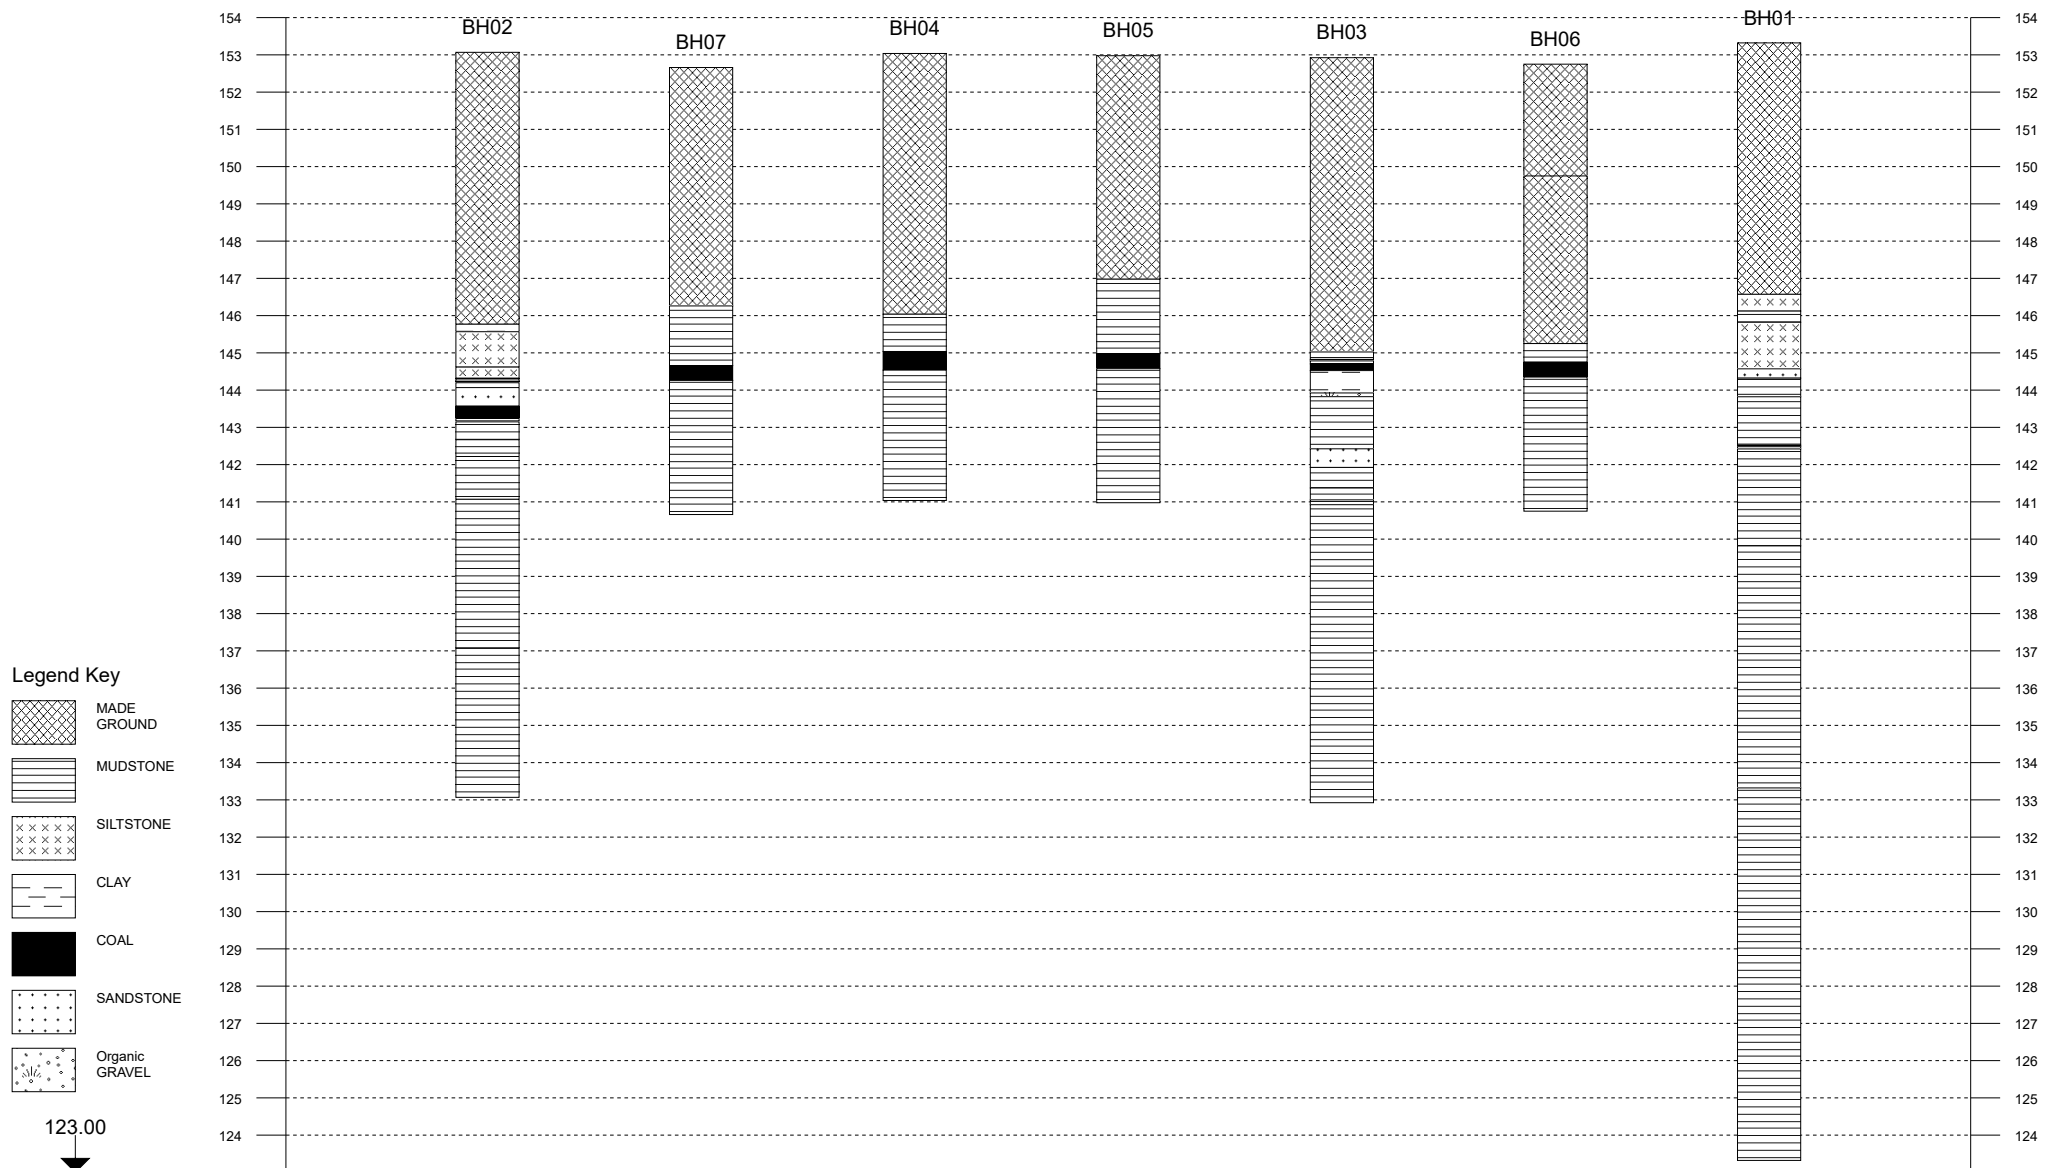
- Legend Key**
- MADE GROUND
 - MUDSTONE
 - SILTSTONE
 - CLAY
 - COAL
 - SANDSTONE
 - Organic GRAVEL
