**Bat Survey  
Wombwell High School,  
South Yorkshire**

Report reference: BE-R-1310-01  
September 2012

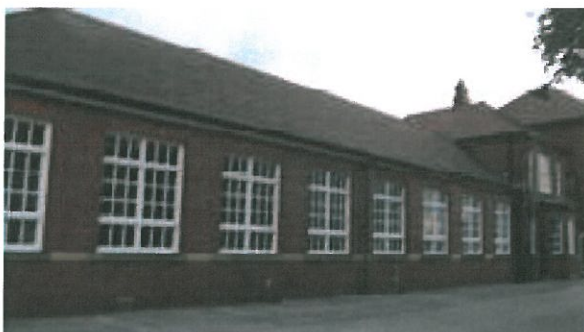
**Figure 2**

General view of original brick sections of the school

14. The solid walls are generally in very good condition and offer little in terms of potential for bats. A series of boxed eaves run the length of these buildings and though generally well sealed, some small gaps are occasionally present between the soffits and the walls which could offer bats access to voids for roosting.

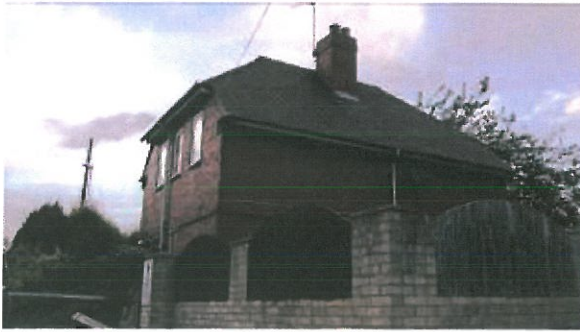
**Figure 3**

Former caretaker's house at the north eastern edge of the site.

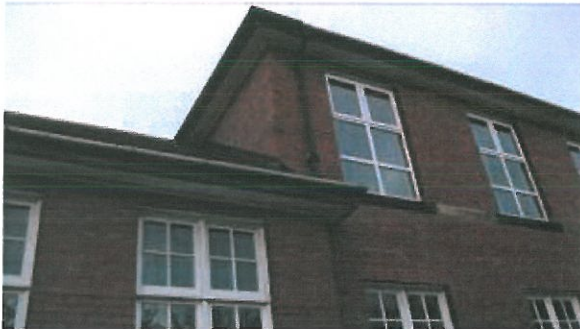
**Figure 4**

General view of boxed eaves present within many areas of the school

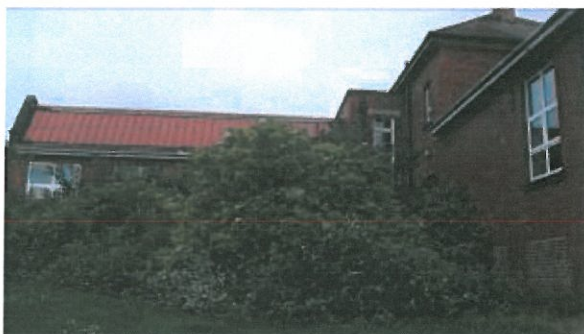
**Figure 5**

15. Most of the roofs are in a sound condition, though there are a small number of slipped tiles and gaps along the ridge which could provide occasional roosting space or give access to potentially large spaces within the roof void. Large areas of the loft spaces had suffered smoke damage making them much less attractive to bats.
16. One section of roof is corrugated steel sealed at the ridge with lead flashing. Some of this flashing is slightly raised creating gaps which could provide occasional roosting for small numbers of bats.

View of metal roof section with raised lead flashing.

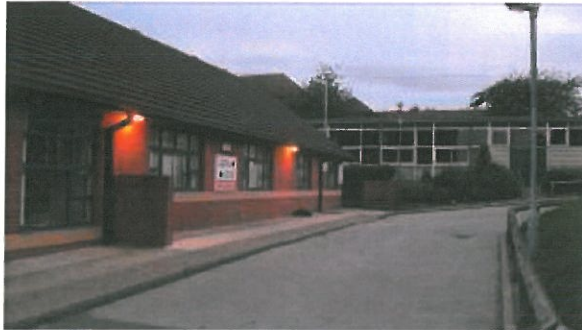
**Figure 6**

17. The most recent addition to the site is a small brick built section which houses staff rooms and offices. This has little in terms of bat roost potential with the exception of a slightly raised roof tile on the northern elevation.

Modern brick built section

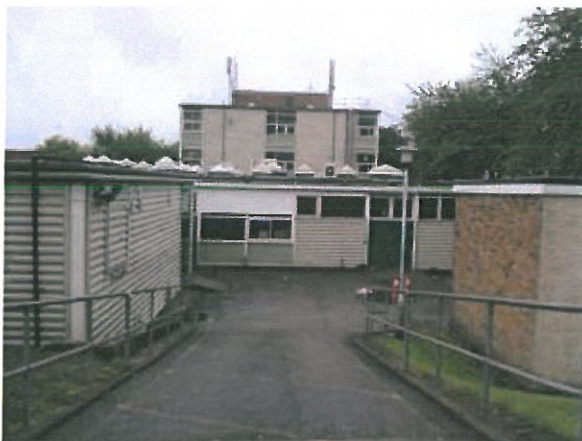
**Figure 7**

18. These are typical of modern school buildings with single skinned walls comprising glass panels and metal cladding. The largest of these is three storeys and all have flat felt roofs with little potential for roosting bats. The only exception was an area of wooden panelling around the tank room on the roof although initial inspection from the ground showed the panels to be fairly snug with no obvious gaps.

Example of metal clad buildings, viewed from the northern boundary

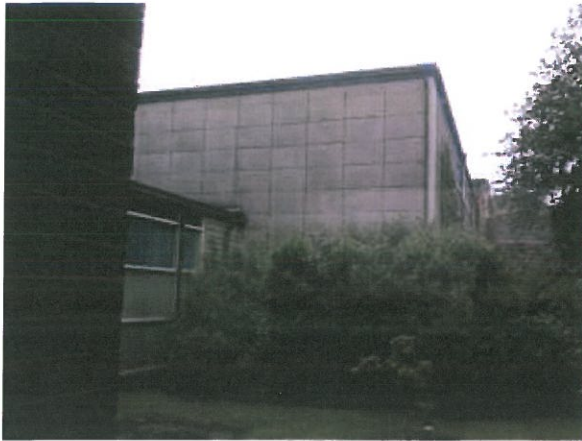
**Figure 8**

19. These are located at the eastern edge of the site and houses the sports facilities for the school with flat roofs and tightly fitting concrete panels lining the walls. They present no clear entry points for bats and are very unlikely to be suitable for roosting.

Concrete clad building at  
the eastern side of the school
