# **Geo-environmental Ground Investigation Report**

**PROPOSED RESIDENTIAL DEVELOPMENT**

**LAND TO THE SOUTH OF CONISTON AVENUE,  
DARTON, BARNSELY**

**E21/7786/R001B**

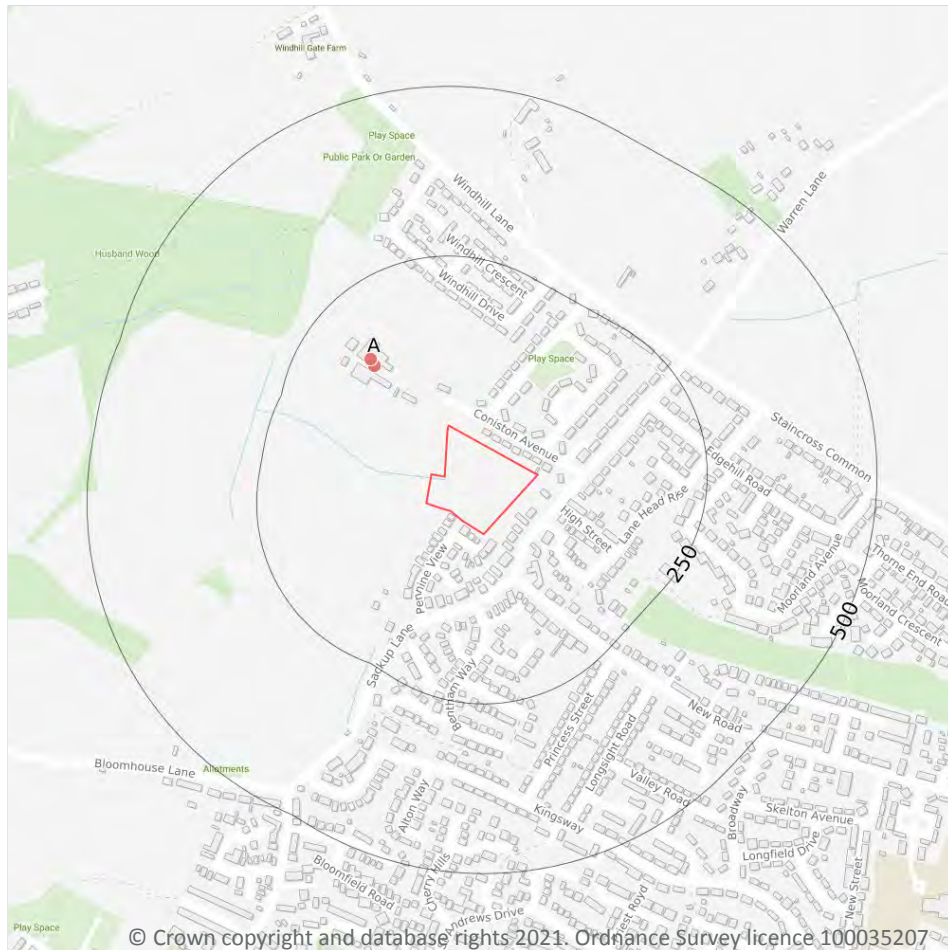
- Site Outline
- Search buffers in metres (m)
- Waste exemptions

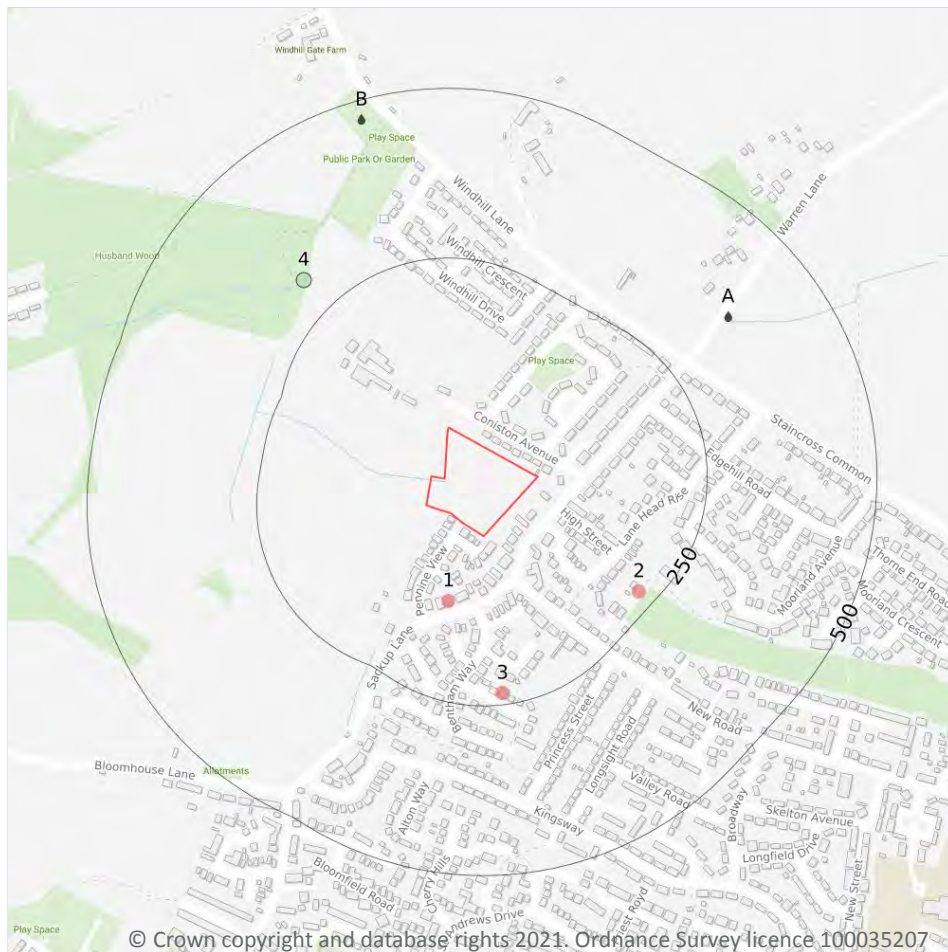
- Site Outline
- Search buffers in metres (m)
- Recent industrial land uses
- Licensed Discharges to controlled waters
- Pollution Incidents (EA/NRW)

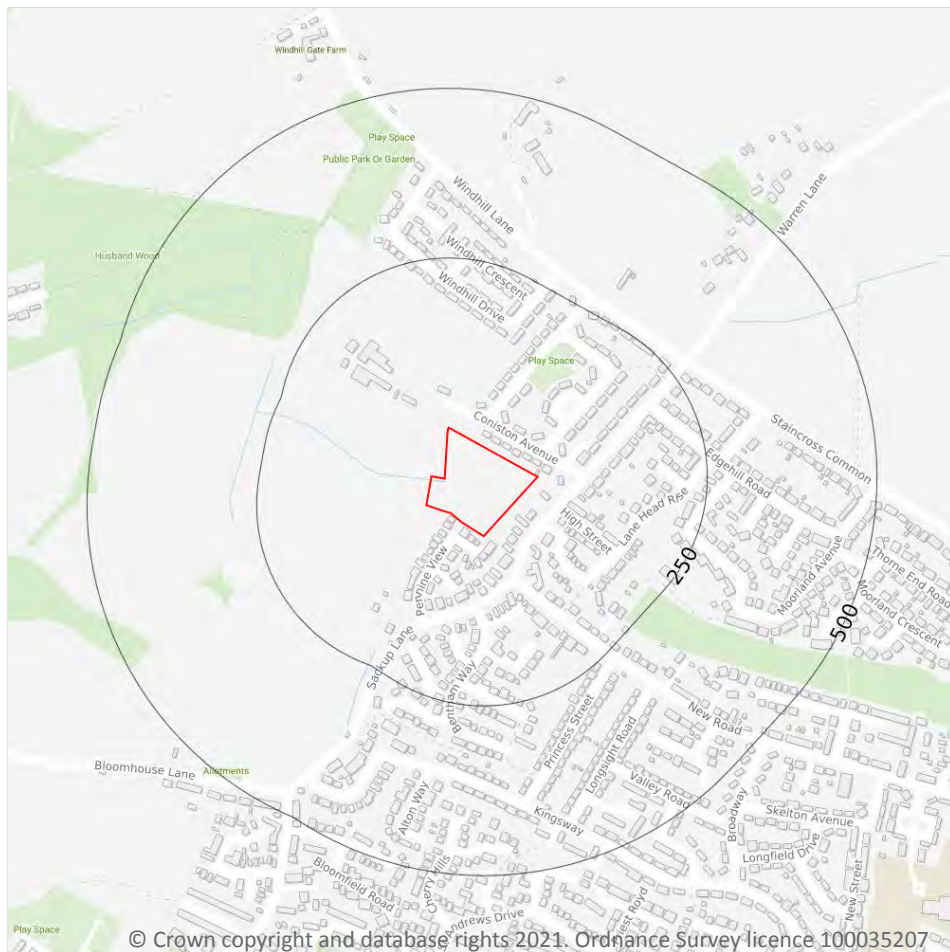
- Site Outline
- Search buffers in metres (m)
- Source Protection Zone 1  
Inner catchment
- Source Protection Zone 2  
Outer catchment
- Source Protection Zone 3  
Total catchment
- Source Protection Zone 4  
Zone of Special Interest
- Source Protection Zone 1c  
Inner catchment - confined aquifer
- Source Protection Zone 2c  
Outer catchment - confined aquifer
- Source Protection Zone 3c  
Total catchment - confined aquifer
- Drinking water abstraction licences  
Polygon features
- Drinking water abstraction licences  
Linear features
- Groundwater abstraction licence (point)
- Groundwater abstraction licence (area)
- Groundwater abstraction licence (linear)
- Surface Water Abstractions (point)
- Surface Water Abstractions (area)
- Surface Water Abstractions (linear)

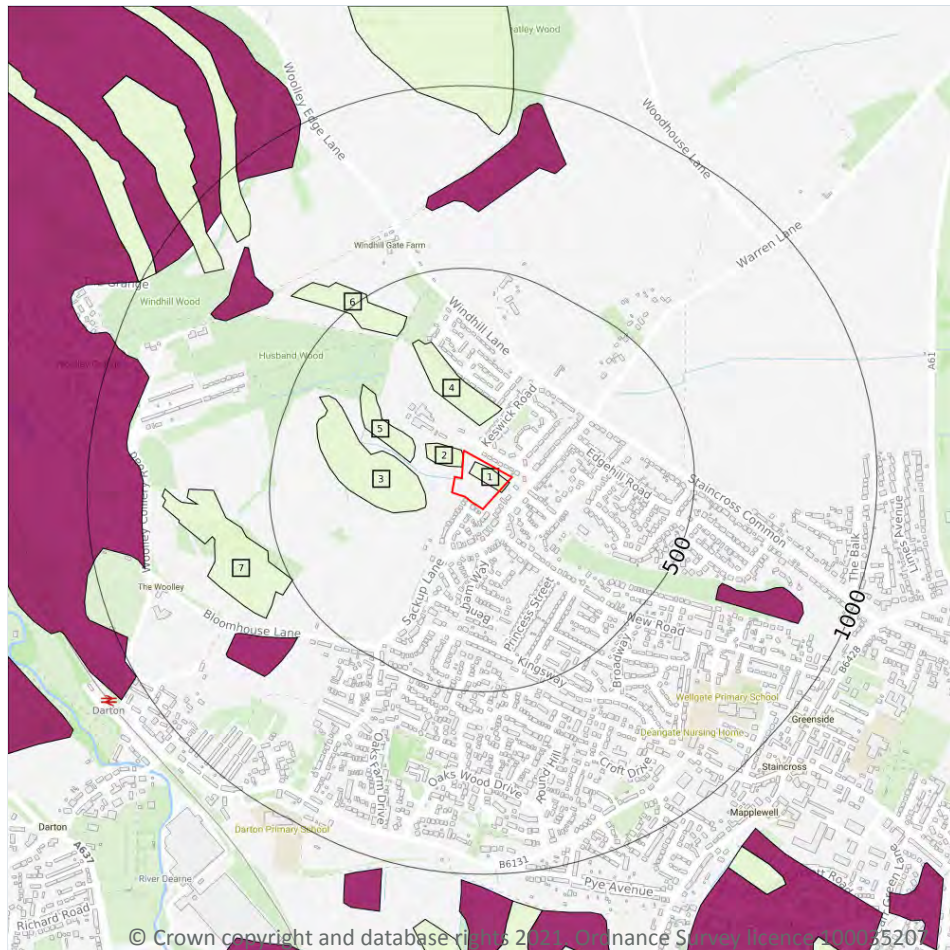
- Site Outline**
- Search buffers in metres (m)**
- Made ground
  - Worked ground
  - Infilled ground
  - Disturbed ground
  - Landscaped ground
