Stables at Frickley Bridge Lane, Brierley

Bat Survey Report

20th July 2020

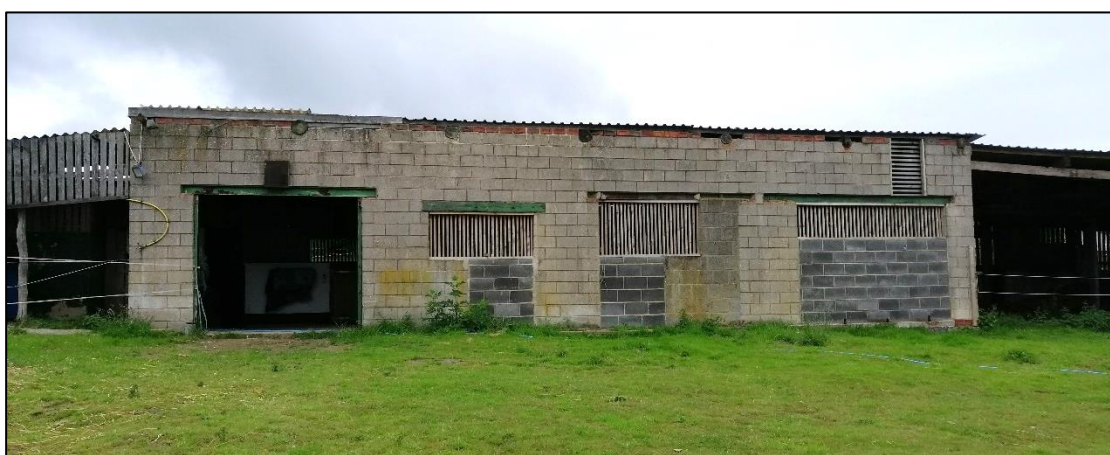
5.2.3 The surveyed buildings comprise a complex of stables and out-buildings which are joined together in a long row. Building 1 (B1) is a somewhat large single-skin concrete block-built stable building with a shallow mono-pitched corrugated sheet metal roof, supported by recycled telegraph poles and timber battens (Plate 1). There is a doorway from B1 to Building 2 (B2). B2 is a dilapidated two compartment stable built of single-skin concrete blocks and timber beneath a shallow mono-pitched corrugated sheet metal roof which also covers a wide open-fronted canopy (Plate 2). Building 3 (B3) is an 'L' shaped open fronted structure used for storing hay. This building has a

- 5.2.4 All site buildings are single skin and consequently, they entirely lack features with potential to accommodate crevice roosting bats as there are no crevices, holes or voids anywhere on the exterior. No signs of bats were found.

Plate 1. Front of B1

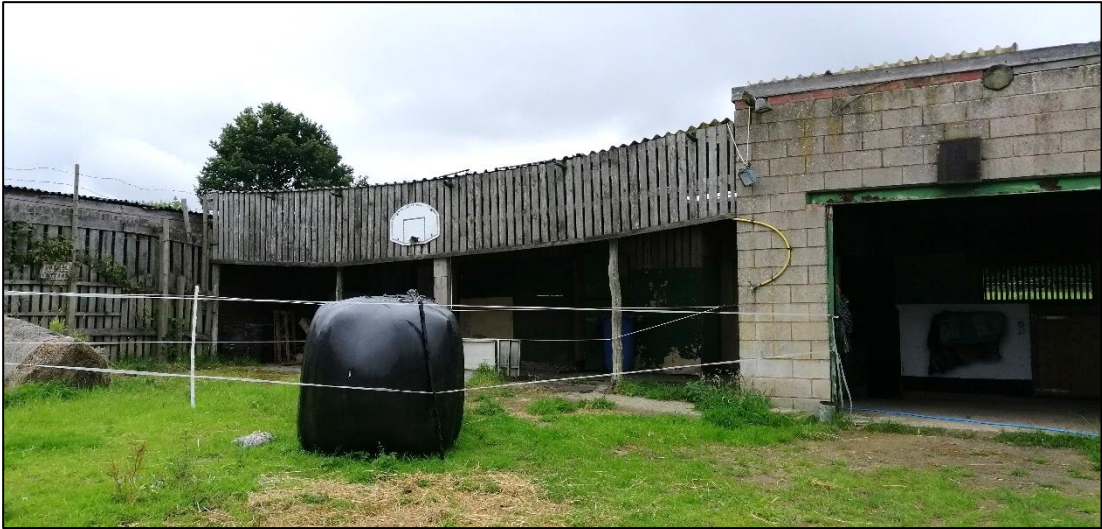
Plate 2. B2 showing open front and wide canopy supported by vertical timber

- 5.2.5 The only features found on the inside of the buildings which have potential to accommodate roosting bats were: a vertical timber support against a wall with a crevice behind in B2, and a gap behind a horizontal timber roof joist adjacent to a wall in B3. Both features were directly inspected with the former found to be heavily 'cobwebbed'. No signs of bats were found, however, a defunct swallow *Hirundo rustica* nest was noted in B2.

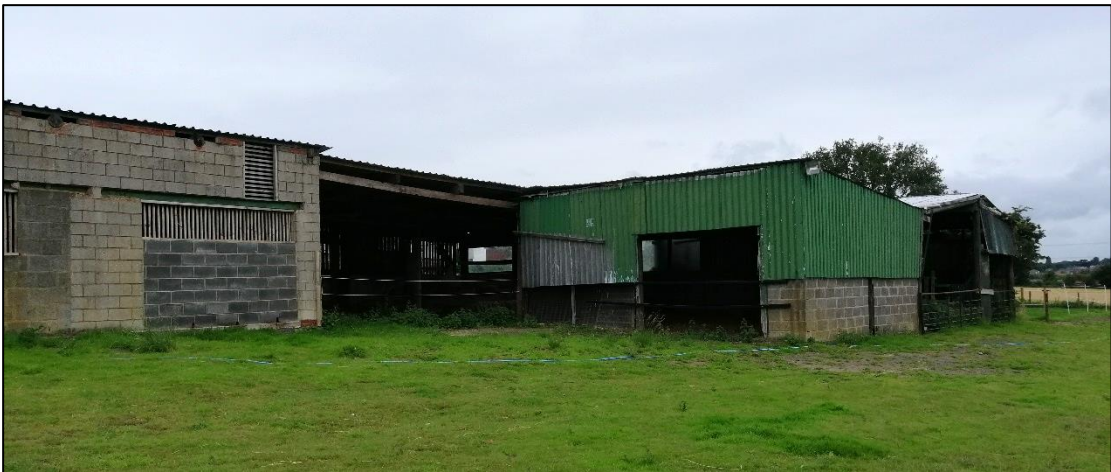
Plate 3. North end of B1 and adjoining B3

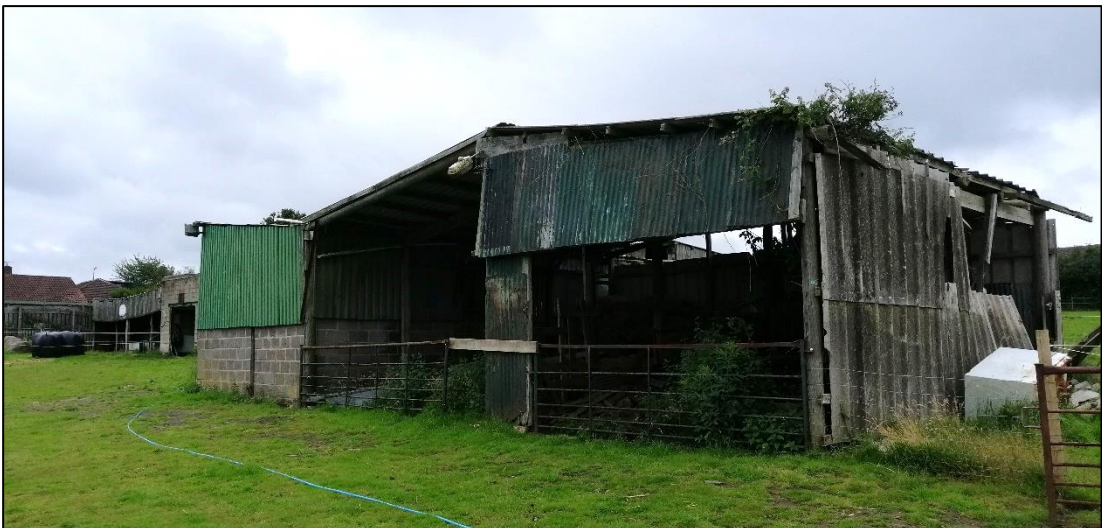
timber frame with single-skin concrete blocks to 1.2m and a shallow pitched corrugated sheet metal roof, supported by a mix of recycled telegraph poles and machine cut timber joists. The building is largely open fronted with the rear and sides clad with a mixture of metal sheets and vertical 'hit and miss' boards (Plate 3). Building 4 (B4) is a dilapidated timber-framed structure with a pitched sheet metal roof supported by recycled telegraph poles, wood joists, and battens. It is open-fronted whilst two sides are clad with asbestos sheets (Plate 4).

Plate 4. Front (northeast elevation) of B4

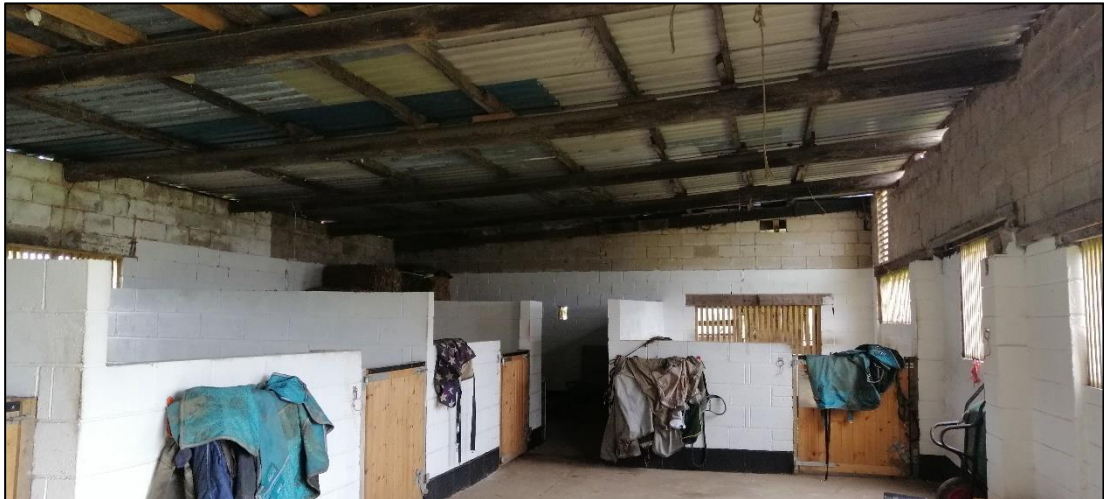
Plate 5. Inside of B1

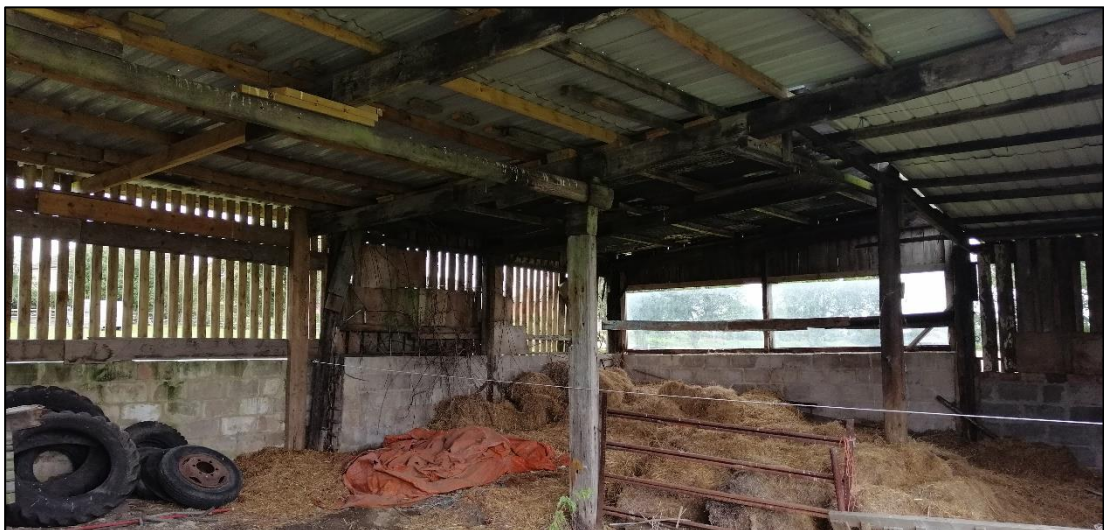
Plate 6. Inside of B3

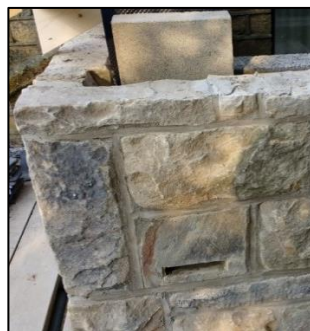
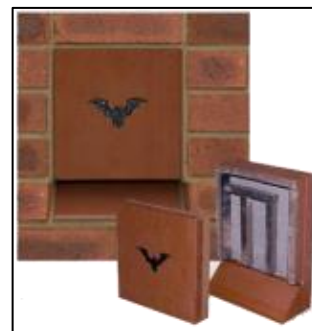
Plates 7-9. Build-in bat roost products

6.3.1 No bats were recorded roosting on site during the survey works and consequently there is no compulsory requirement for mitigation. However, in order to enhance the ecological value of the site and in accordance with the aims of the National Planning Policy Framework (2019), it is suggested that bat roosting features are added as part of the re-development. It is advised that one or more bat boxes, of a design such as the Build-in WoodStone Bat Box or Ibstock Enclosed Bat Box C (see Plates 7 - 9) are integrated into the new dwelling. The box/s should be sited at wall top height on the south or west elevation and away from areas of light spill. For further information on appropriate bat roosting features please contact Middleton Bell Ecology.
