**ARBORICULTURAL SAFETY  
SURVEY**

**Darley Cliffe Hall  
Kingswell Road  
Barnsley  
South Yorkshire  
S70 4AG**

15687/DK

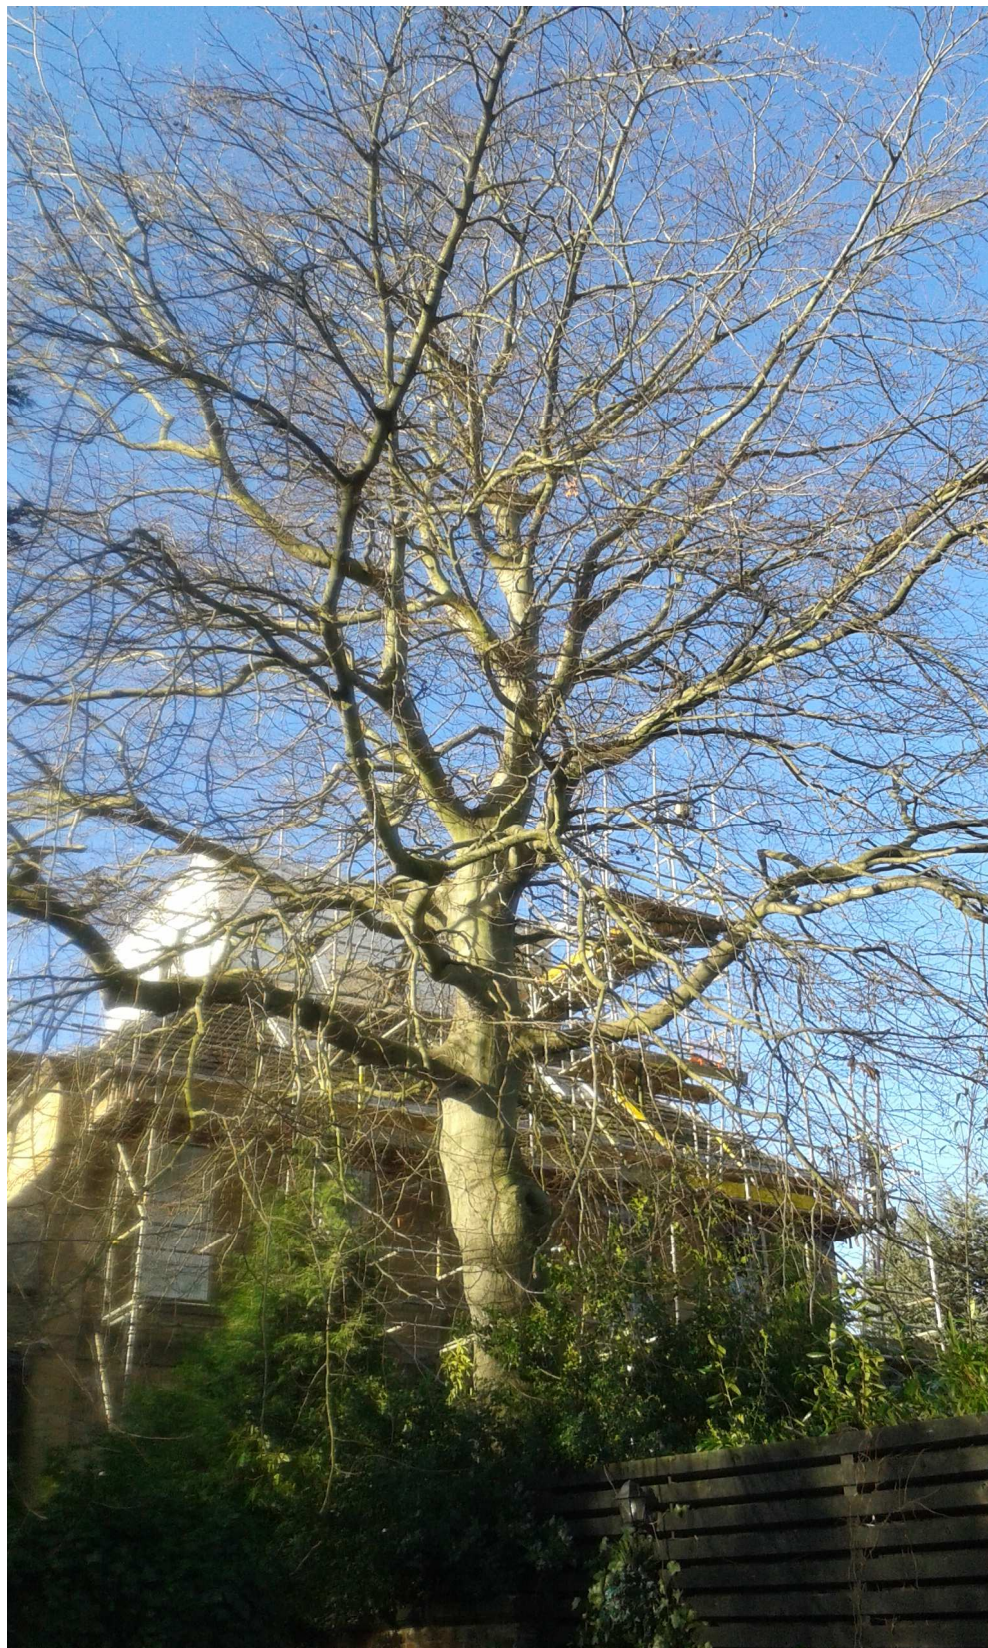
**Photograph 1:** Tree in relation to its surroundings.

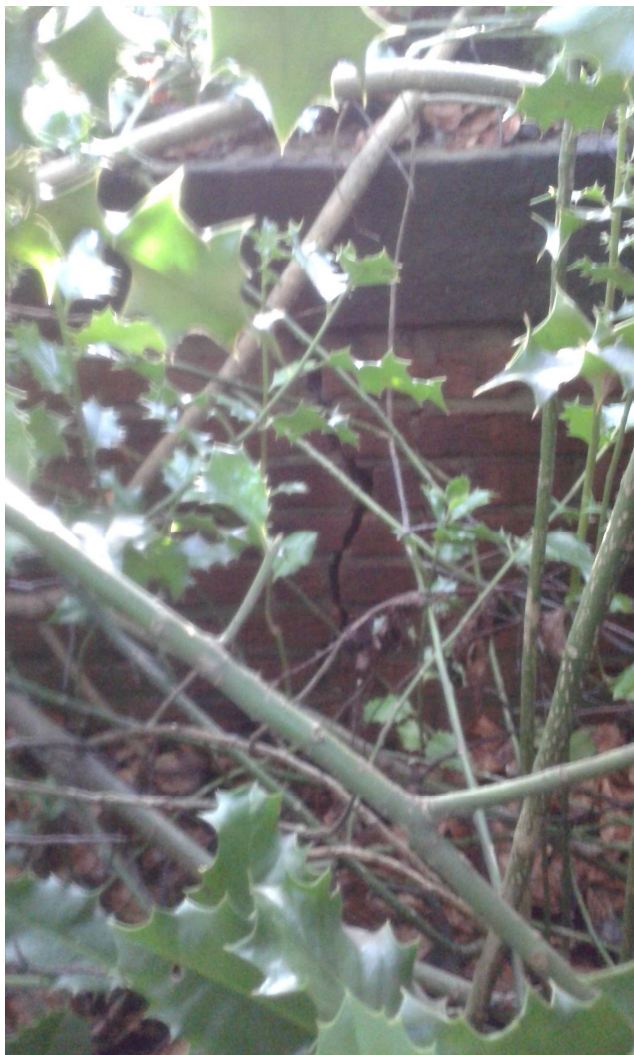
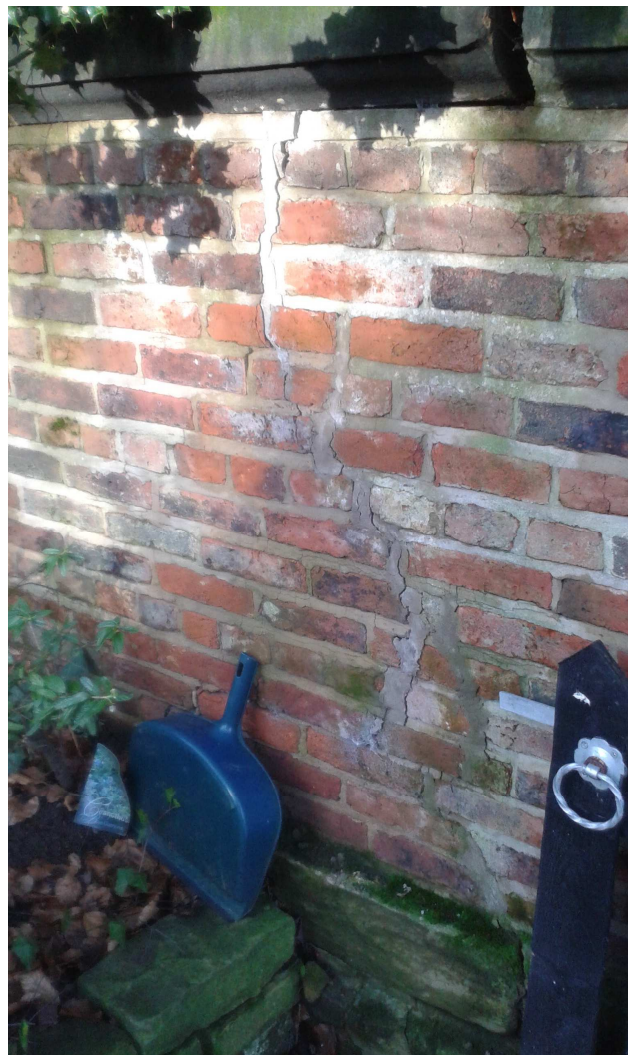
- 5.1 One mature Copper Beech was surveyed and was found to be in a good structural and physiological condition. However, cracks in a Grade 2 listed building (wall) are visible on both the north and south sides of the wall adjacent to the main stem of the tree.

The secondary thickening of the tree's root system is causing direct structural damage to the wall and therefore the tree has been recommended for removal so the wall may be repaired and to avoid future damage and repair works.

**Photograph 2:** Crack in north side of Grade 2 listed wall (left image). Crack in south side of Grade 2 listed wall with historical repair work (right image).

Tree Ref.	Age	Species	Latin Name	Height (m)	Crown Height (m)	Diameter (cm)	Crown Spread (m)	Observations	Physiological Condition	Structural Condition	Life Expectancy (yrs)	Target Value	Recommendations	Priority	Safety Category	Re-Inspection Timing (yrs)
T 1	Mature	Copper Beech	<i>Fagus sylvatica</i> 'Atropurpurea'	20+	2 to 3 #	76	20 #	<p>Vertical main stem to 4 to 5 metres with widely spreading crown. Crown tips nearly touching subject property. Main stem with several old branch wounds, one to north side with open wound. minor bark canker to 1 metre from ground level on north and east sides of main stem. Bark inclusions near base of main stem possible indications of original graft union. <i>Cryptococcus fagisugii</i> Beech bark scale insect exudations in fine longitudinal bark lesions of lower main stem and beneath several main branch unions in lower crown area.</p> <p>Damage in the form of cracking has occurred to a reportedly Grade 2 listed building (wall). The adjacent brick boundary wall is cracked on both the north and south sides. The crack damage has been caused by secondary thickening of the buttress/lateral root growth of the tree <b>TI</b> and will become more severe over the forth coming years. It is requested that the tree be removed in order that repairs to the damaged wall may be undertaken and to prevent damage to the wall continuing. Please see the attached photographs at <b>Appendix 6</b> for images of the damage observed at the property.</p>	Good	Good	40+	MOD	Remove - fell to ground level and treat stump with a view to preventing regrowth.	MOD	R	N/A
