**PHASE 2  
GEOTECHNICAL AND GEO-ENVIRONMENTAL  
SITE INVESTIGATION**

**LOCKWOOD ROAD, GOLDTHORPE**

**GLEESON DEVELOPMENTS LIMITED**

**44271-003**

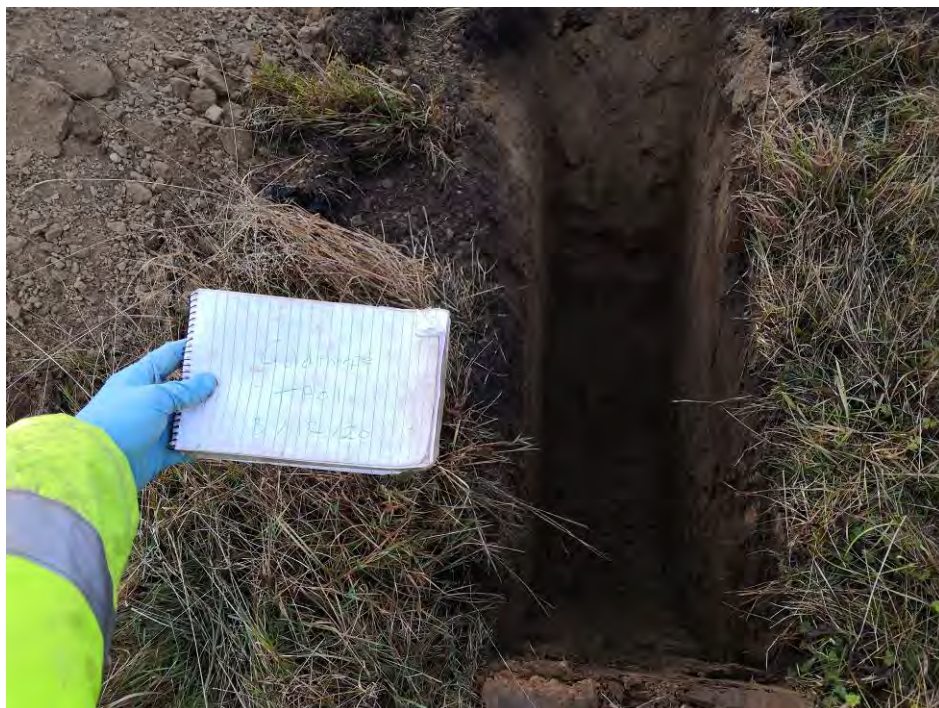
**TP01**

| Remarks<br>No groundwater encountered. Terminated due to refusal on bedrock. Backfilled with arisings on completion. | |

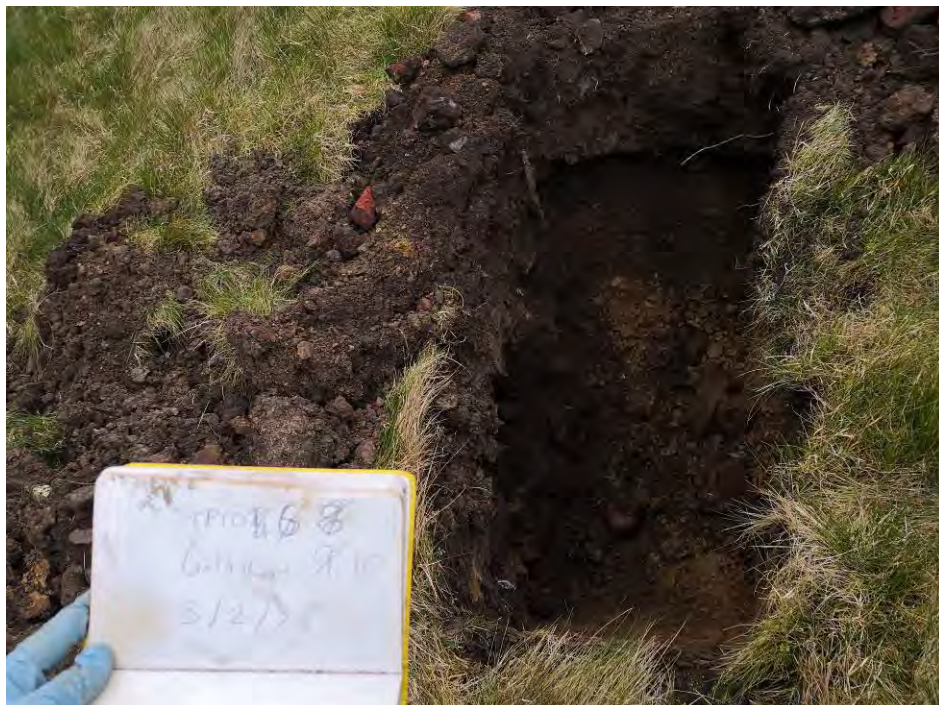
**TP110**

Two samples of made ground were tested. A SOM of 1% has been assumed as 'worst case'. One sample (TP110 at 0.4 m) recorded elevated concentrations of lead and two PAH determinants, with respect to human health. Lead was recorded at a concentration of 320 mg/kg, in excess of the assessment value of 200 mg/kg. Benzo[b]fluoranthene and dibenz[a,h]anthracene were found at concentrations of 3.1 mg/kg and 0.36 mg/kg, exceeding their assessment criteria of 2.6 mg/kg and 0.24 mg/kg, respectively.

Elevated concentrations of lead and polycyclic aromatic hydrocarbons were recorded within the made ground. The elevated levels may be considered representative for the made ground. Therefore, the made ground is not considered suitable to remain beneath gardens or soft landscaping. It is recommended that a 600 mm thick capping layer of clean soil (of which at least 100 mm should consist of topsoil) is placed over the made ground wherever it remains below private gardens or other areas of soft landscaping. Alternatively, the made ground can be removed from these areas and placed below hardstanding areas, such as driveways or parking areas.
