Kennet Properties  
Harborough Hill Road,  
Barnsley Interchange.

Phase II Geo-Environmental Risk  
Assessment.

Ref: LDS126/02/v1

Date: September 2006

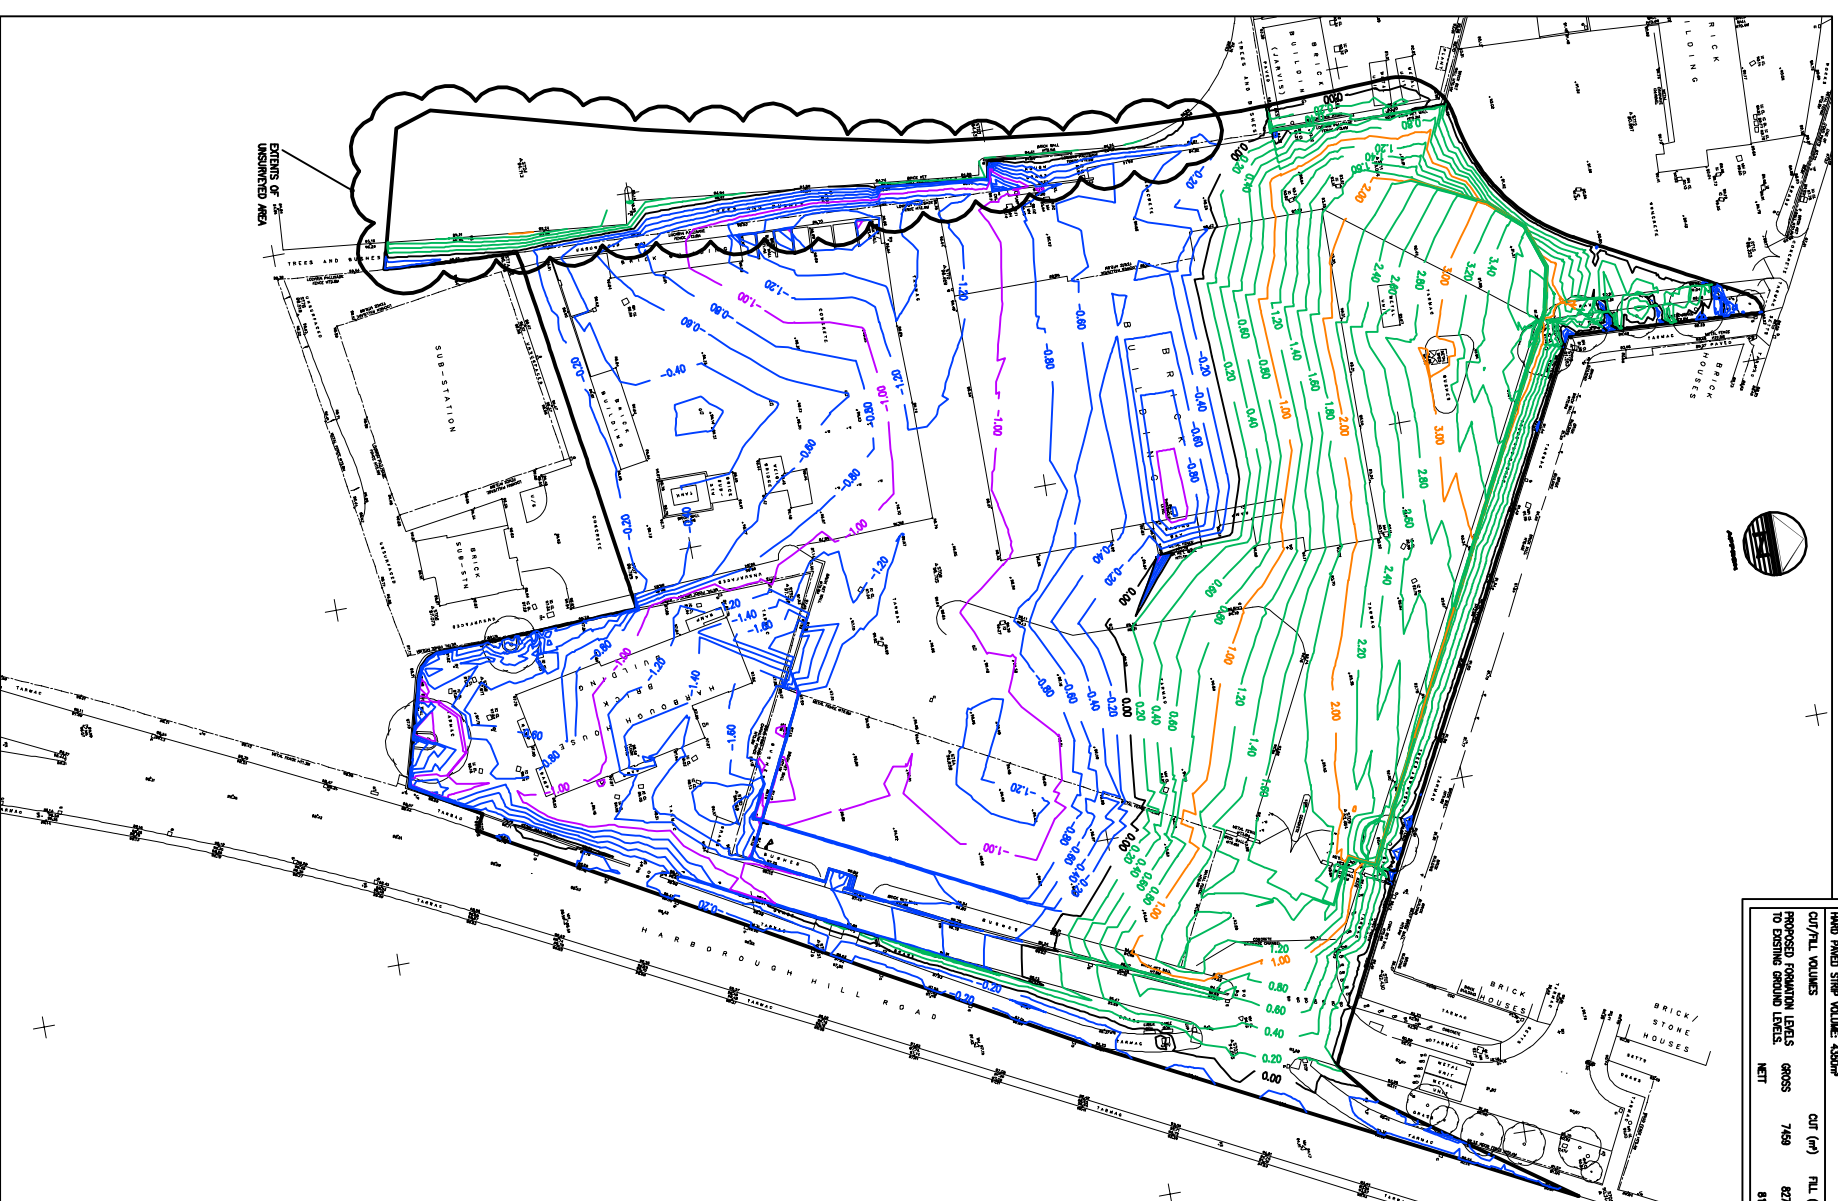
**FIGURE 4**

**PROPOSED CUT AND FILL EARTHWORKS**

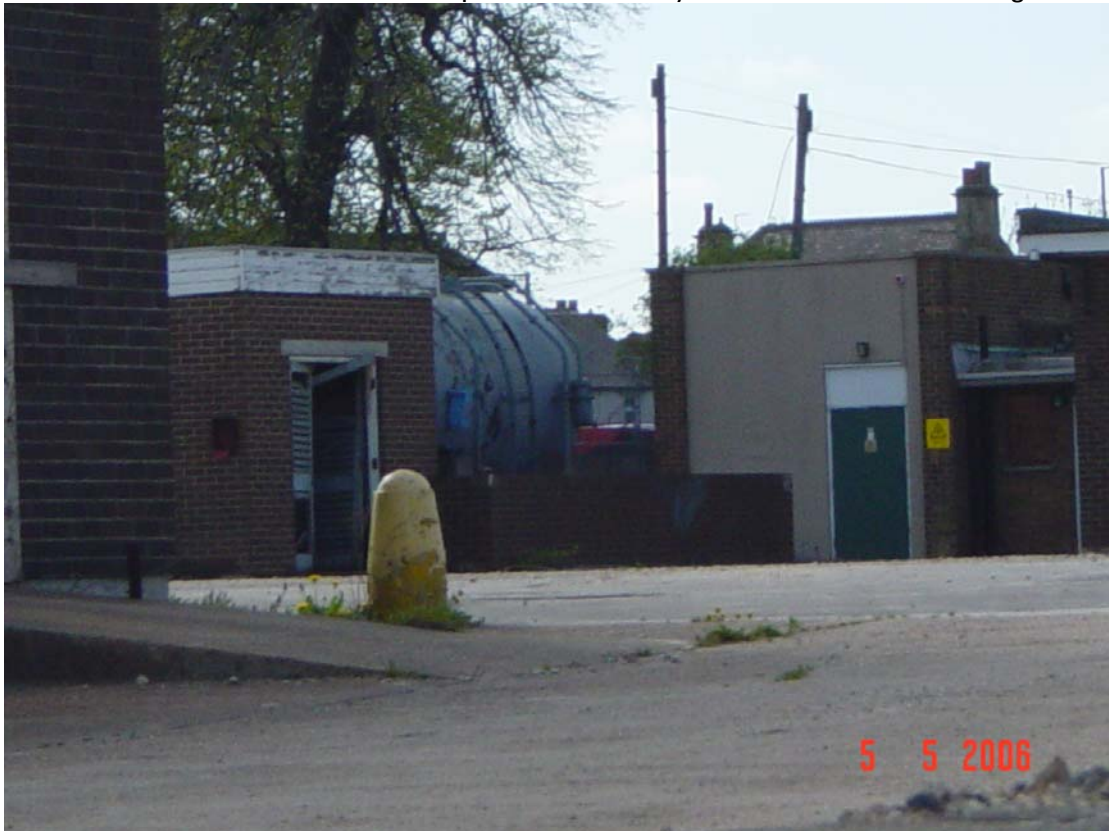
Plate 5 – Redundant tank close up with electricity sub-station in the background.

A diesel above ground storage tank (UST) with secondary containment has been located at the south western part of the site. Visually, several rust patches are evident on the tank. No information is available regarding the presents of any product inside the tanks. The adjacent plant room to the UST which appeared to be the control room consists of broken disused pipe works and several valves systems and an electronic box mounted on the wall. The pipe works and the valves have been found to be connected to the adjacent tanks which may have been used to control the flow of hydrocarbons from the UST to the unknown delivery system at the site.

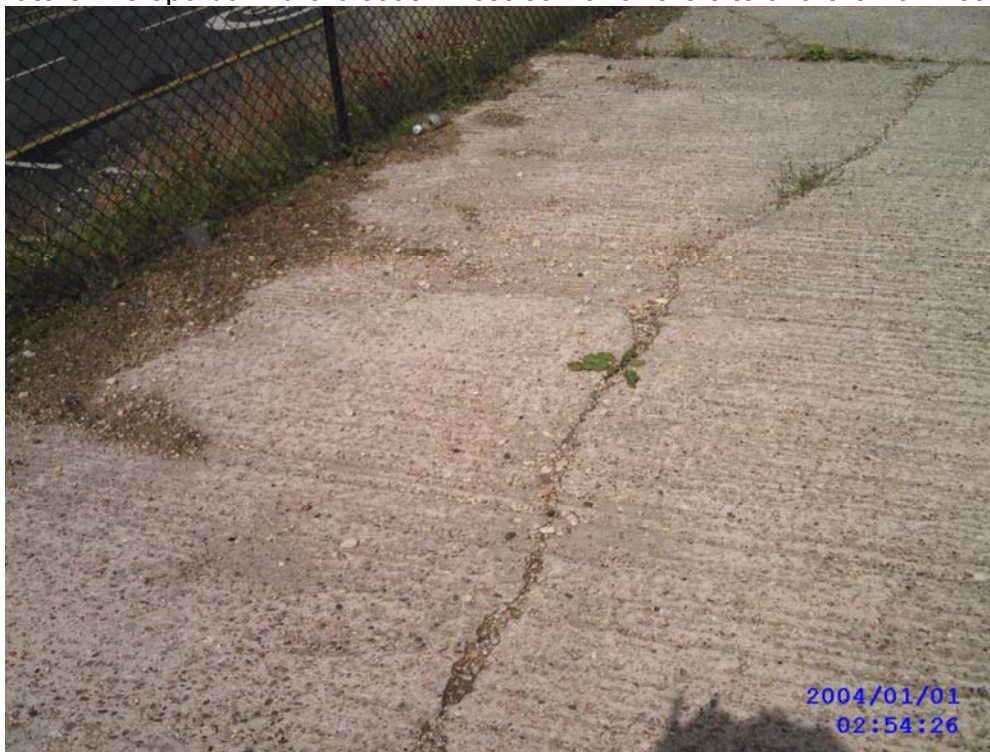
Plate 9 – Slope behind the south west corner of the site and the new road.

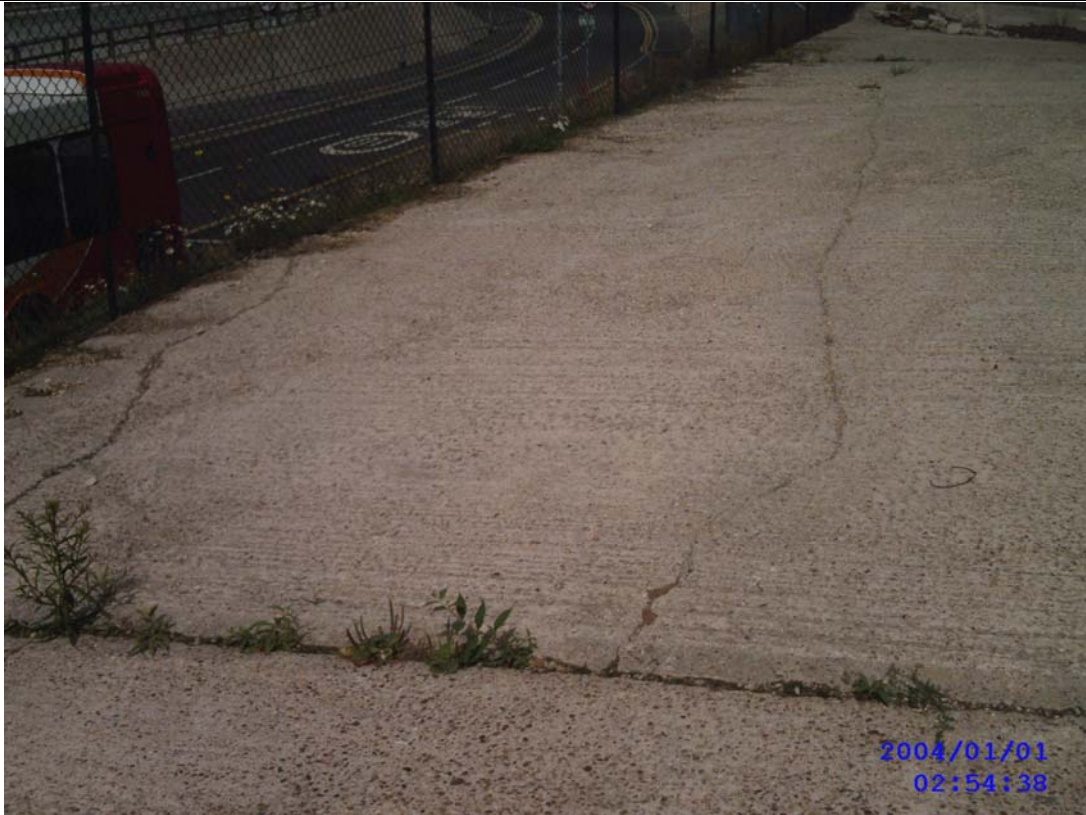
Plate 10 – Fractures in the roadway above the slope.

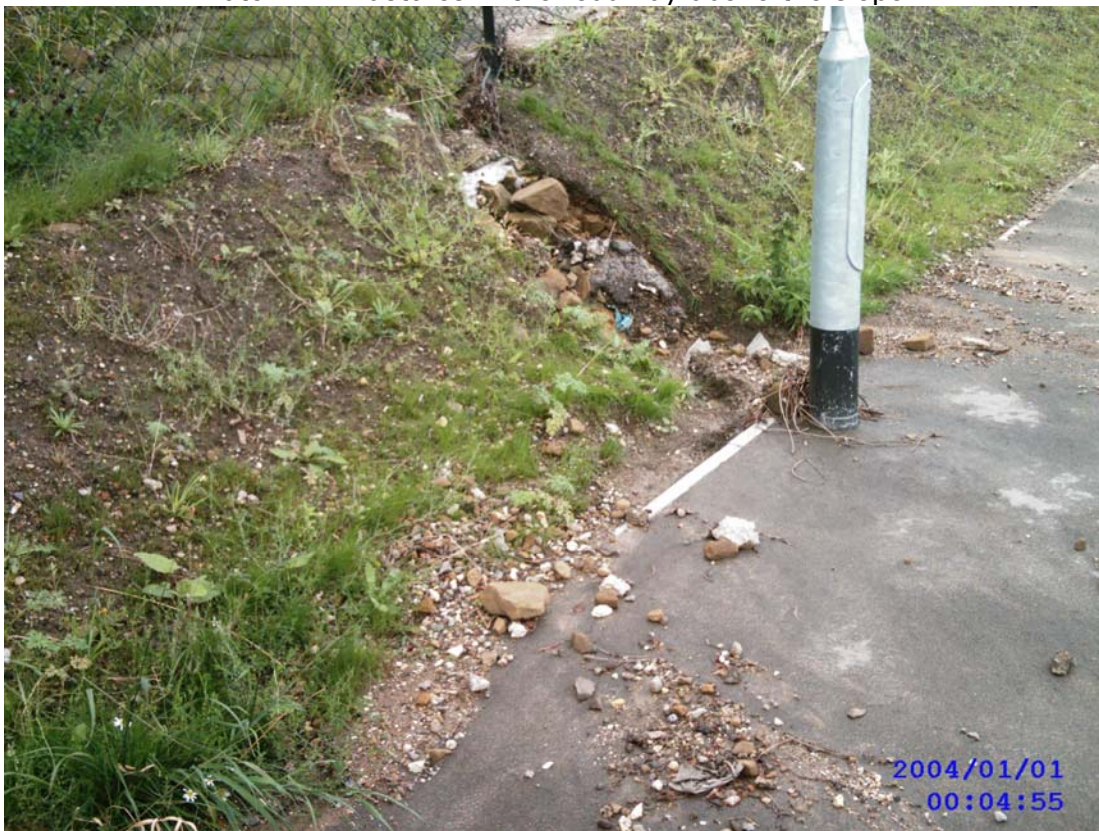
Plate 11 - Fractures in the roadway above the slope.

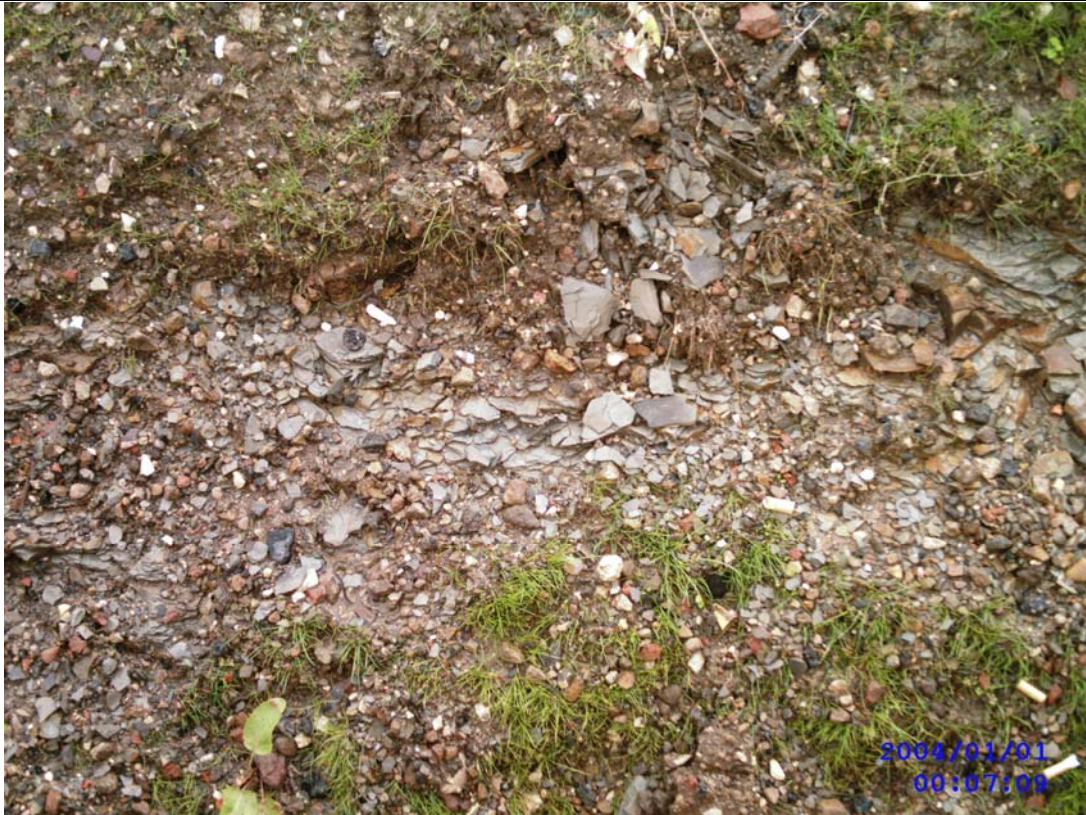
Plate 12 – Outwash from the slope below.

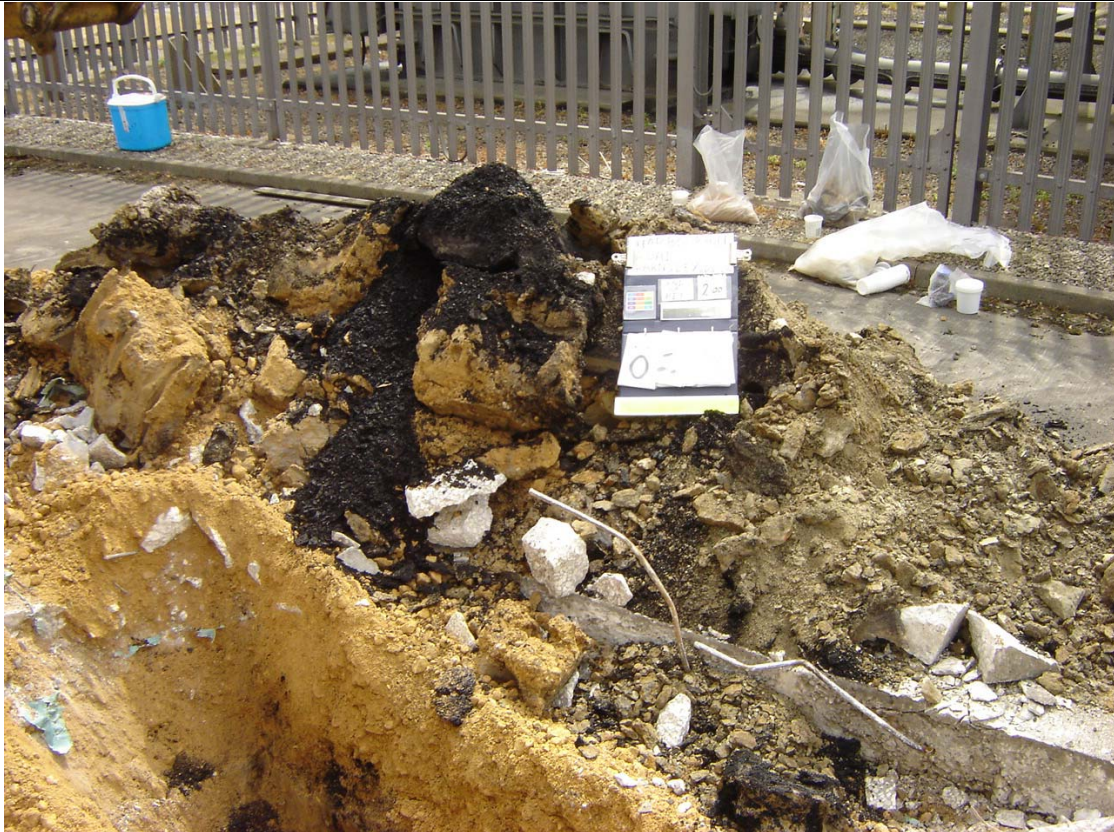
Plate 20 – Made ground was commonly above rockhead.
