# Geoenvironmental Appraisal

Land at Lidgett Lane, Pilley

For Barratt & David Wilson Homes  
Yorkshire West

Report no: 2222/5

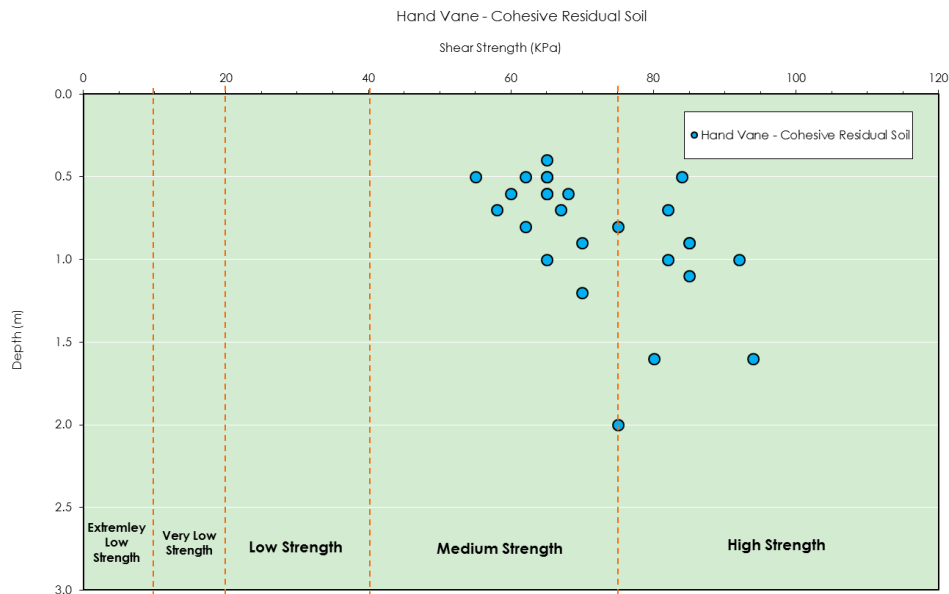
### Hand shear vane testing

- 12.5.1 Hand shear vane testing was undertaken within trial pits in-situ to around 1.2m depth and from larger blocks of excavated clay below that depth.
- 12.5.2 The results are summarised within the plot below and illustrate a broad linear increase in undrained shear strength ( $S_u$ ) with depth within the cohesive deposits. Below approximately 0.5m depth  $S_u$  is typically greater than 60kPa (medium strength).

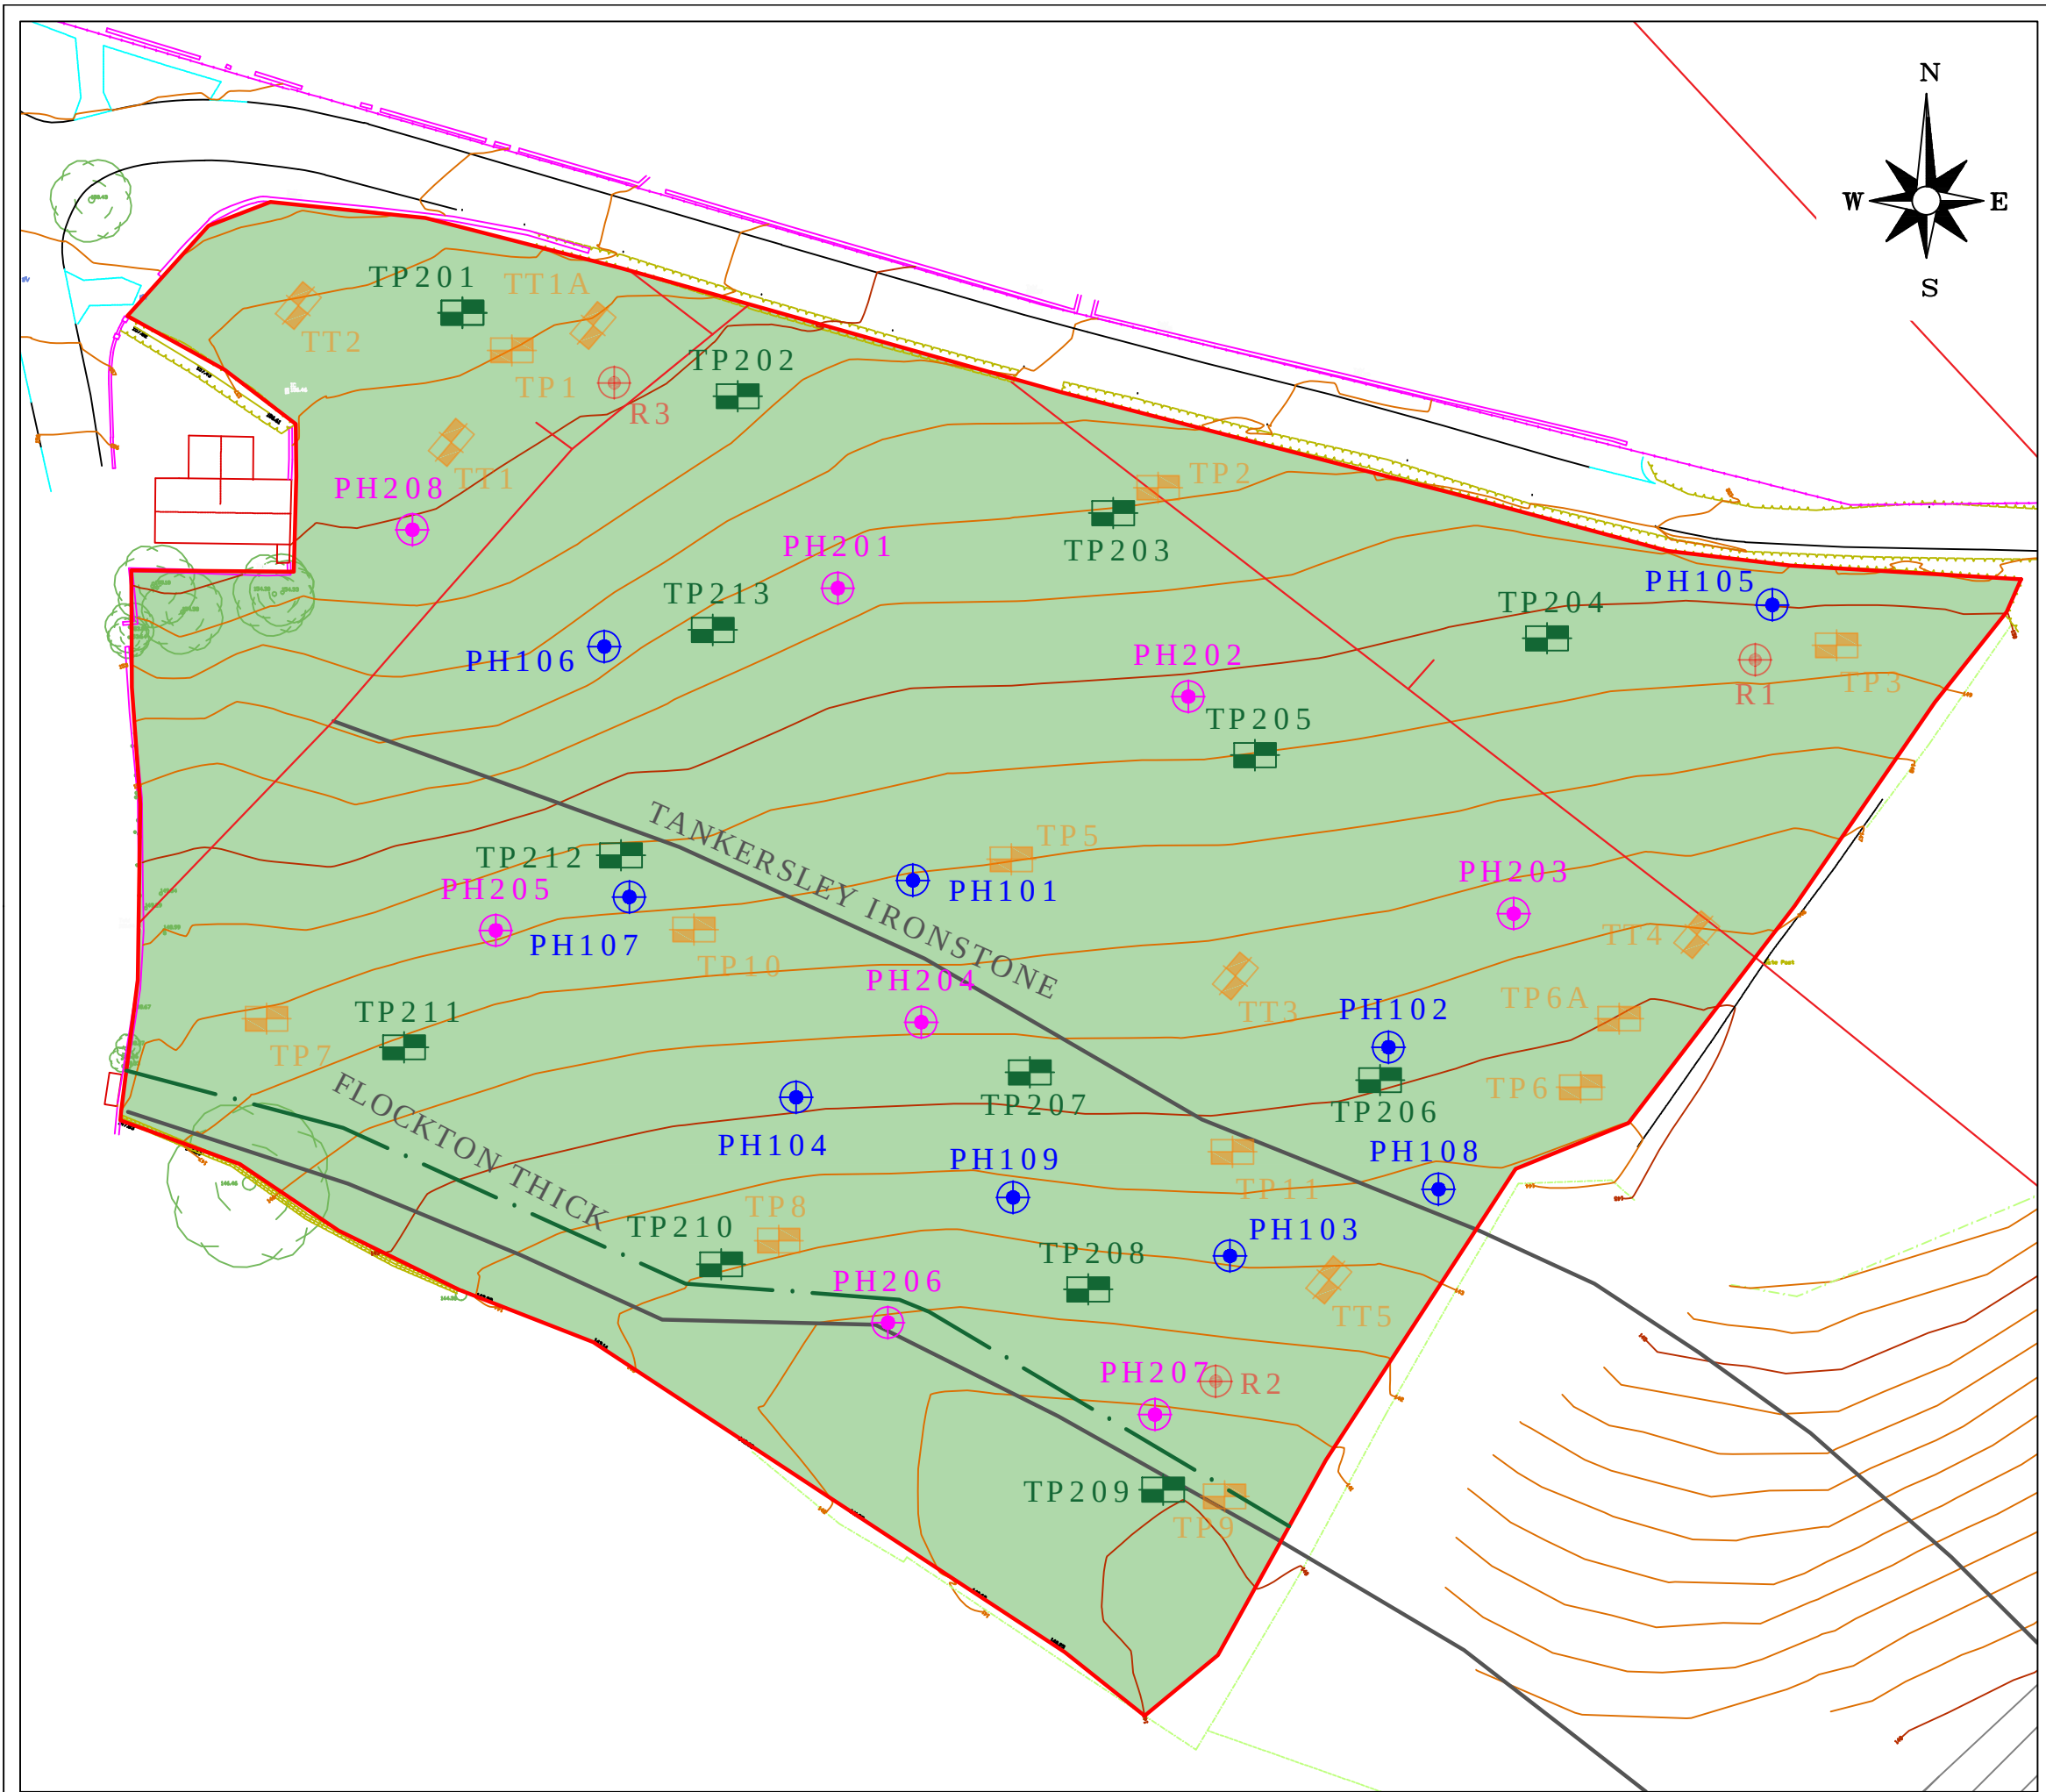
| SCALE | SHEET | DRAWING NO. | REVISION |
|---|---|---|---|
| 1:2,000 | A3 | 2222/W/6 | |

- CODA PROBEHOLE (2014)
- LITHOS PROBEHOLE (2015)
- LITHOS PROBEHOLE (2018)
- CODA TRIAL PIT LOCATION (2014 & 2015)
- LITHOS TRIAL PIT LOCATION (2018)
- PUBLISHED OUTCROP
- INFERRED OUTCROP
- PUBLISHED FAULT
- APPROXIMATE SITE BOUNDARY

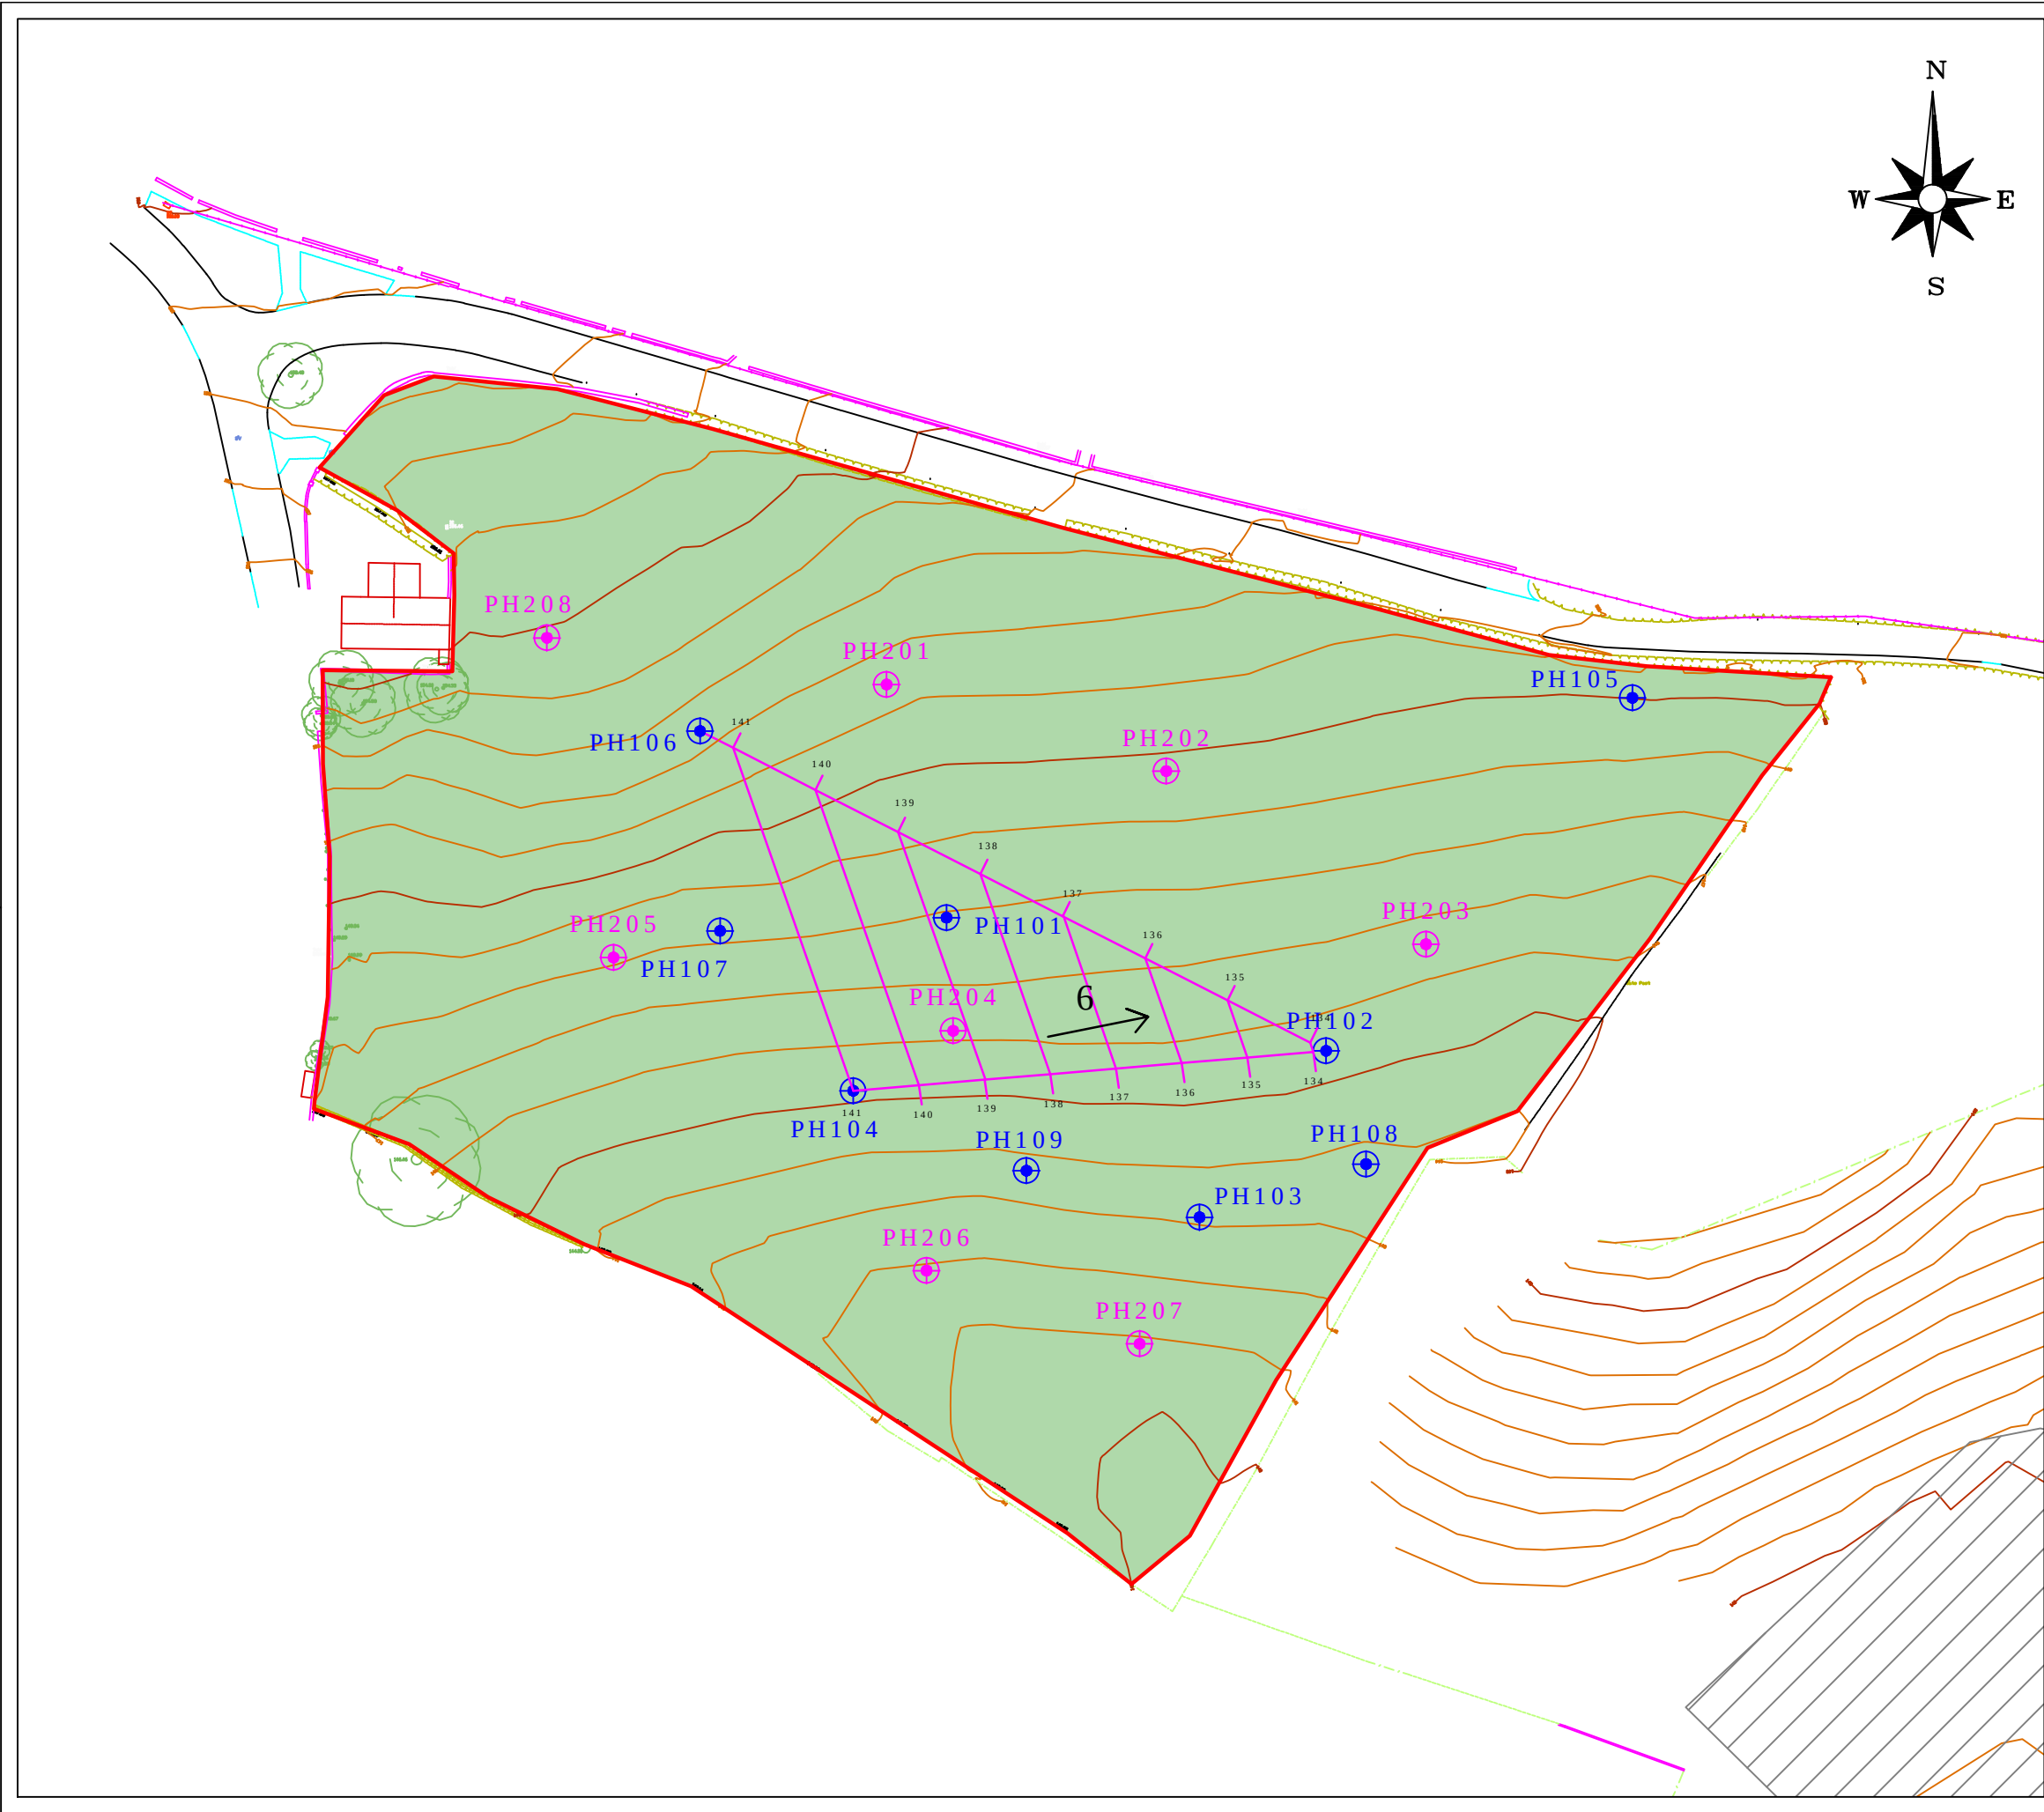
| SCALE | SHEET | DRAWING NO. | REVISION |
|---|---|---|---|
| 1:1,000 | A3 | 2222/W/9 | |

135 STRIKE LINE & DEPTH (mOD)  
6 DIP (DEGREES)

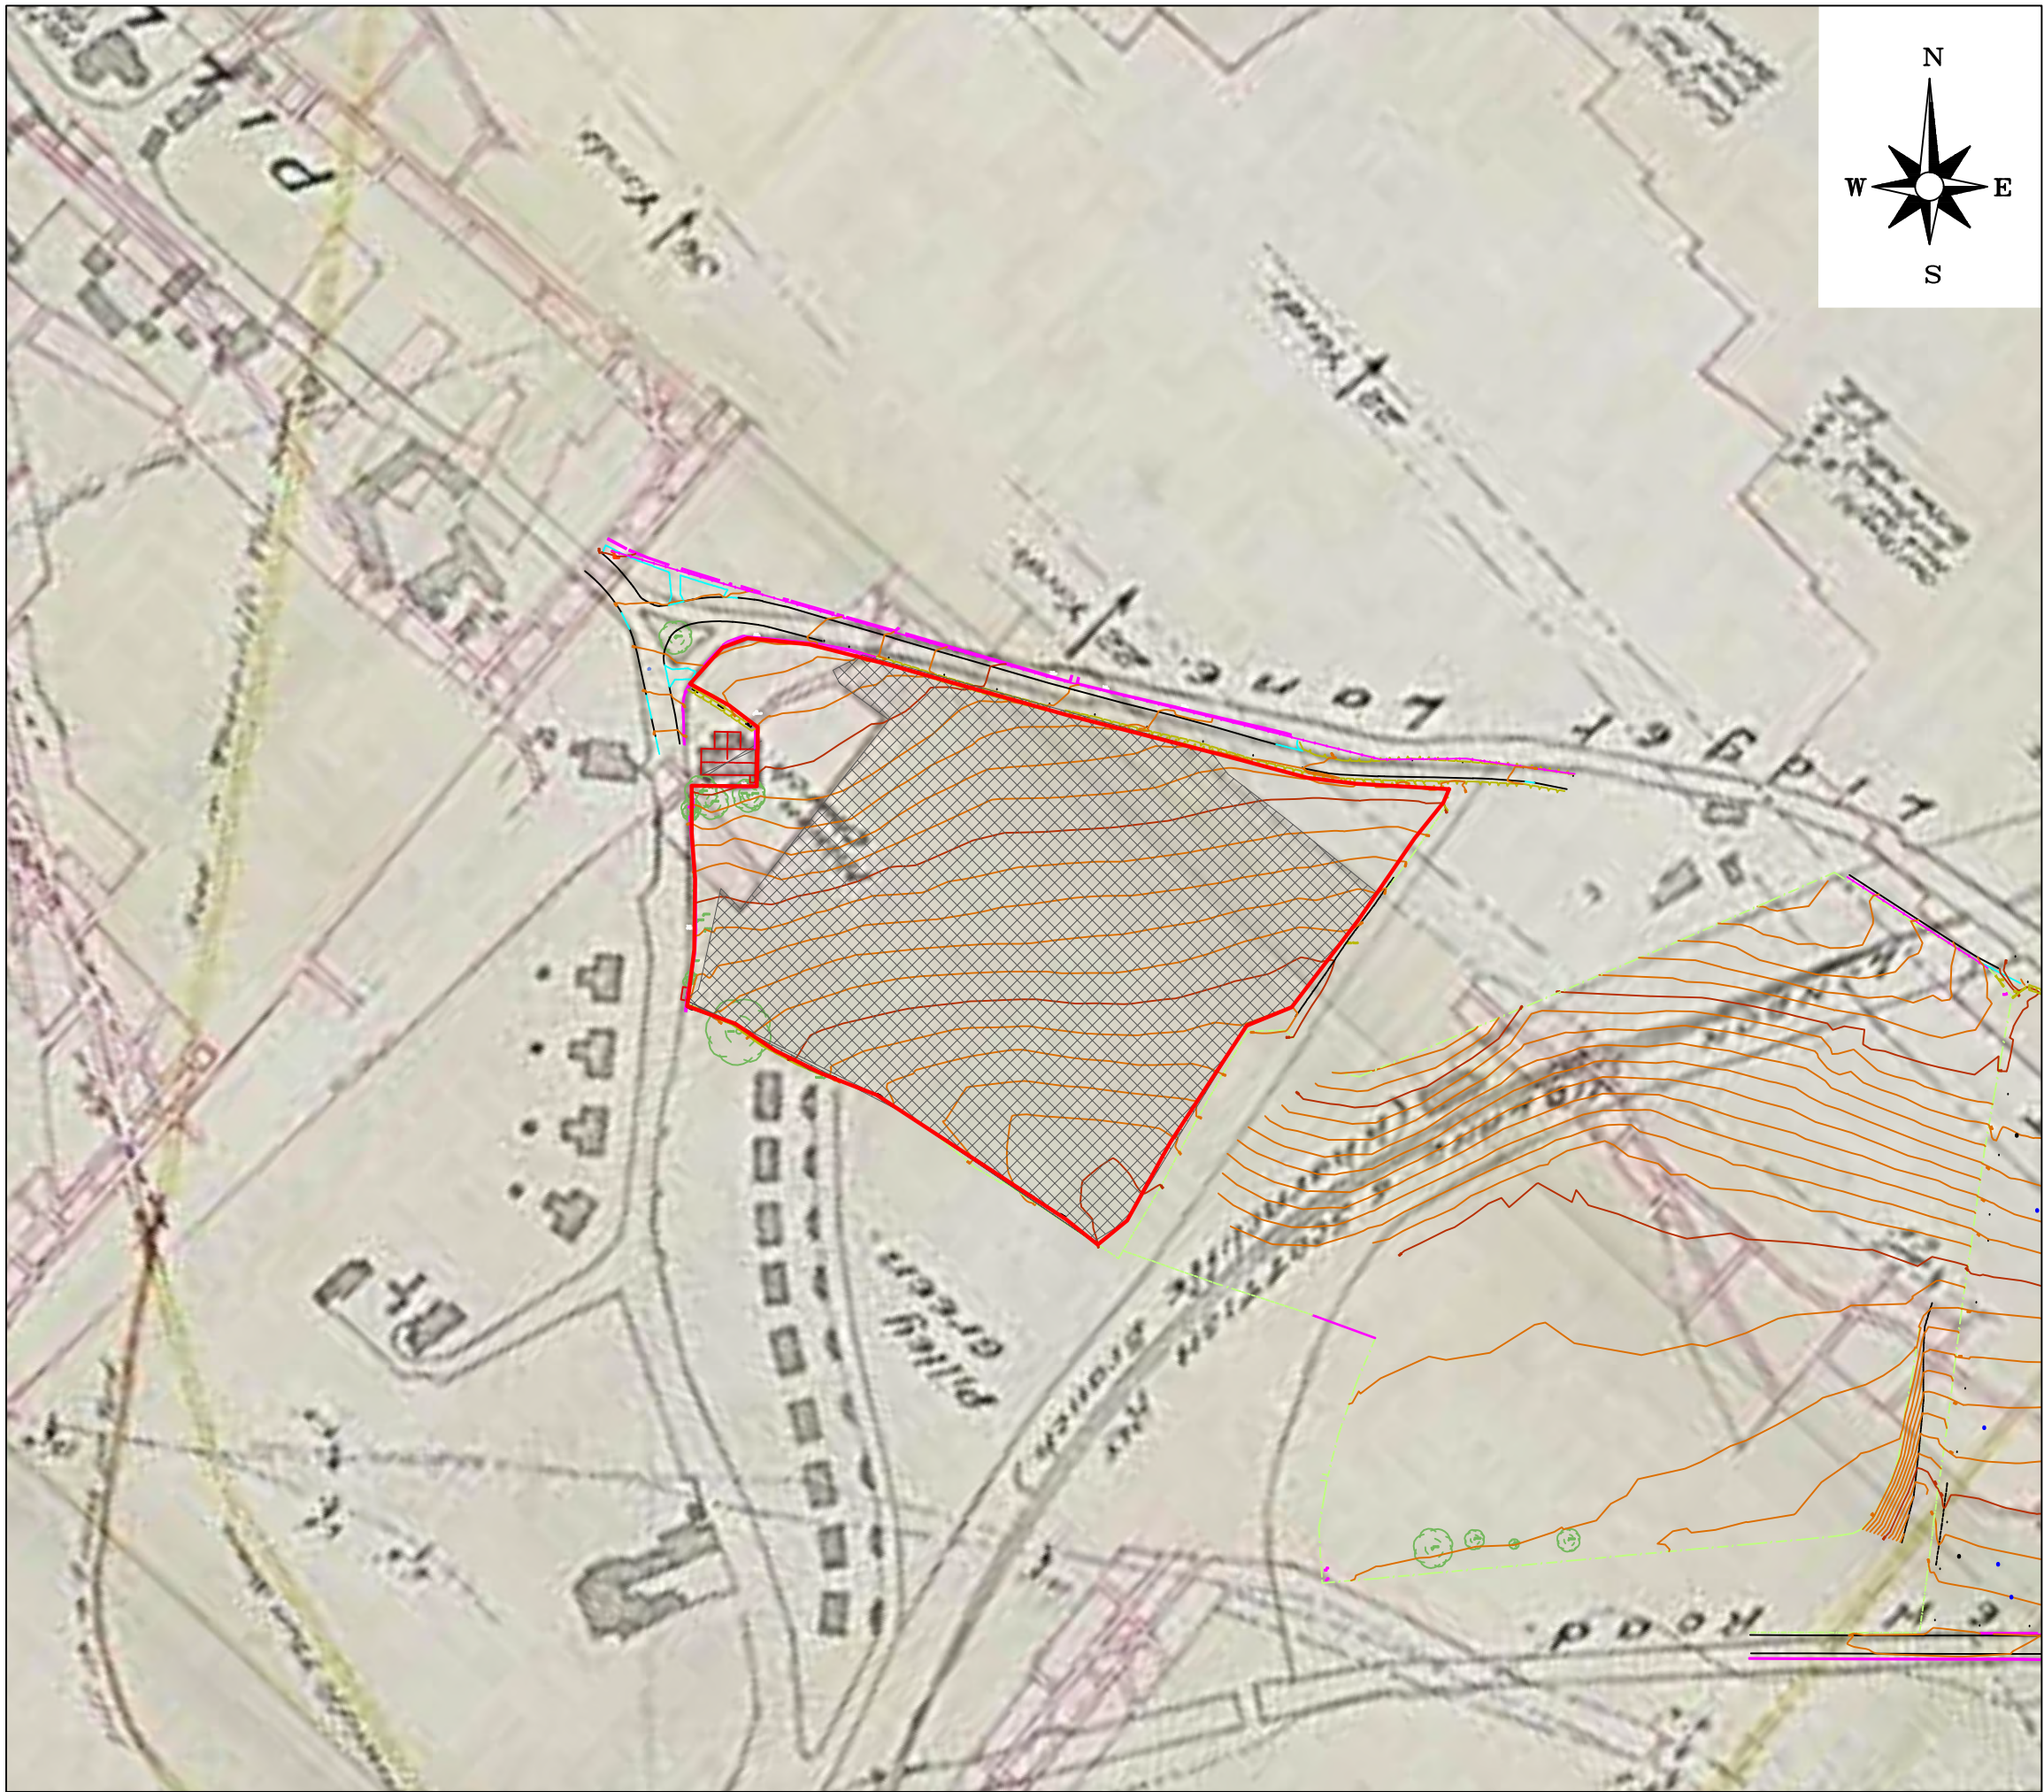
| SCALE<br>1:2,000 | SHEET<br>A3 | DRAWING NO.<br>2222/W/11 |

| NOTES | | |
|---|---|---|
| <div><div></div> APPROXIMATE SITE BOUNDARY</div> <div><div></div> EXTENT OF WORKINGS</div> | | |

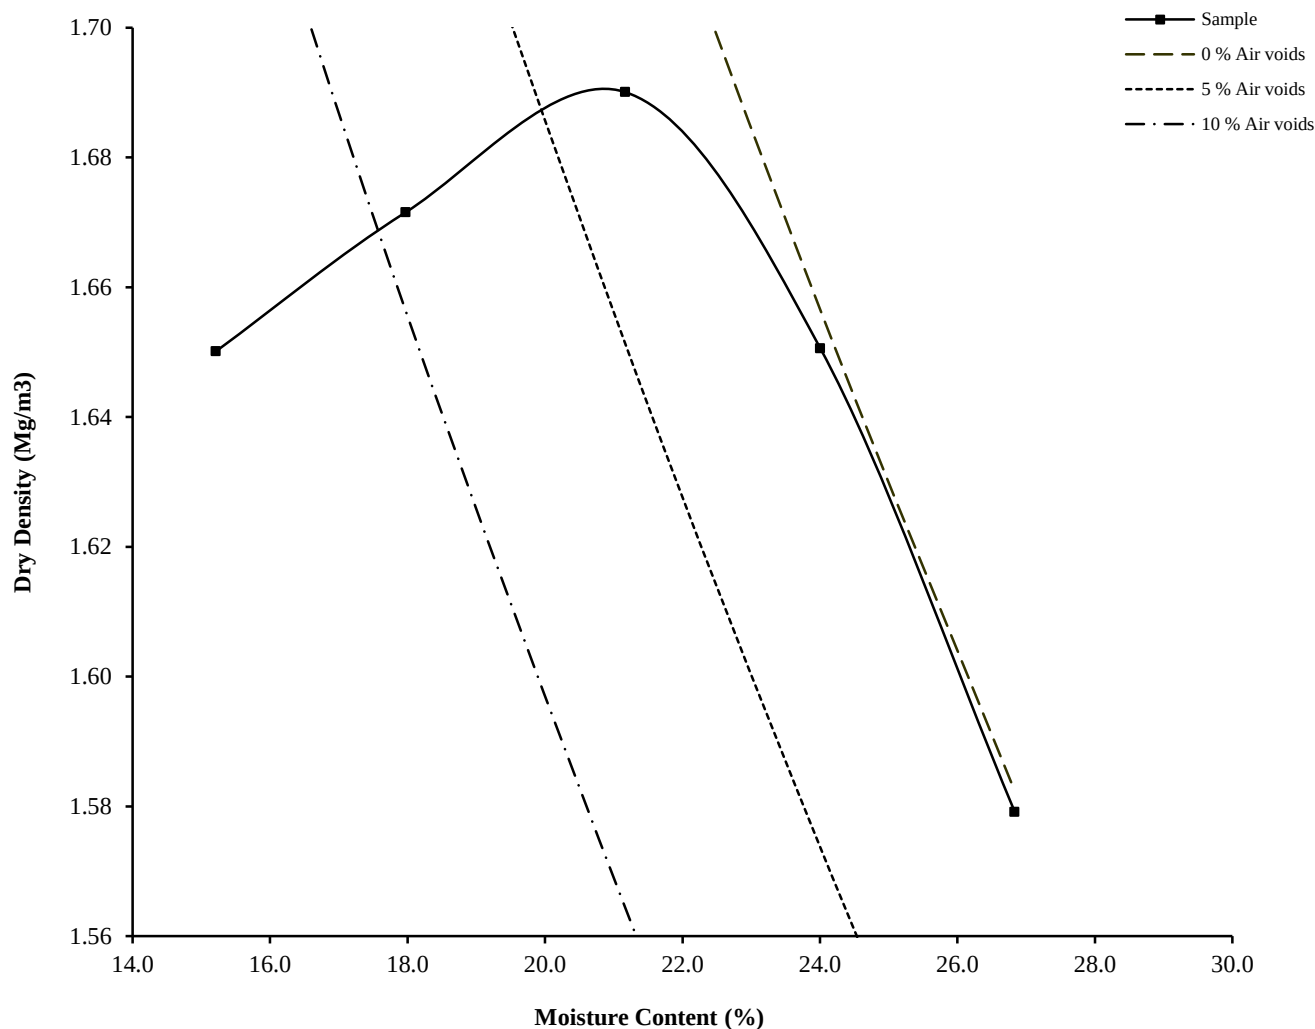
| Initial Moisture Content: | 30 | Method of Compaction: | 2.5kg | Separate Samples |
| Particle Density (Mg/m <sup>3</sup> ): | 2.75 | Assumed | Material Retained on 37.5 mm Test Sieve (%): | 0 |

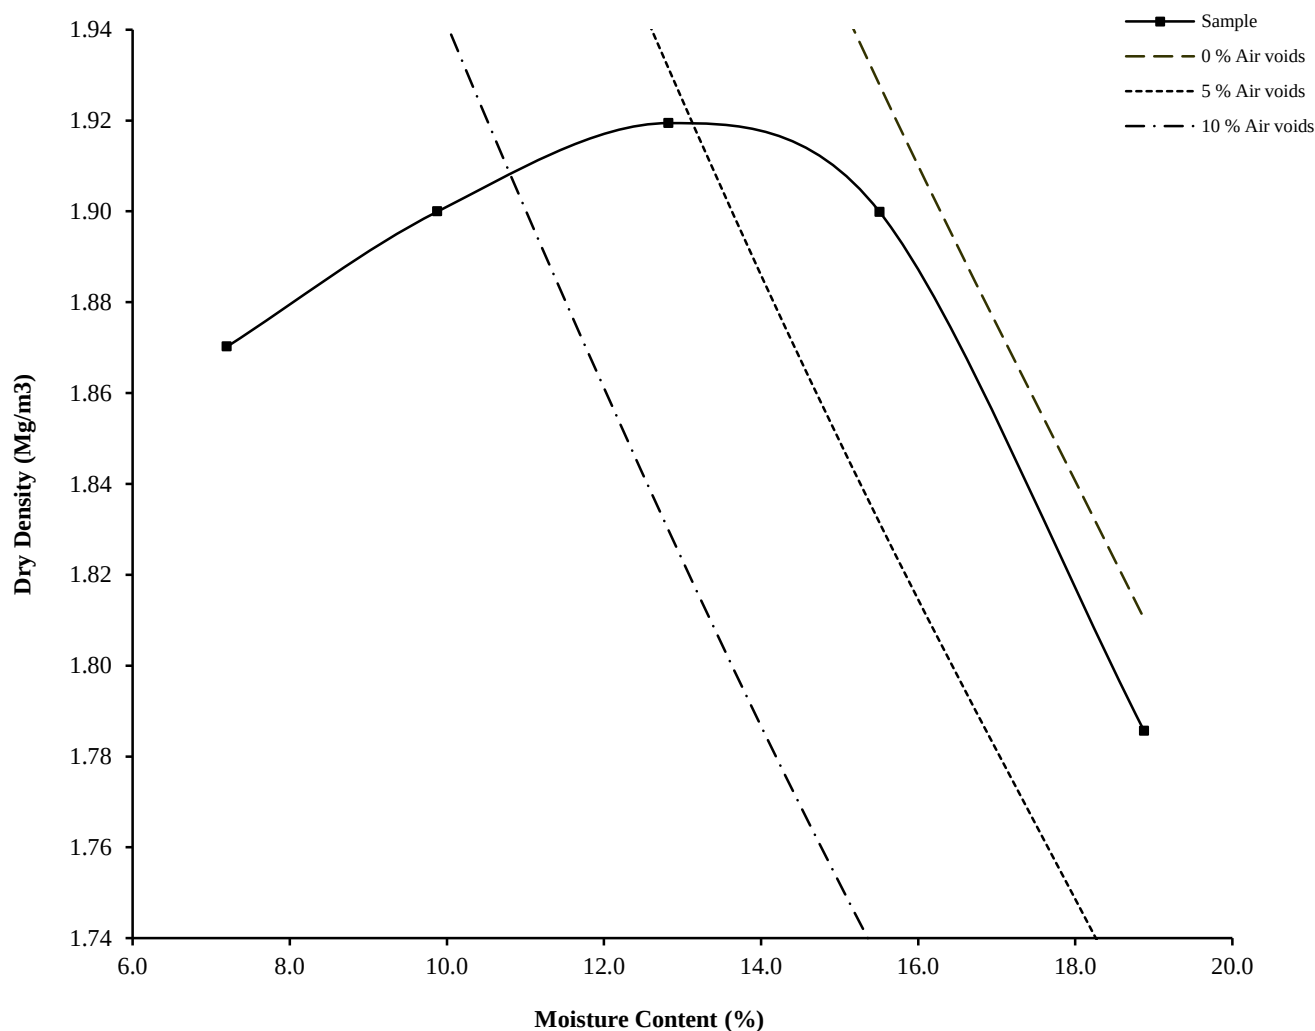
| Initial Moisture Content: | 21 | Method of Compaction: | 2.5kg | Separate Samples |
| Particle Density (Mg/m <sup>3</sup> ): | 2.75 | Assumed | Material Retained on 37.5 mm Test Sieve (%): | 4 |

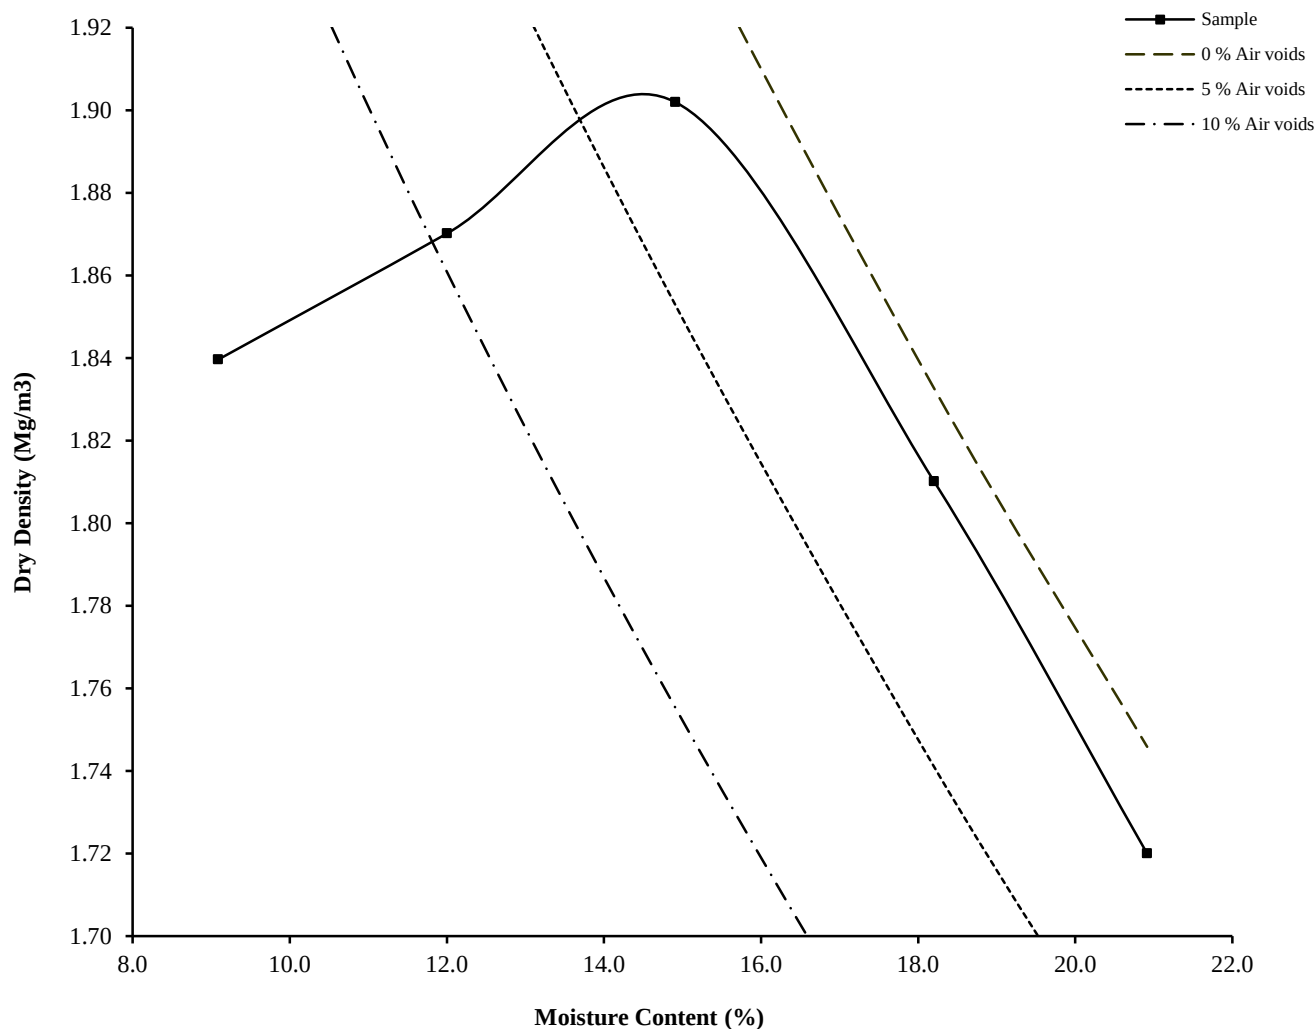
| Initial Moisture Content: | 18 | Method of Compaction: | 2.5kg | Separate Samples |
| Particle Density (Mg/m <sup>3</sup> ): | 2.75 | Assumed | Material Retained on 37.5 mm Test Sieve (%): | 0 |

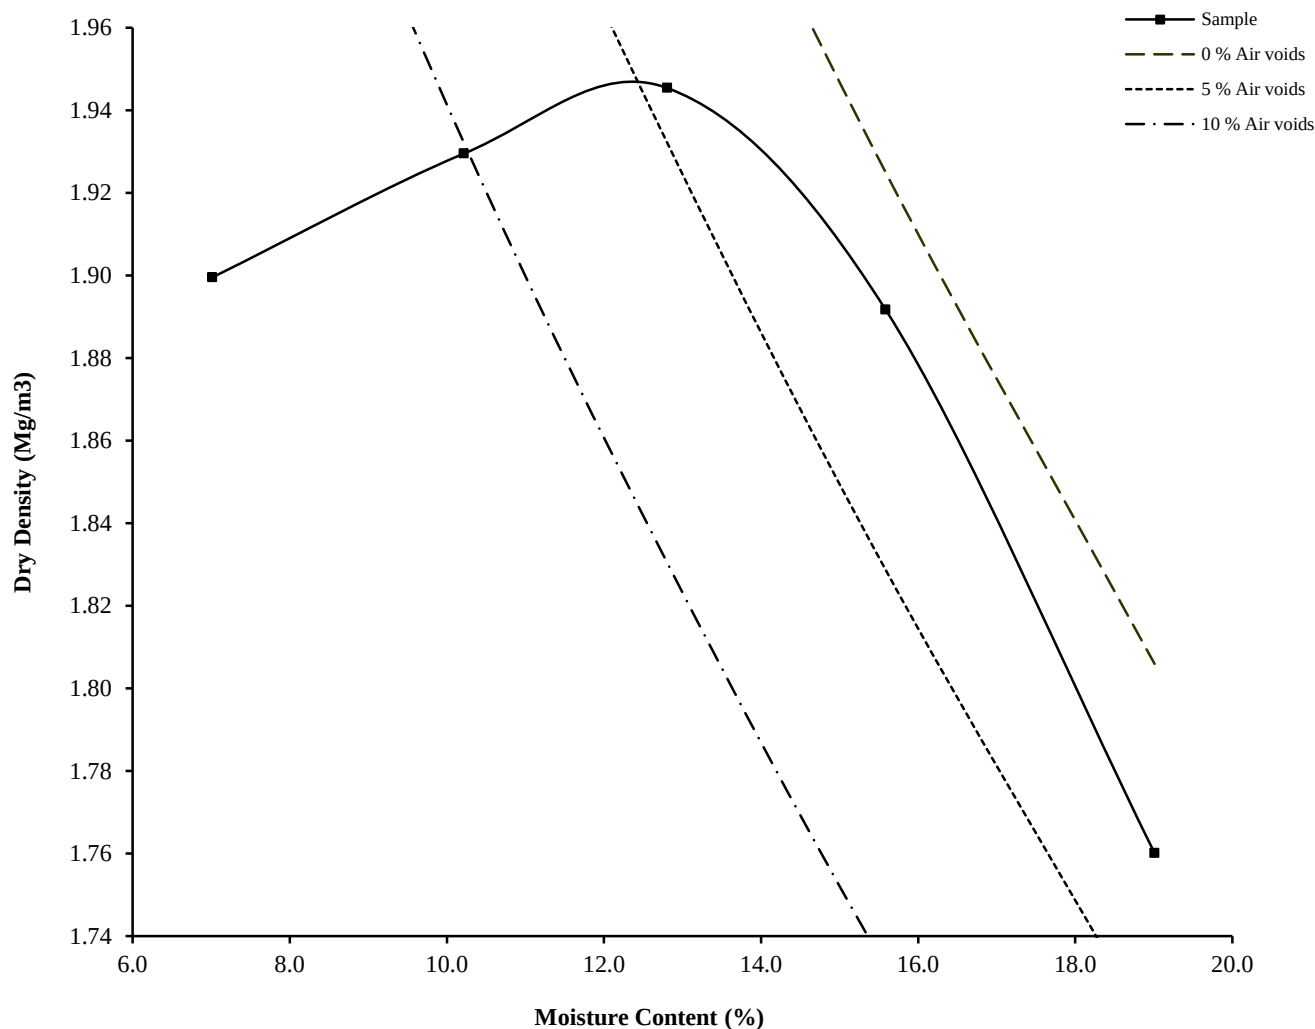
| Initial Moisture Content: | 16 | Method of Compaction: | 2.5kg | Separate Samples |
| Particle Density (Mg/m <sup>3</sup> ): | 2.75 | Assumed | Material Retained on 37.5 mm Test Sieve (%): | 0 |
