## PROJECT OVERVIEW

5 FIELD HEAD MANOR  
ELMHIRST LANE  
SILKSTONE  
BARNSELEY  
S75 4LD  
25th April 2012

### Proposal to replace windows to rear elevation Pre-application discussion

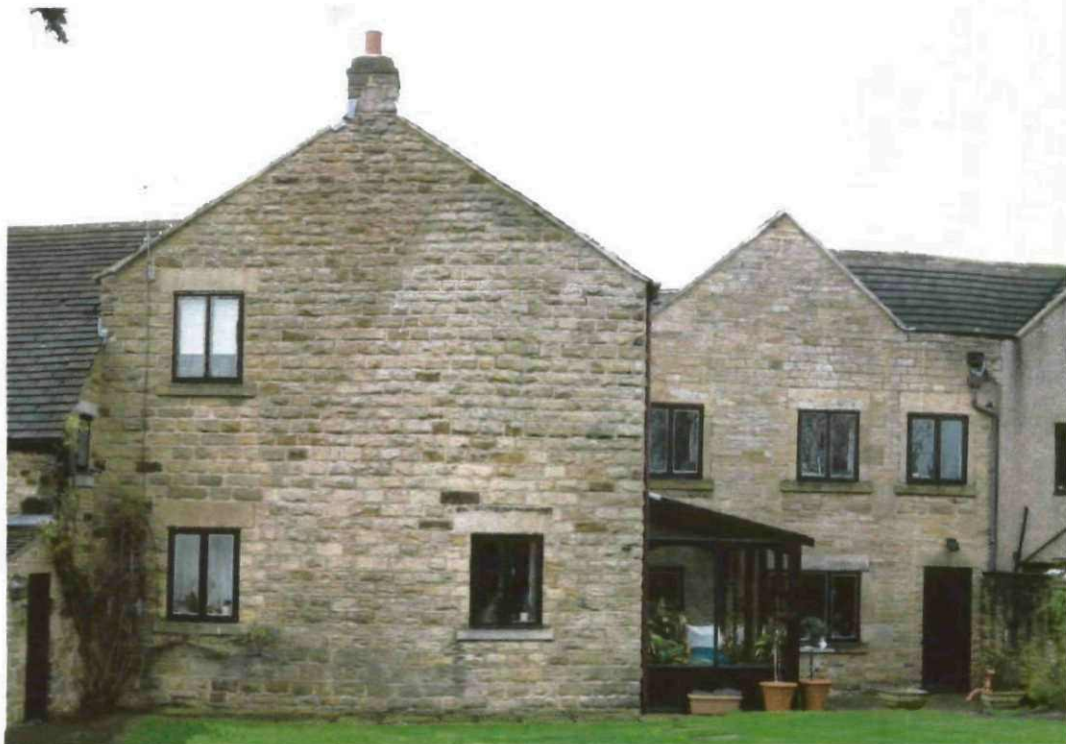
**Picture 1** Field Head Farmhouse rear elevation.

The gable on the left of Picture 1 is actually a farm worker's cottage built around 1860 attached to (and now incorporated into) the farmhouse. Prior to the 1985 renovation work, the windows to this cottage were sliding sash units of Victorian 4 pane construction, see Picture 2, an aerial photo taken around 1965.

The gable on the right of Picture 1 is actually the rear end of a timber-framed medieval hall, which was clad in stone around 1690. The stonework to this gable appears to have been rebuilt in the 18<sup>th</sup> century, at which time sliding sash windows were added to the first floor (see Picture 2). It is assumed the Victorian 4 pane units were replacements. They also show up clearly in Picture 3, which is a painting done earlier than the aerial photo.

- 2 It is also proposed to replace the first floor units on the right-hand gable with matching sashes. If you examine the masonry below these windows in Picture 1, it can be seen that the opening has been reduced by the builder to accept the standard casements, and 2 additional courses of stonework added. Contrast Pictures 1 & 3. This makes for excessively high sills in the room on the first floor, and we would propose to reinstate the original openings, giving windows the same size as when the house was listed. The ground floor window on the RH gable also needs replacement, and we would propose horizontal Yorkshire sliding sashes with panes to match.

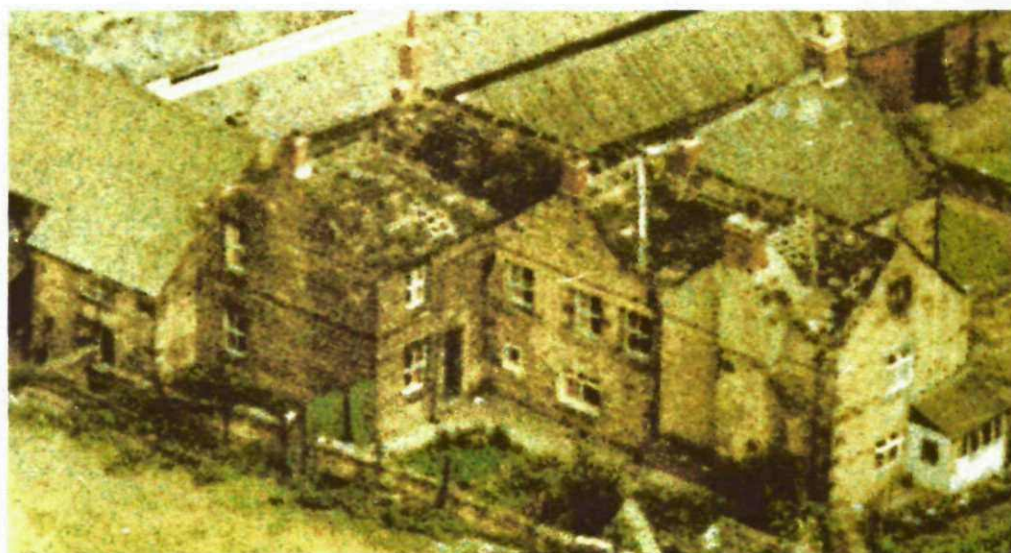
**Picture 2** Aerial photo of rear elevation taken around 1964.

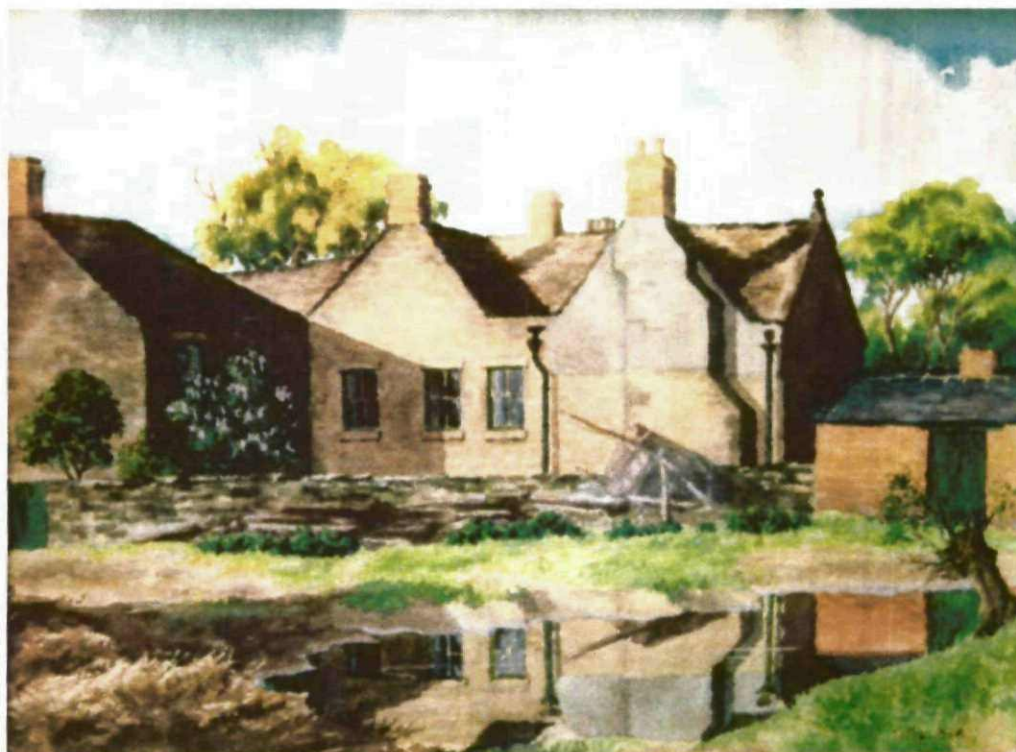
**Picture 3** Painting of rear elevation (probably 1950's)

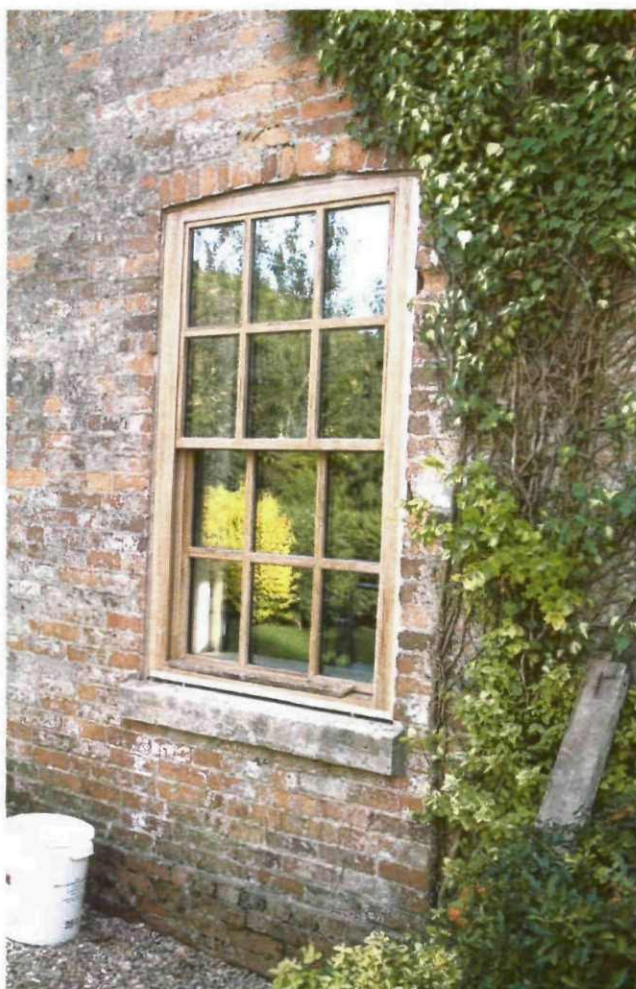
1. We would propose to replace the existing casements on the Victorian cottage with double glazed sliding sashes similar to that shown in Picture 4, with 30mm glazing bars, as recommended by Lander (House & Cottage Restoration, Hugh Lander 1999)

**Picture 4** Proposed sash design

It is proposed to use untreated European oak for the frames, as it will weather to blend in with the stonework. We would seek advice from yourselves regarding recommended glazing materials.
