### COAL MINING RISK ASSESSMENT

# **ARBORICULTURAL REPORT**

**to BS 5837:2012 at:**

***Land Adjacent to  
Westfield House  
Wellthorne Lane  
Ingbirchworth  
Penistone  
South Yorkshire  
S36 7GJ***

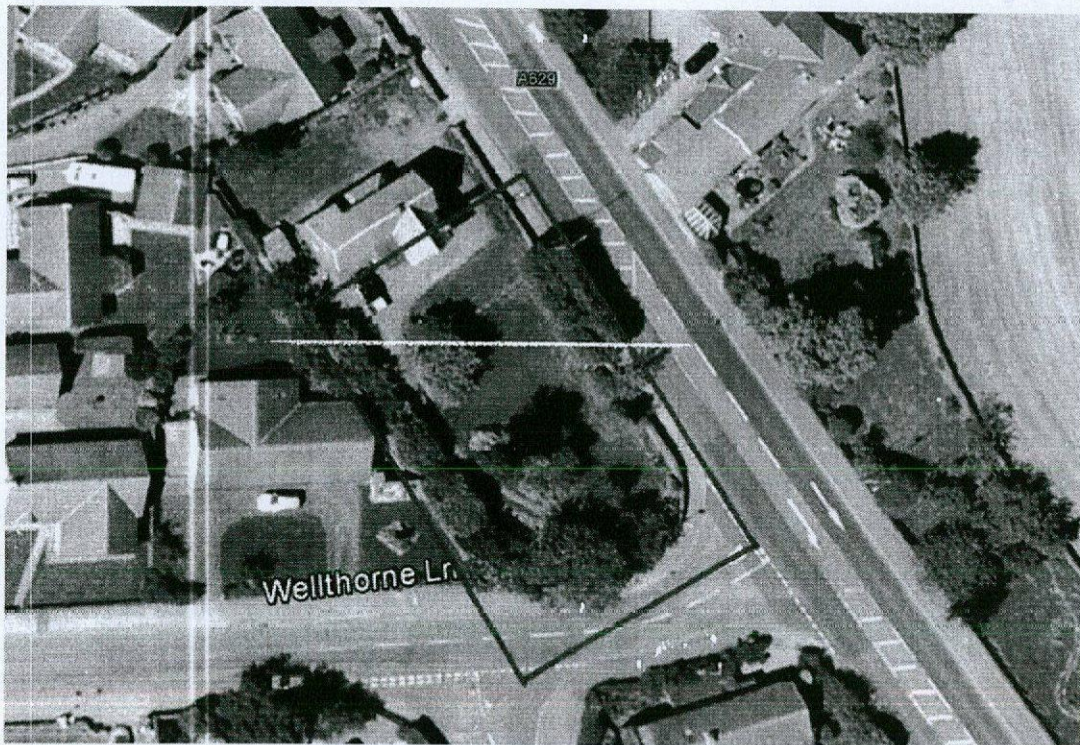
2.1.2 The tree survey was limited to the area within the red line, shown in the (2009) image below:
