# Stainborough Castle, Wentworth Castle Gardens

## Bat Survey Report

1<sup>st</sup> September 2020

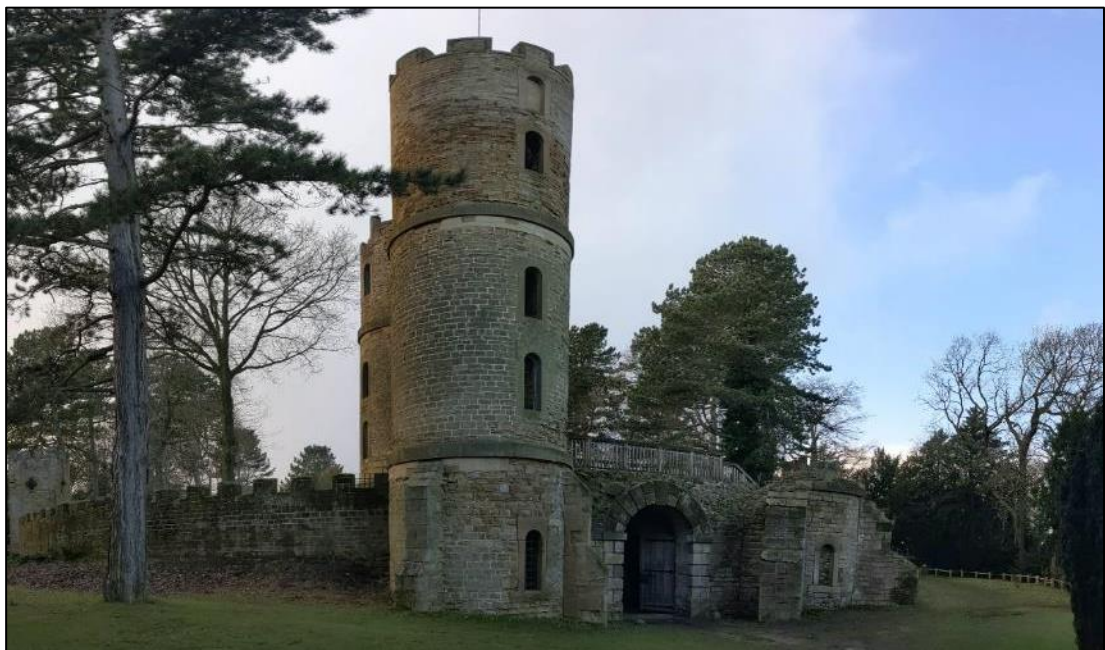
**Plate 1. Gatehouse viewed from east, with the southeast turret (GT1) in the foreground**

- 5.2.2 Stainborough Castle comprises a Grade II\* listed gothic folly, constructed between 1728-1730 from coursed dressed sandstone with ashlar dressings. The castle comprises a roughly circular curtain wall, with four square guard towers, and a large gatehouse on the east side which includes an archway, originally located beneath four circular turrets. Two of these turrets remain either at, or close to, their original height (GT1 & GT2, Figure 3; Plates 1 & 2).

- 5.2.3 Turrets GT1 and GT2 are linked by a wall, which includes a tall round-arched doorway. The southeast turret (GT1, Figure 3) had a spiral metal staircase fitted c.2005, which allows visitors to reach a viewing platform just below parapet height. Turrets GT1 and GT2 both have numerous window openings present in the outer walls. The embattled parapet present on GT1 is missing from GT2. Turrets GT1 and GT2 are connected by an arched stone passageway, with a second arch forming the roof of the main vault. The vault comprises the main entry point into the folly for visitors. On the north side of the vault, a stone passageway connects the vault to turret GT4, which comprises the single storey remains of a tower, with two arched roofed former window openings built into the wall (Figure 5). Little remains of turret GT3, with the outer wall now largely collapsed.

- 5.2.4 The exterior of the turrets GT1 and GT2 includes mostly superficial gaps in masonry joints, with occasional deeper holes present. Deeper crevices were noted on the south side of GT2, within the area where the Natterer' bat roost was recorded in 2004 (Figure 4). Joints in this area were difficult to inspect from the ground due to their height. Numerous shallow crevices are present between masonry in the areas where a former wall has collapsed, or been removed, on the north side of turrets GT1 and GT2 (Plate 2). Bats may also roost within deeper crevices and voids between stone blocks on the turret exteriors.

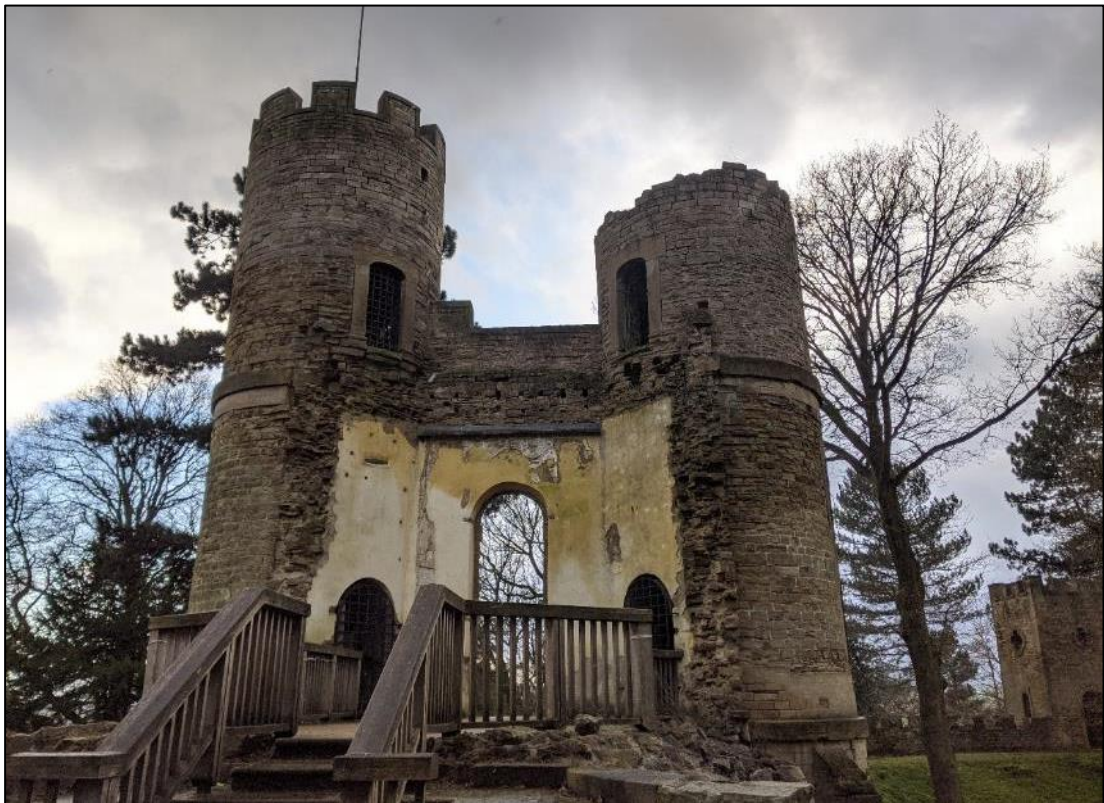
**Plate 2. North side of turrets GT1 and GT2**

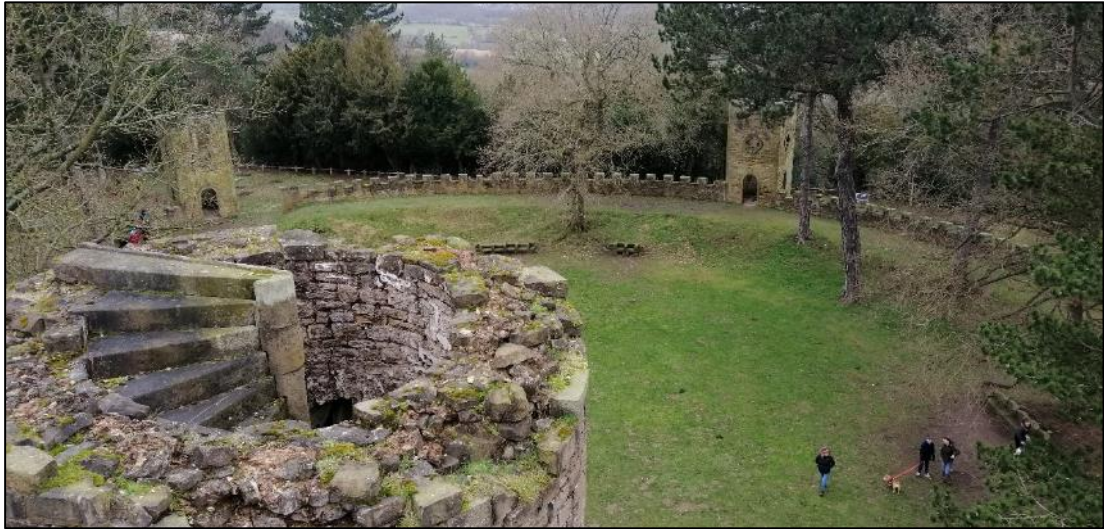
**Plate 3. View from top of GT1, GT2 in foreground plus T2, T3 and curtain wall**

- 5.2.6 Four square towers are present in the curtain wall (Plate 3). These are mainly two stories in height, with T4 (Figure 6) also supporting a basement room. None of the towers have roofs and all have two door or window openings in each elevation. Pairs of wooden lintels are present above upper window openings and above door openings. Door openings connect the tower interiors to the open space enclosed by the curtain wall. A fire opening and associated flue is built into the wall on the north side of T4, with the basement room beneath this tower accessed from the outside of the curtain wall.

- 5.2.7 The tower exteriors are generally reasonably well pointed; however, some deeper crevices were recorded, for example, the open joint between parapet masonry on the north side of T1, from which a hibernating noctule bat was noted (Plate 4). On the interior of the towers, all lintels above upper windows and lower doors display good potential to support roosting bats, both between lintels and within voids in masonry either side of the lintel ends. A pair of brown long-eared bats were recorded roosting within the wall, beside a lintel beam in the west wall of T1 (Plate 5). Deep crevices were also noted in the north wall of T4, above the doorway into the basement room.

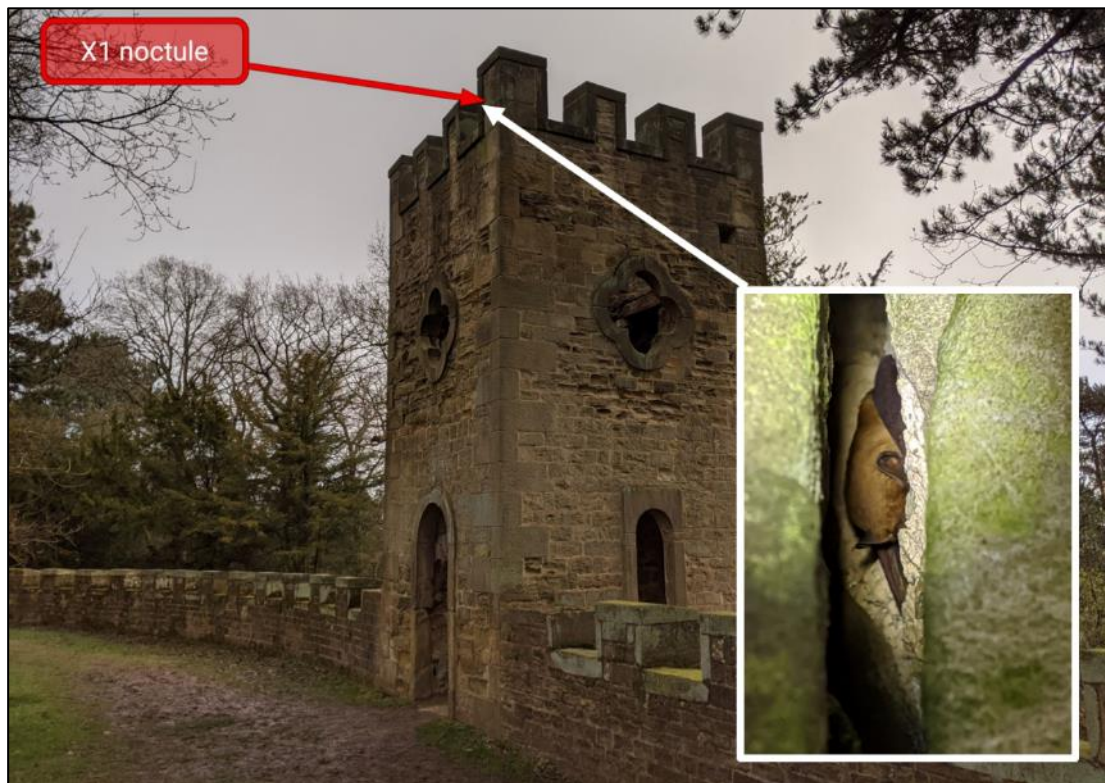
**Plate 4. Noctule roost in north elevation of T1**

- 5.2.9 Between 03:59 (37 minutes before sunrise) and 04:18 (18 minutes before sunrise) a total of 11 brown long-eared bats were recorded roosting between the top window lintel and masonry on the west side of T1 (Plate 5; Figure 7). Following completion of the survey a re-inspection of the exterior of T1 recorded a single soprano pipistrelle roosting in the open joint between parapet masonry, from which a noctule had been recorded previously (Plate 4).

5.2.14 Prior to the survey commencing a visual inspection of the castle recorded a soprano pipistrelle roosting in the T1 parapet roost (Plate 4) and at least one bat in the brown long-eared lintel roost in the west elevation of T1 (Plates 5 & 6).

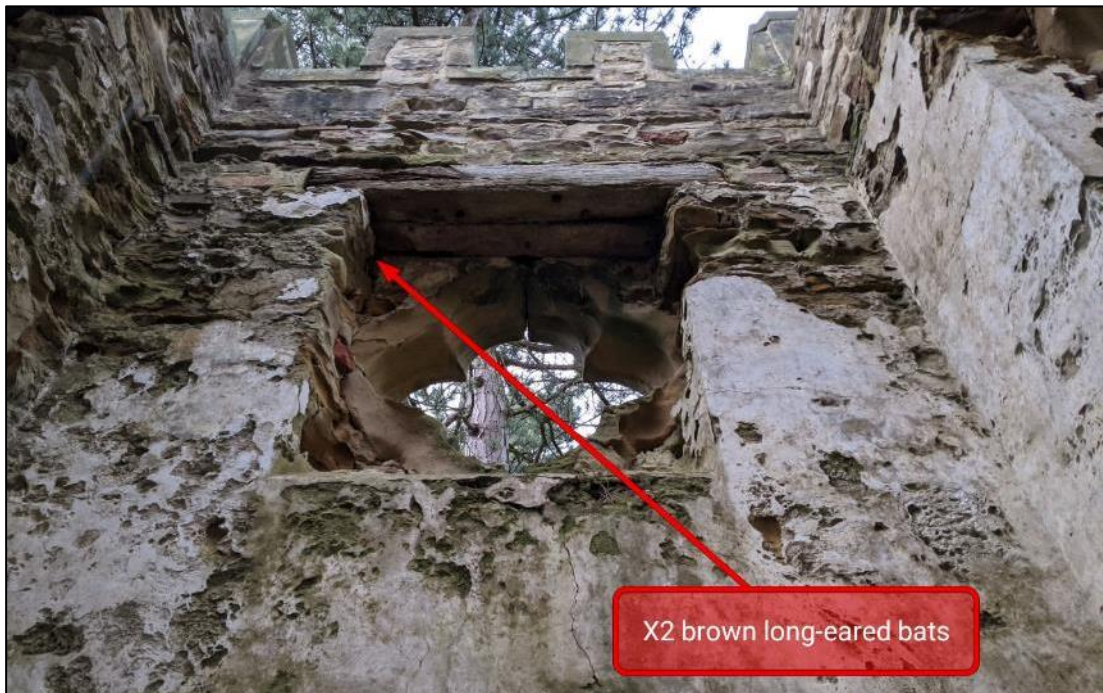
Plate 5. Brown long-eared bat roost in west wall of T1

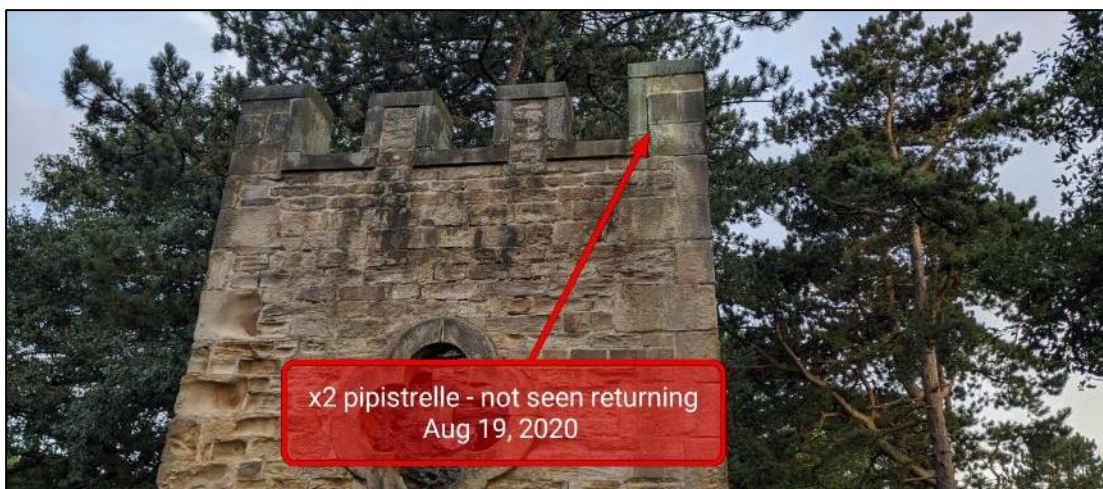
**Plate 10. Pipistrelle roost recorded from east elevation of T1 on 19<sup>th</sup> August 2020**

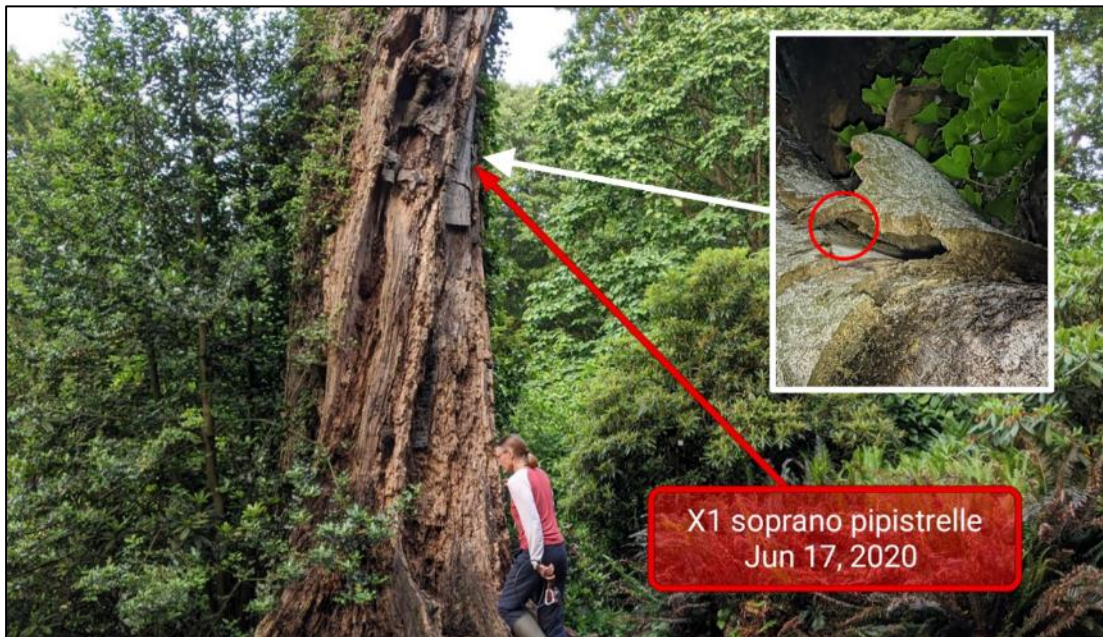
**Plate 11. Soprano pipistrelle in beech tree roost**

- 5.2.20 Prior to the dusk emergence survey on 17<sup>th</sup> June, a visual inspection of Stainborough Castle and a number of nearby trees was carried out. During this inspection a single soprano pipistrelle bat was recorded roosting behind flaking bark at 4m on the south side of a dead beech *Fagus sylvatica* monolith at OS Grid Ref.: SE 31622 03082 (Plate 11).
