# Stables off Royd Moor Road, Thurlstone

## Bat and Bird Survey Report

17<sup>th</sup> December 2020

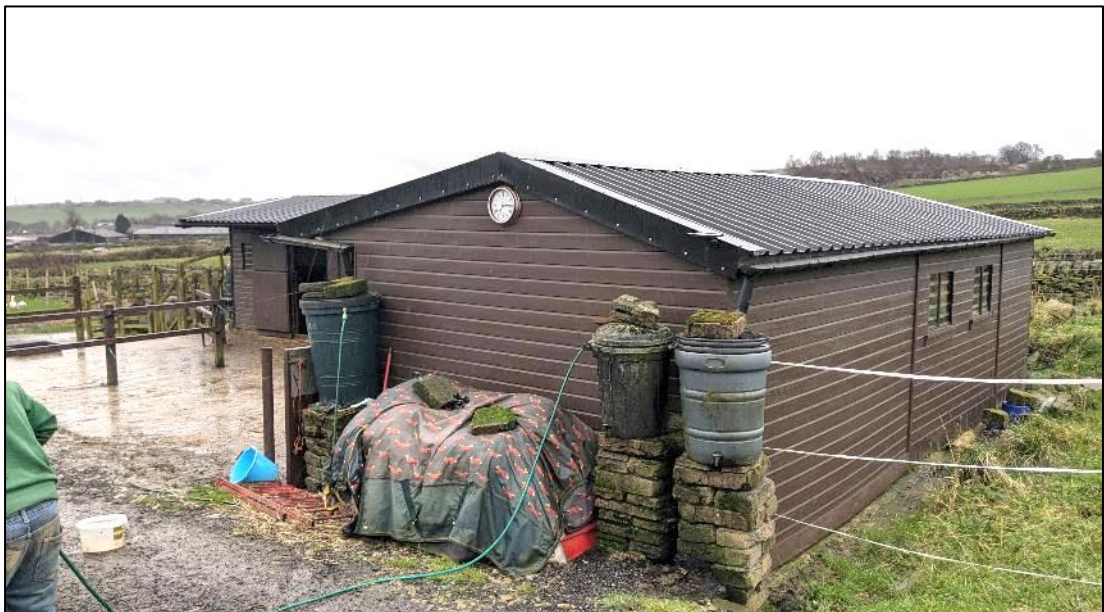
- 5.2.2 The surveyed stable building was constructed between 2003 and 2009. It comprises a single-storey L-shaped timber framed and wood clad structure with a pitched corrugated metal sheet covered roof, metal ridge and verge capping (Plates 1-3). Single paned windows and wooden stable doors are present. Guttering is uPVC and runs into water butts.

**Plate 1. Northern corner of stables**

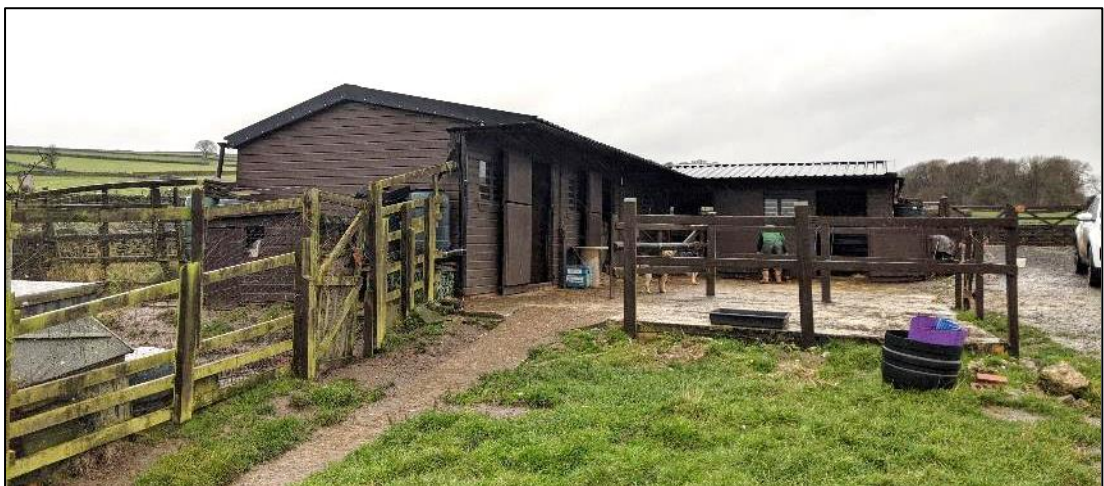
**Plate 2. East elevation of stables**

- 5.2.3 The exterior of the stables was in a good state of repair and lacked any suitable bat access points or features offering more than negligible bat roost potential.

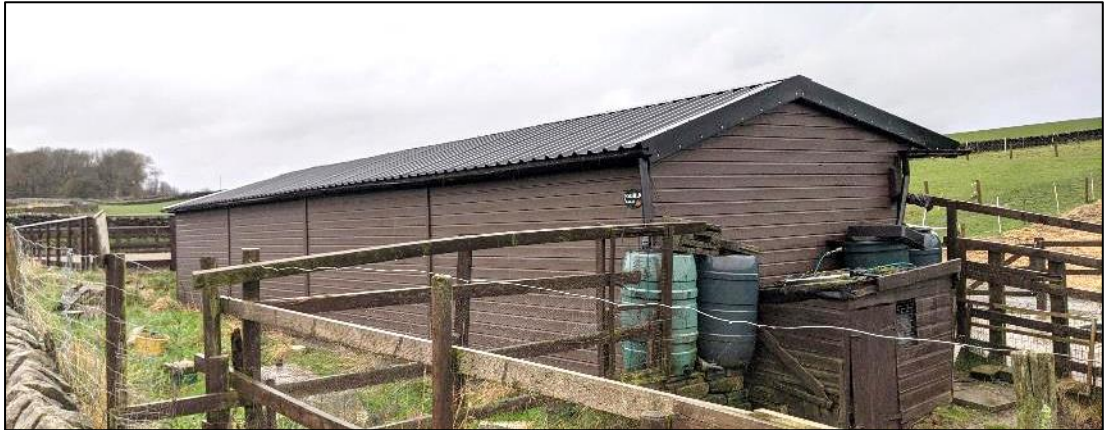
**Plate 3. Southeast corner of stables**

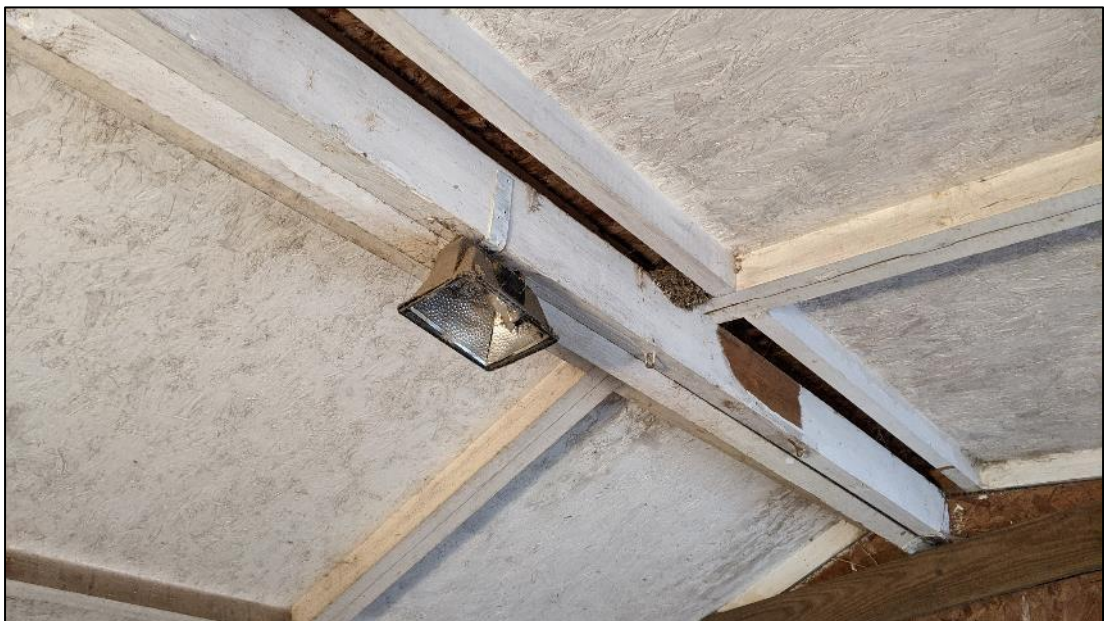
- 5.2.1 No signs of roosting bats were recorded from the stables and they are considered to offer negligible bat roosting potential. Approximately eight historic swallow *Hirundo rustica* nests were however recorded across various sections of the stable block.

- 5.2.4 The roof is lined with chipboard and suspended on a simple timber framework. The external walls are single skin from 1m up, with a double skin below this height. There are however no potential bat access points into the double skin section of the wall.
- 5.2.5 Approximately eight former swallow nests were recorded from various compartments of the stables. These were mainly above a floating double ridge beam (Plate 4) but also at the base of the roof pitch (Plate 5).

**Plate 4. Interior of roof with old swallow nest visible**

6.3.3 It is also recommended that mitigation for nesting swallows is incorporated within the development. Suitable mitigation may include the provision of two swallow nest cups within a newly constructed open sided structure (i.e. car port, stables or log store).

6.3.4 Demolition of B1 will either need to be undertaken outside the bird nesting period (March to September inclusive), or the works will need to be preceded by a nesting bird check undertaken by an experienced ecologist.

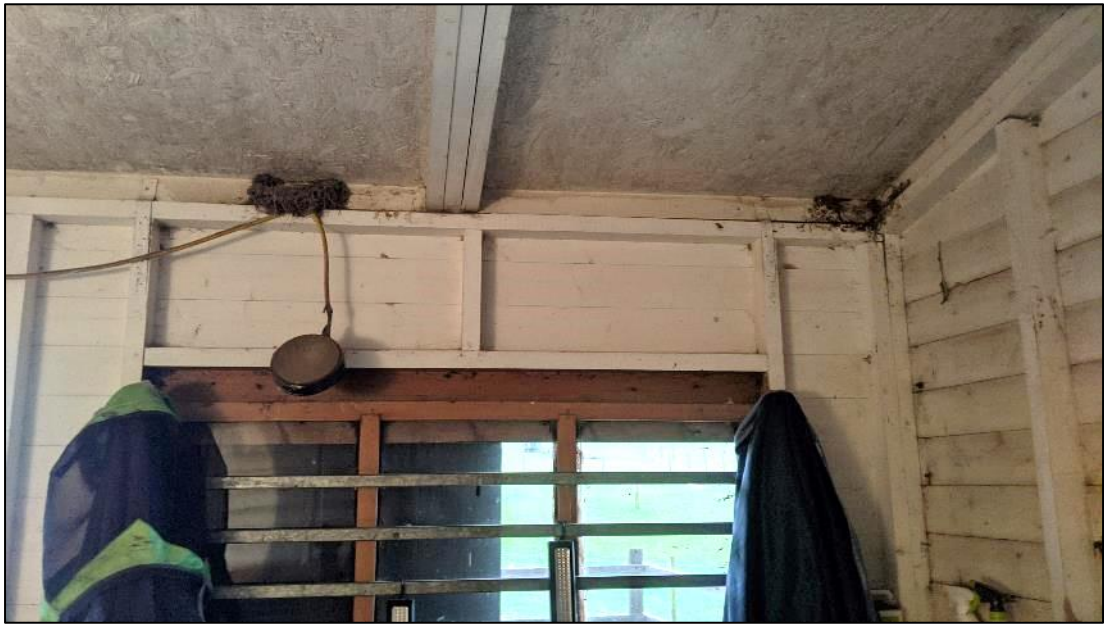
**Plate 5. Swallow nests at base of roof pitch**

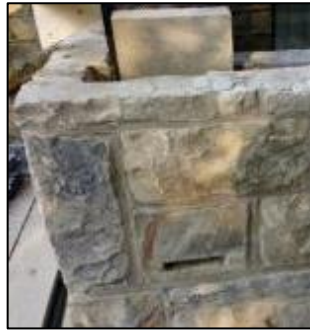
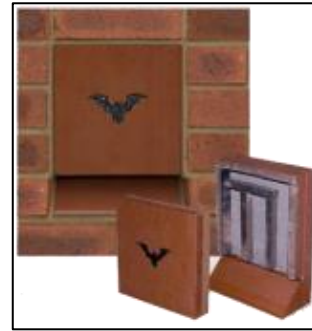
### Plates 6-8. Build-in bat roost products

- 6.3.2 No bats were recorded roosting on site during the survey works and consequently there is no compulsory requirement for mitigation. However, in order to enhance the ecological value of the site and in accordance with the aims of the National Planning Policy Framework (2019), it is suggested that one bat roosting feature is incorporated within the new dwelling. It is advised that an enclosed and integrated bat box, such as either the Build-in WoodStone Bat Box or Istock Enclosed Bat Box C (Plates 6-8) is installed, preferably high on a south or west facing gable. The box should be sited at wall top height away from areas of light spill. For further information on appropriate bat roosting features please contact Middleton Bell Ecology.
