**PHASE 2  
GEOTECHNICAL AND GEO-ENVIRONMENTAL  
SITE INVESTIGATION**

**PHASE 2 SITE, BARNBURGH LANE, GOLDTHORPE**

**GLEESON DEVELOPMENTS LTD**

December 2014

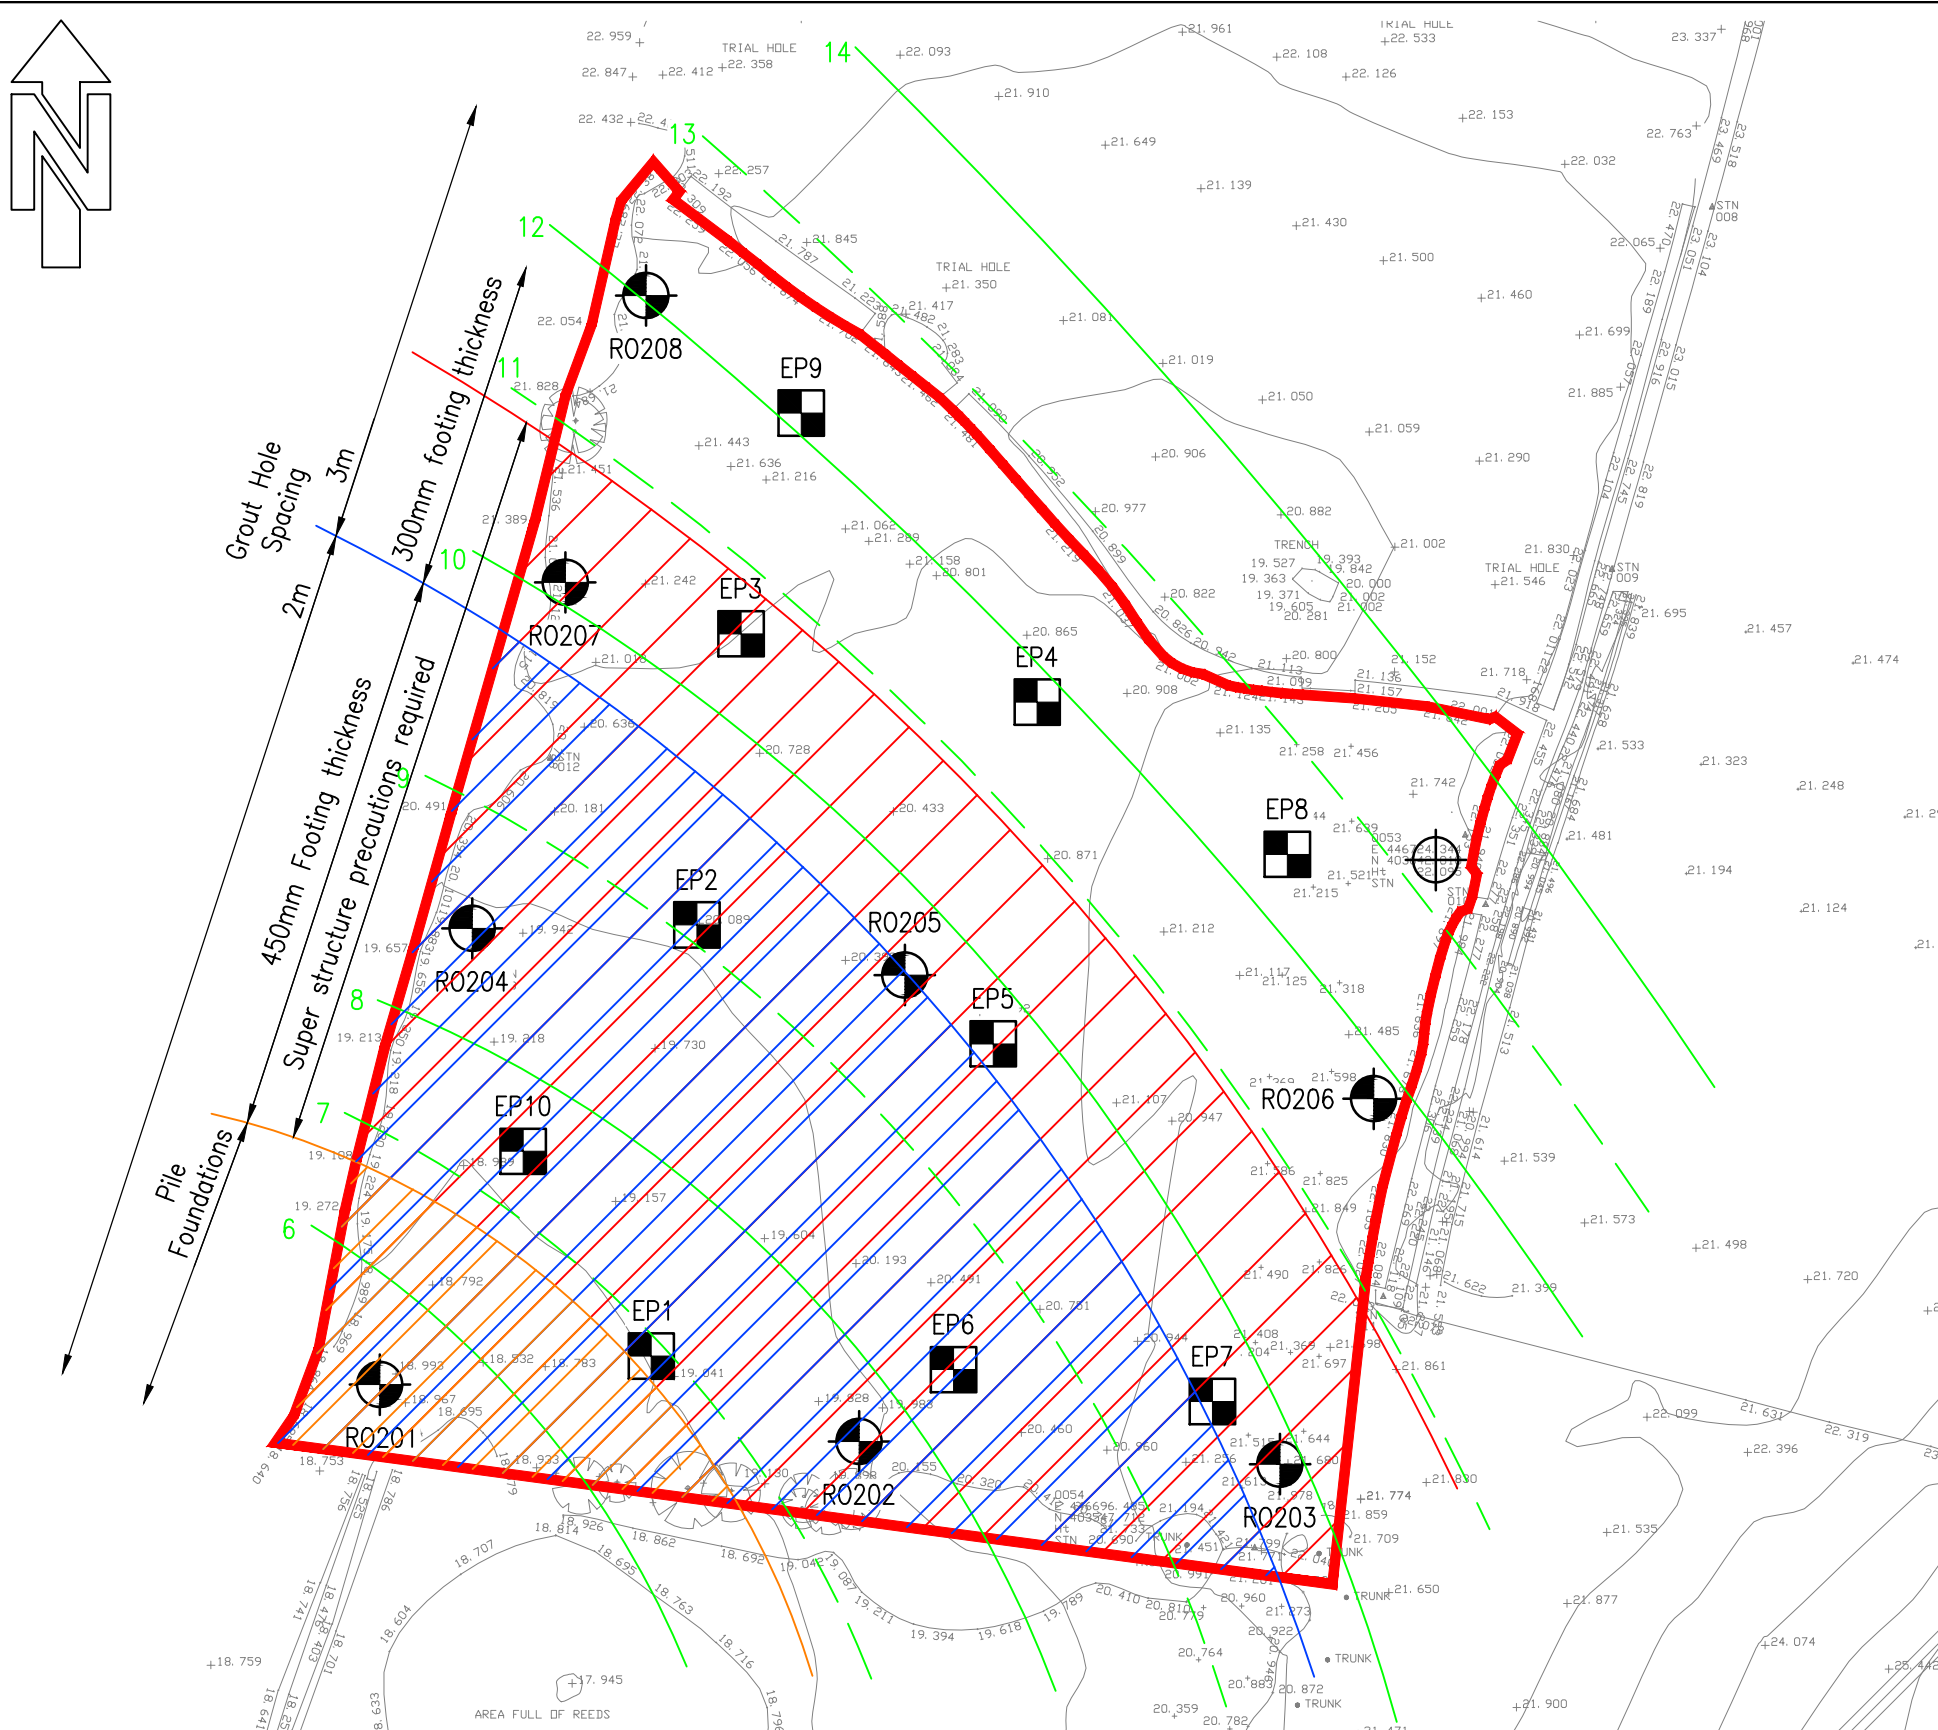
Exploratory Hole Location Plan, drawing 34041/013/A

- Approximate position of Trial Pits excavated by Eastwood & Partners on 25/09/2014
- Approximate position of Boreholes drilled by Sirius Remediation between 24/09/2014 – 26/09/2014
- Approximate location of mineshaft (Ref: 446403-021)
- Approximate Site Boundary
- Estimated depth to base of Shafton Coal (m bgl).
- Estimated zone where pile foundations required.
- Estimated zone where 450mm footing thickness required.
- Estimated zone where superstructure precautions required.

The appended 'Exploratory Hole Location Plan', drawing number, 34041/013A indicates the approximate location of the described features.

Copies of the trial pit and borehole logs are presented in Appendix 2, and their approximate locations are plotted on the 'Exploratory Hole Location Plan', drawing number 34041/013A in Appendix 1.

Grouting of a shallow coal seam is normally recommended where the depth from the bottom of the foundations to the top of the coal seam is less than 10 times the extracted seam thickness. Where there is less than 4 times the seam thickness, it is considered necessary to use a spacing of grout holes to 2 m. Elsewhere 3.0 m spacing can be adopted. The approximate extent of grout hole spacing is presented on drawing 34041/013.

Where the depth to the coal is very shallow and the seam has been worked, collapse and distortion of the strata immediately above the coal may make it unsuitable as a founding material. This could occur where the depth to the top of the coal seam from ground level is less than about 4.5 m. Therefore where the seam is expected to have been worked and where the depth to the base of the seam is less than 6.0 m, pile foundations should be adopted and founded below the base of the coal. This is likely to only affect a few plots. The approximate extent of this is shown on drawing 34041/13A.

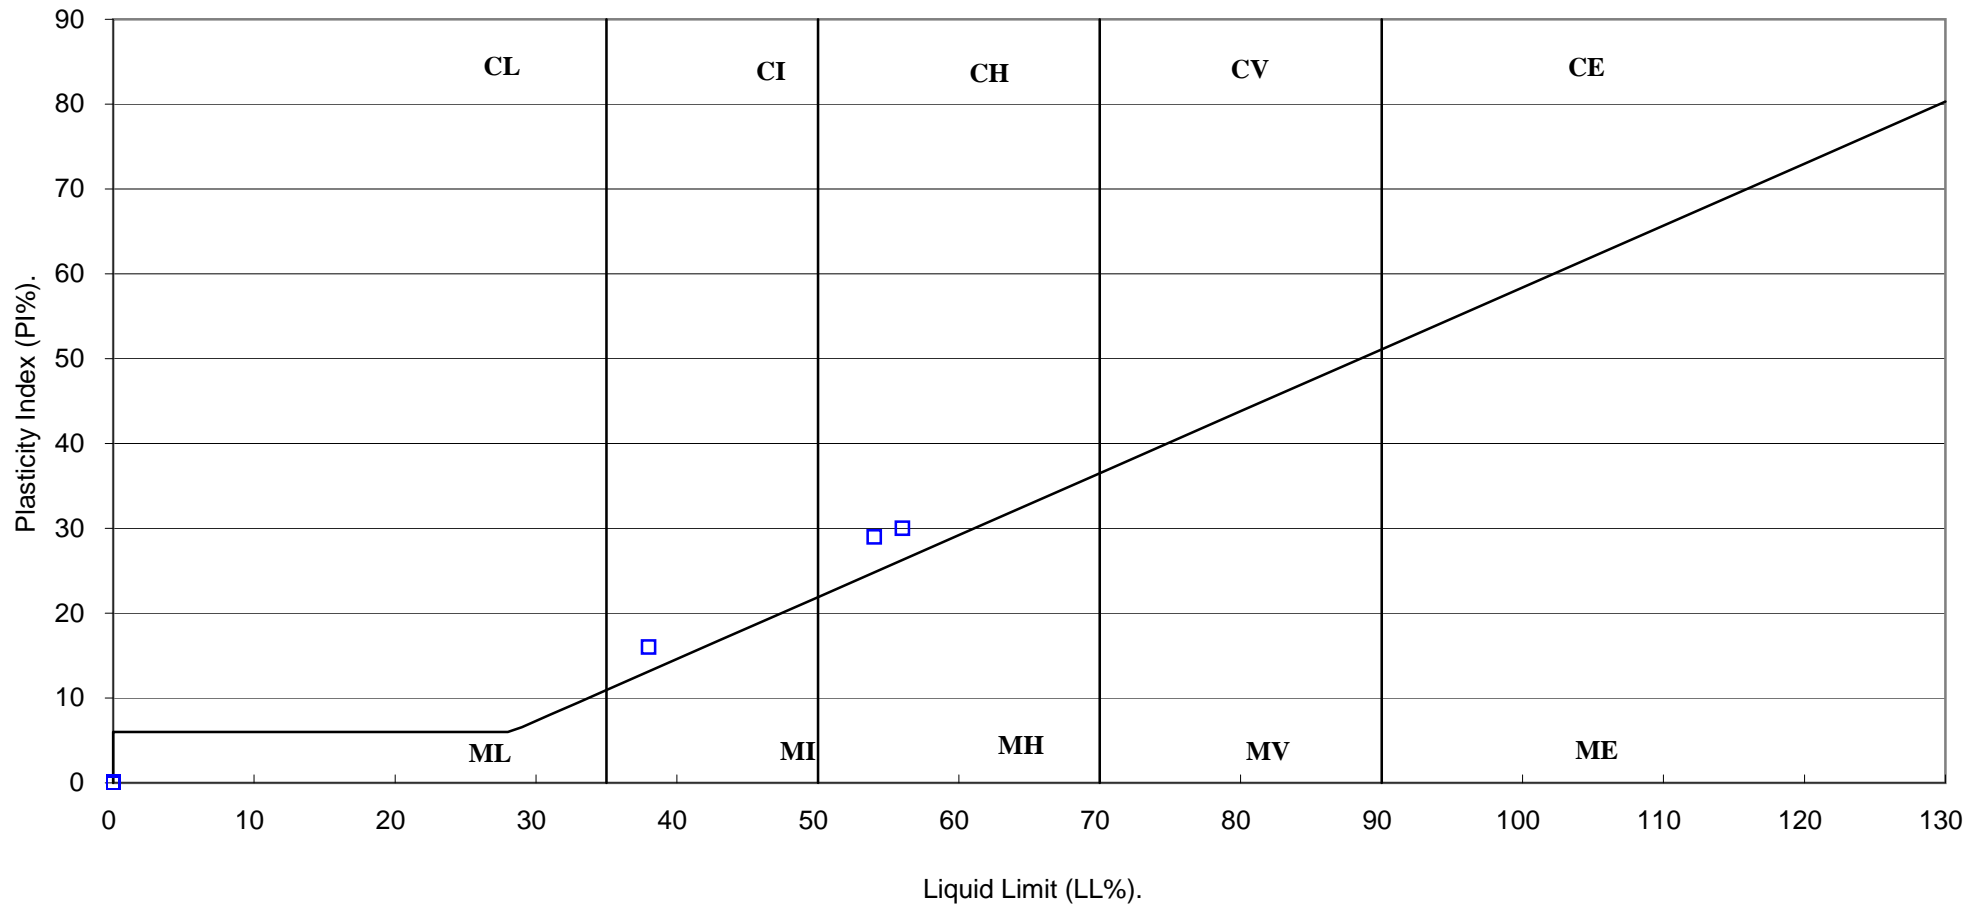
# PLASTICITY CHART FOR CASAGRANDE CLASSIFICATION.

(B.S.5930 : 1999)

Three samples of the natural clay were tested to assess the volume change potential. The modified plasticity indices recorded were 16, 29 and 30%. These results equate to low and medium volume change potential in accordance with NHBC Standards. It would be prudent to use the medium volume change potential classification for foundation design.
