PHASE 2 SITE INVESTIGATION - BUILDING 2 PROPOSED REPLACEMENT DWELLING (NEW BUILD)

Hill End Farm, Hill End Road, Mapplewell, Barnsley, S75 6DU

Report Ref: TH/Hill End/Bldng2/New Build/PHASE2/Mar2023/v01

11th March 2023

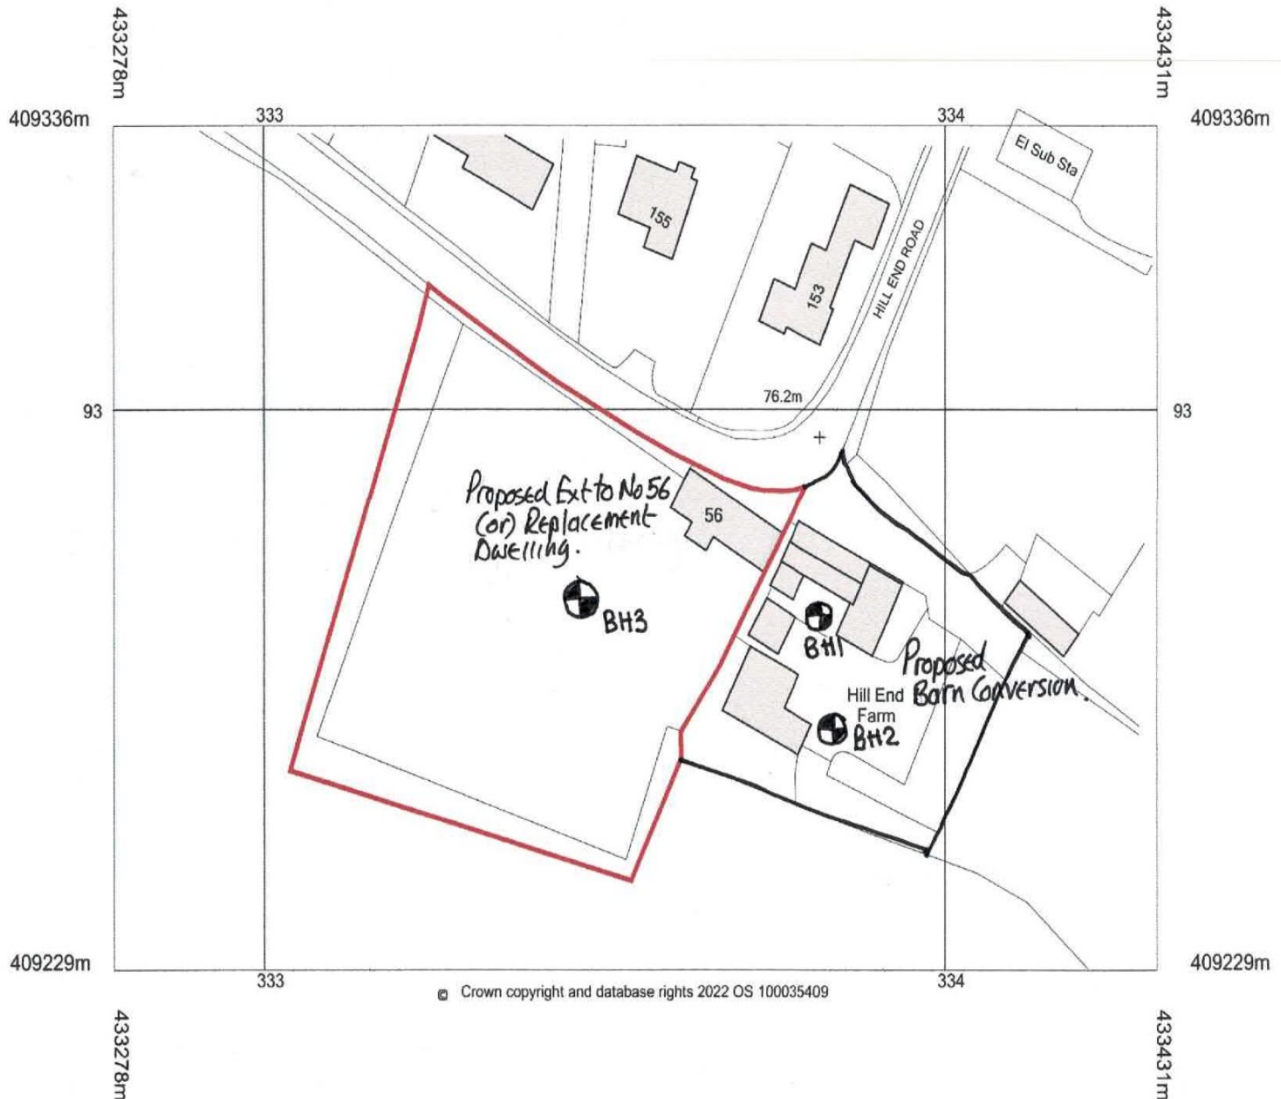
Fig 3 – BH Location Plan - Hill End Farm, Mapplewell.

[*Note! – Borehole BH3 specifically relates to the land parcel identified for the position of the replacement (new build) dwelling, and Trail Pit TP1 is located 8m to the left of BH3 (but not shown on the above sketch)]

On this basis, it was considered appropriate to commission **3No. rotary boreholes to 30m deep** across the **whole site area** to identify any unstable zones, coal seams etc., + **1No. Trail Hole (TP1)** in direct proximity of the new build dwelling, all with a qualified watching brief to ensure that if made ground is also observed (with anthropogenic debris) or if visual/olfactory (malodorous) evidence of fuel/oil type contamination is identified, then **contamination screening** and more detailed laboratory testing and/or human health risk assessment can be undertaken as required.

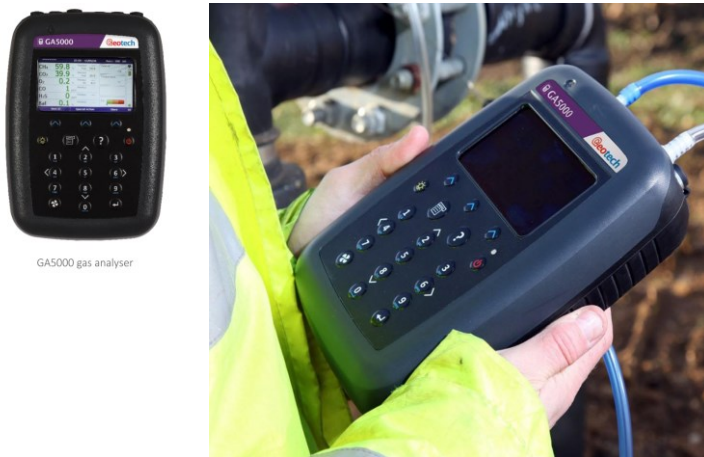
Fig 7 – Earth Tech’s *Geotechnical Instruments GA5000* sampling system used at Hill End Farm, Hill End Road, Mapplewell, S75 6DU

Nonetheless, in accordance with the recommendations in the Phase I Desk Study and the CMRA, standpipe piezometer tubes were installed in BH1 and BH3 and a structured phase of Ground Gas monitoring was carried out for a duration of 6 weeks from 7th January 2023 to 18th February 2023 using a **Geotechnical Instruments GA5000** which is used to monitor landfill gas extraction systems and is designed to meet all current demands for landfill & Brownfield site monitoring protocols set by government legislation in Europe and the UK. It measures % CH₄, CO₂ and O₂ and barometric pressure.

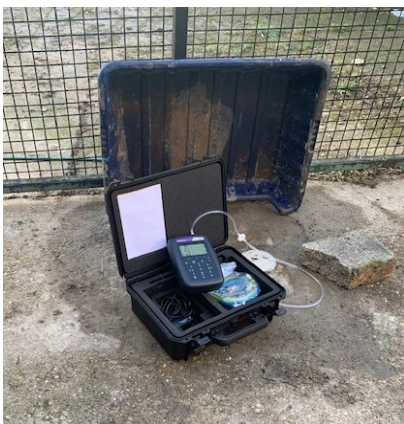
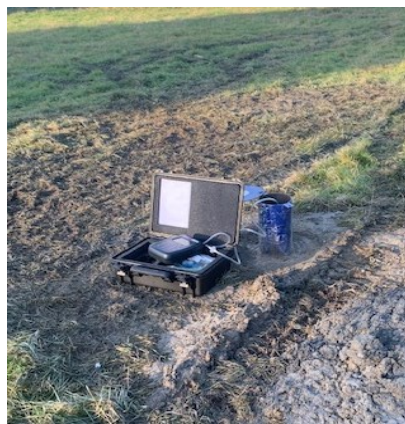
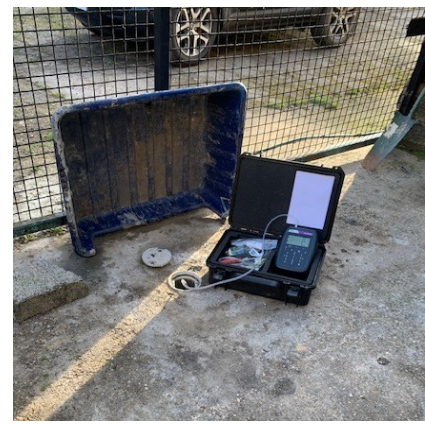
BH1 and BH3 were fitted with the necessary equipment to allow ground gas monitoring to be carried out over the course of 6 to 8 week period. Gas monitoring standpipe zones were set at the position of the Coal Seams +/- 2m in each case.
