**ANCHOR FARM, DODWORTH.**

**BAT SURVEY.**

**Ref No: 250608 / 1.**

**Date: 2<sup>nd</sup> July 2025.**

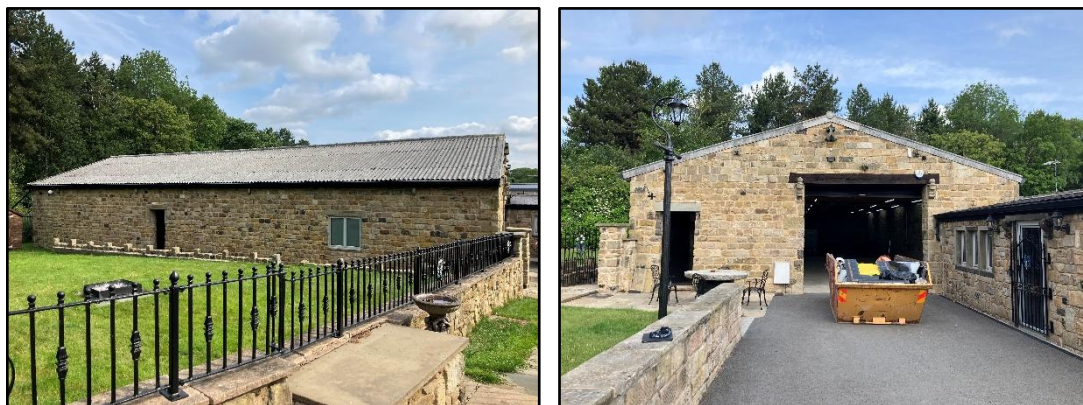
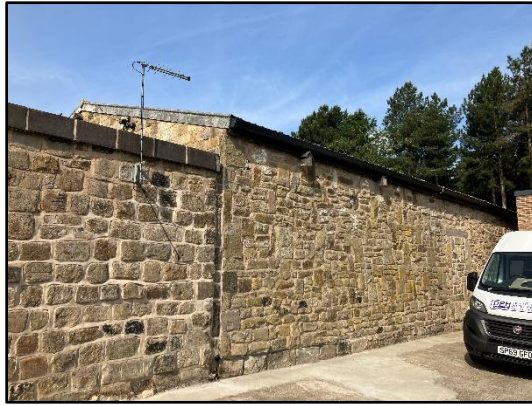
3.2.4. The barn is a large single storey barn constructed from concrete backfilled, cut and dressed stone walls, with a single window and door on the south west elevation and a large roller shutter door and single door on the south east elevation.

3.2.5. The roof is pitched with a cement sheet covering lined with a breathable membrane. There are fascias with soffits along each side of the building and just fascias on each gable end.

3.2.6. The photographs below demonstrate the external of the building.

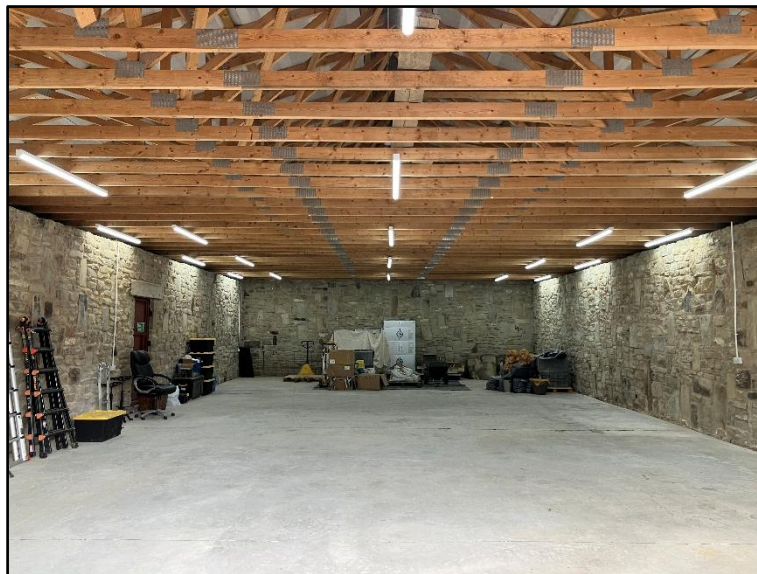
3.2.7. Internally, the building is completely open throughout and not used for anything other than some small storage items. The open roof structure comprises a modern complex queen post design. The photograph below demonstrates the internal of the barn.

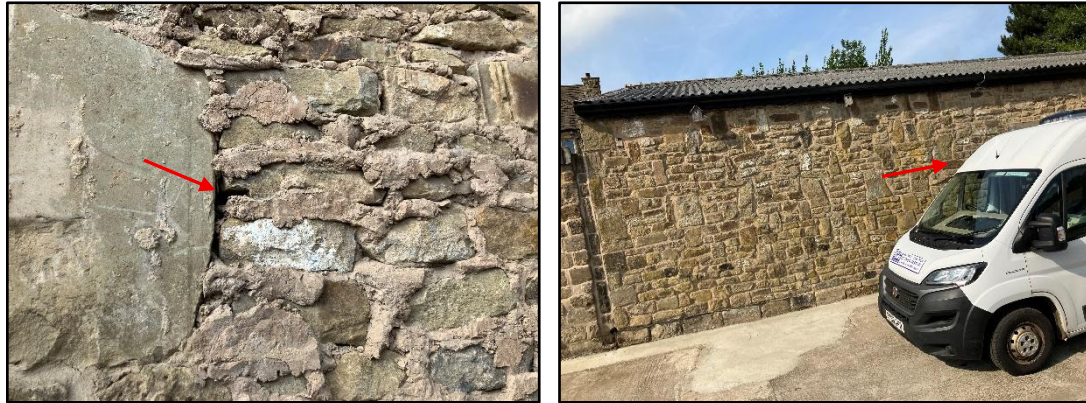
3.3.2. Firstly, the external of the stone walls are generally in excellent condition, except for one patch of stonework on the north-east elevation wall with poor pointing. There is just one point where this creates a hole that leads further into the wall, shown in the photograph below. Whilst this feature is suitable for roosting bats, it is located

approximately 2m above ground level on the wall that forms the boundary of an adjacent busy yard, and it was noted that commercial vehicles were parked up against this wall and building materials are stored leant up against this wall, as can be seen on aerial imagery of the site and the photograph below, making it less desirable for bats to utilise that feature.

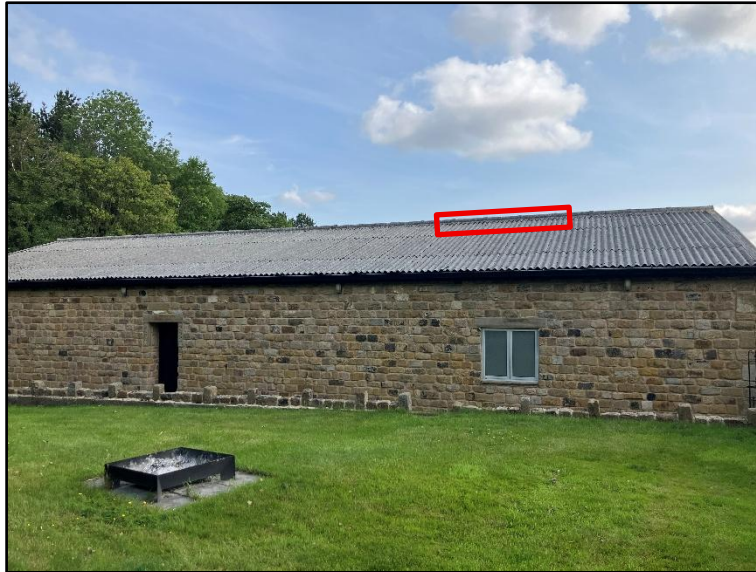
3.3.4. The roof was again, in excellent condition, although one small section of the southwest elevation of the roof, there were some gaps visible where the cement sheets along the ridge were not fitted as tight to the sheets below. These are outlined in red in the photograph below. The breathable membrane lining the roof beneath the cement sheets is not ideal material for bats to utilise due to how smooth it is. Therefore, these features are likely to only be used by individual bats at the most.

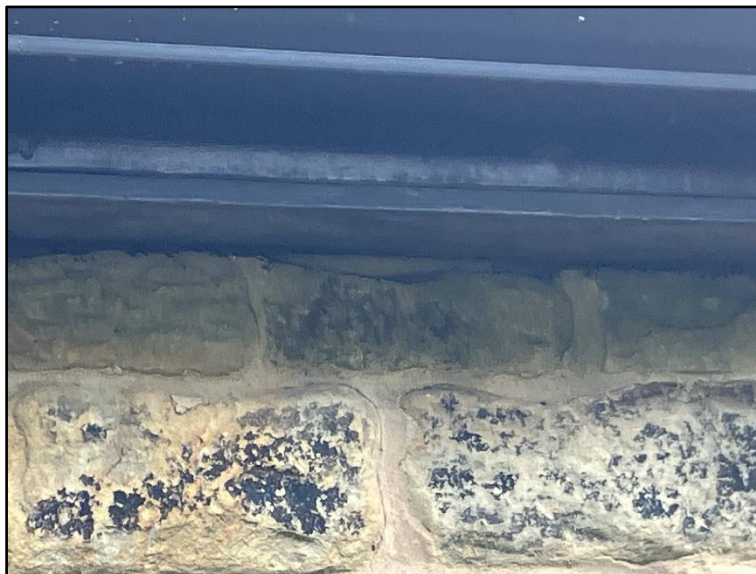
3.3.5. The soffits are well sealed against the top of the walls, although upon first glance there appears to be gaps along the soffits. However, when inspected up close these were found to be sealed with just a small ledge left under the soffits. The photograph below shows this, albeit a slightly blurry image.

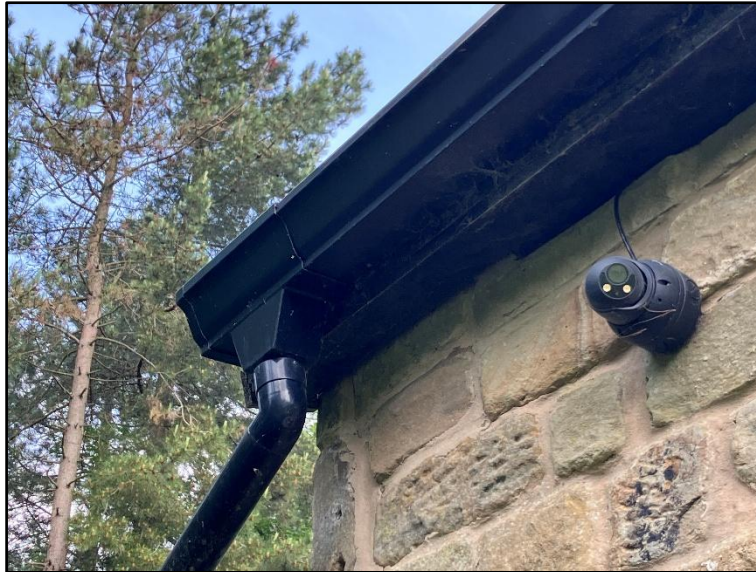
3.3.6. Just one small section of the soffit on the southwest elevation wall has some gaps behind the soffit. This provides some potential for roosting bats and is shown in the photograph below. This potential is limited to this short section of the soffit.

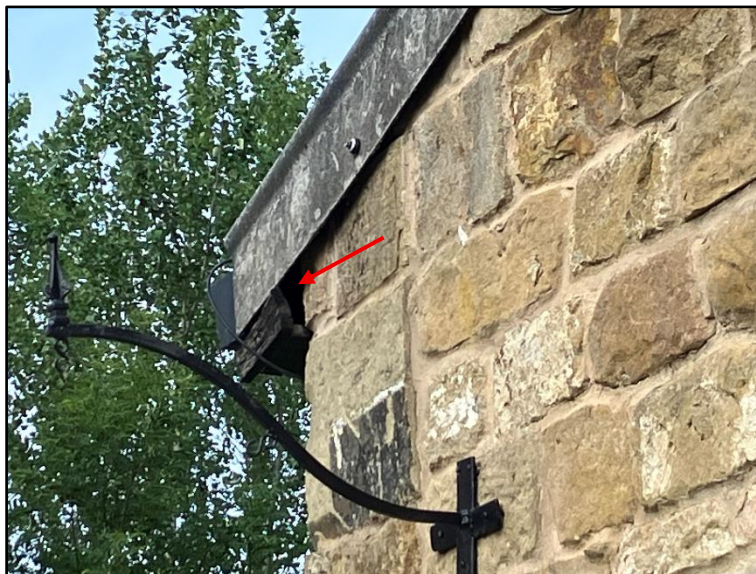
3.3.7. Gaps were noted at each end of the soffit leading directly into the soffit cavity. Whilst there is some potential that bats could utilise these features, they are not ideal as they are not wide enough for bats to fly directly into and are generally larger than crevice dwellers would typically access into, susceptible to use by birds.

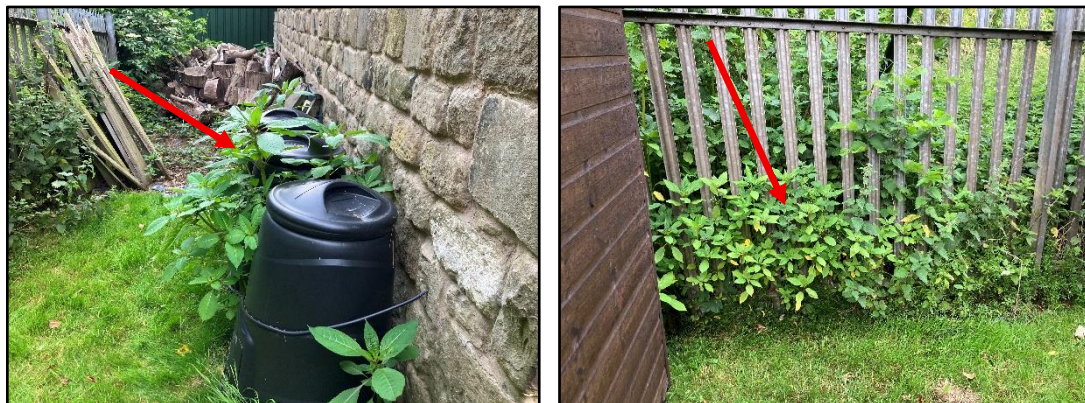
3.3.12. Himalayan balsam was also noted growing against the northwest gable end wall of the barn, shown in the photograph below. This has spread from the adjacent woodland, where it is seen growing up the boundary fence of the property, as shown in the second photograph below. Himalayan balsam is an invasive non native plant species listed on Schedule 9 of the Wildlife and Countryside Act (1981).

4.5. There is also Himalayan balsam growing up against the north west gable end wall of the barn, which appears to have spread from the adjacent woodland. This is an invasive non native plant species listed on Schedule 9 of the Wildlife and Countryside Act (1981), and it is an offence to cause or allow the plant to spread into the wild. Himalayan balsam spreads via seeds that are ejected from the seed pods on the plant and can land on the ground anywhere up to 7m from the plant. Even though the plants die back over the winter months, the seeds can remain viable in the soil for up to two years. Therefore, any works or access within 7m of the plant could potentially cause the plant to spread.

5.4. It is recommended that a 7m buffer is demarcated around the Himalayan balsam plants. A toolbox talk document has been attached to the end of this report to aid in the identification of the plant and provide additional information. This should be briefed to all staff working on site prior to works commencing. If there is a requirement to access or undertake any works within the buffer zone at any time of year, a method of working should be in place to ensure that the works do not cause the plant to spread. This should include, but should not be exclusive to, the following:

- The plants growing up immediately against the barn wall should be pulled during the early summer months, or any time before they start to seed at the end of the summer.
- A wash station will need to be set up upon exit of the buffer zone to wash all footwear, machinery or equipment that comes into contact with the ground. All washed arisings should be caught in a membrane, which will then need to be disposed of as controlled waste.
- Any soil that are excavated from that zone, should be left in situ or should be disposed of as controlled waste.

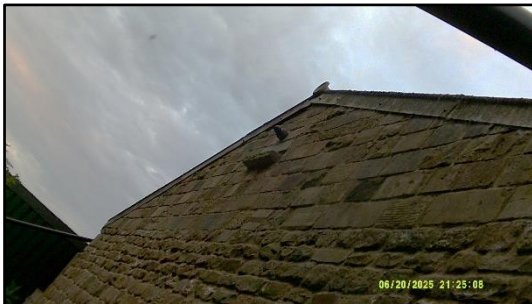
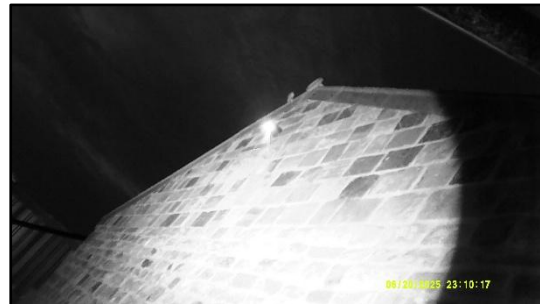
Camera 1:

3.4.6. Shown below are photographs which show the view of each camera at both the start and end of the survey.

3.4.10. Neither of the surveyors observed any bats emerge from the building, and subsequent analysis of the video camera footage confirmed this to be the case.
