**BANK VIEW, WELL HILL, GREEN MOOR.**

**BAT SURVEY.**

**Ref No: 210944.**

**Date: 10<sup>th</sup> September 2021.**

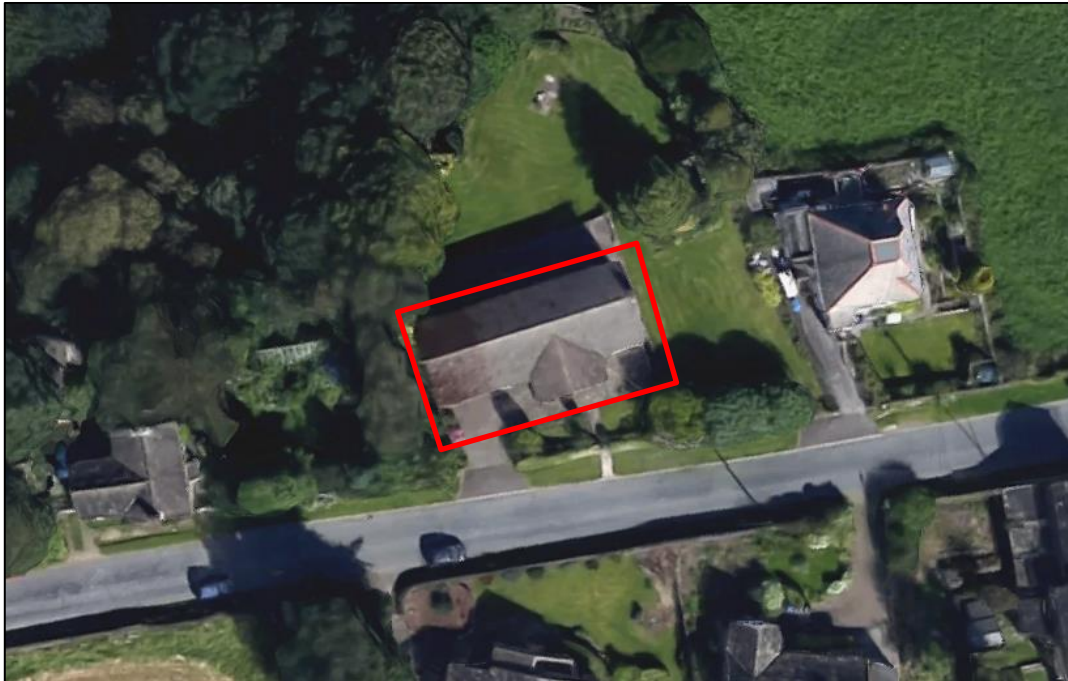
3.2.1. The survey area is the bungalow, Bank View off Well Hill in Green Moor. The aerial photograph below shows the bungalow.

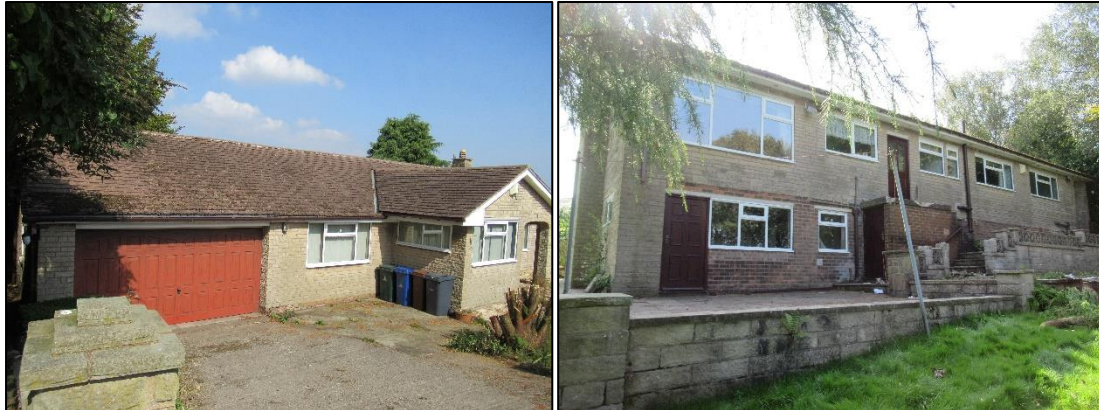
3.3.1. The bungalow is built on a hill and is single storey at the south and west sides and two storey on the east and north. There is an integrated garage on the western end of the building.

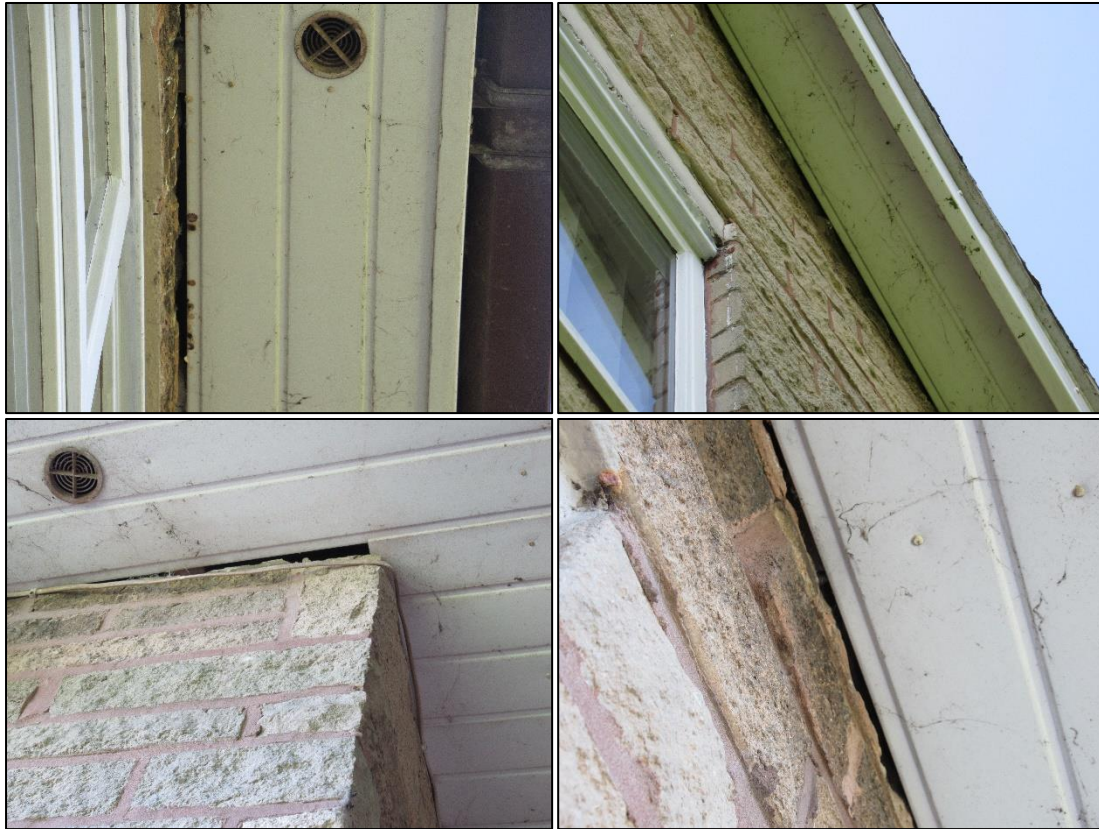
3.3.6. There are gaps where the soffits meet the stone walls on all sides of the building. This provides potential for roosting bats. The photographs below show some of these gaps around the building.

4.1. The building is generally in good condition, however, there are gaps where the soffits meet the stone walls on all sides of the building, which could provide potential for roosting bats.

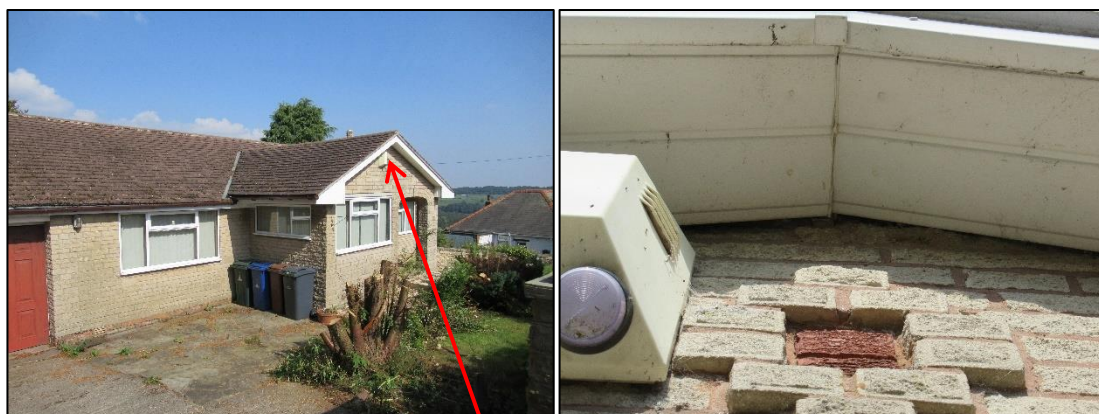
3.3.7. During the survey approximately 25 fresh bat droppings were found on the window cill of the southern porch gable end, on the wall, window, window frame and alarm box. Above these droppings there is a gap between the soffit and the wall at the ridge of the gable end. No droppings were found on the floor below as the slabs here have recently been removed.

3.3.8. The photographs below show the location of the bat roost.

4.2. During the survey a bat roost was identified in a gap behind the soffit on the southern gable end of the building with approximately 25 fresh bat droppings found.

5.1. As a bat roost has been found and the building assessed as **high** potential for roosting bats further bat activity surveys are required in line with the Bat Conservation Trust Good Practice Guidelines. Three bat surveys are required during the survey season, between May and August. One dusk emergence survey, one dawn swarming survey and the final survey either a dusk or a dawn. Each survey must be at least two weeks apart.

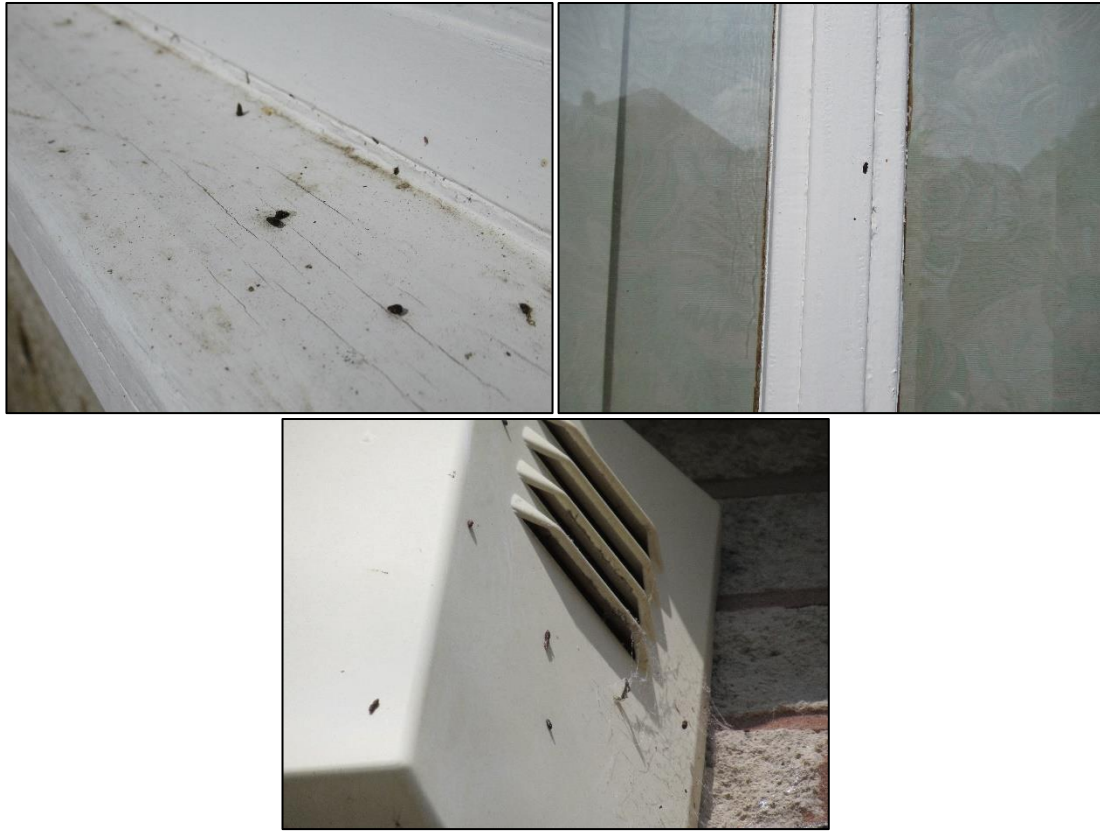
3.3.9. The photographs below show the droppings found below the roost.

3.3.10. As there is a bat roost present on the southern side of the building and potential on all sides for further roosts behind the soffits the building is assessed as providing **high** potential for roosting bats.
