**Ecological Appraisal  
Land off Saville Lane,  
Thurstone**

Report reference: BE-R-1255-01  
May 2012

| Report Title: | Ecological Appraisal<br>Land off Saville Lane, Thurlstone |

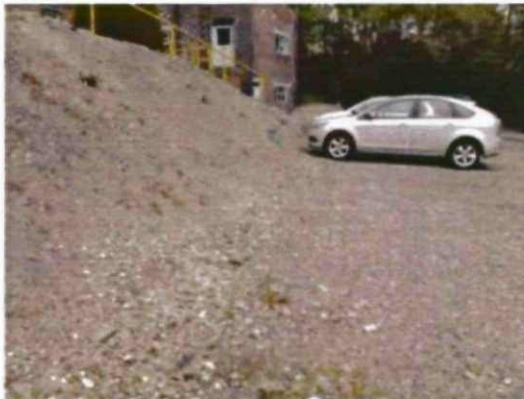
**Figure 2**

24. Large areas of the site are comprised of hard standing and access roads. Saville Road itself is tarmaced and in regular use supporting little in the way of vegetation although at the southern end of the site, this gives way to areas of compacted rubble where few opportunistic species are visible. These include pineapple weed (*Matricaria discoidea*), groundsel *Senecio vulgaris*), wavy bittercress (*Cardamine flexuosa*), cocksfoot (*Dactylis glomerata*) and small patches of white clover (*Trifolium repens*).

General view of hard standing on the site

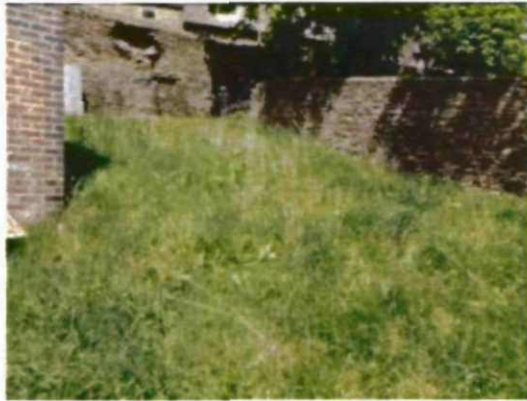
**Figure 3**

25. At the eastern corner of the site is a small lawned area, enclosed by drystone walls and facing onto site buildings. The lawn is dominated by perennial rye grass (*Lolium perenne*) with fescues (*Festuca* sp.) and meadow grasses (*Poa* spp.) although as it does not appear to have been mown for some time this area is now being colonised by a range of other common species. These include creeping buttercup (*Ranunculus repens*), groundsel, broad leaved dock (*Rumex obtusifolius*) cleavers (*Galium aparine*), cocksfoot, dandelion (*Taraxacum* agg.) nettle (*Urtica dioica*) and willowherbs (*Epilobium* spp.). At the edges of the grassland, saplings of ash (*Fraxinus excelsior*) and horse chestnut (*Aesculus hippocastanum*) are evident along with small patches of bramble (*Rubus fruticosus* agg). A small stand of the invasive Japanese knotweed (*Fallopia japonica*) is located at the western edge of the lawn.

Lawned area at eastern edge of site

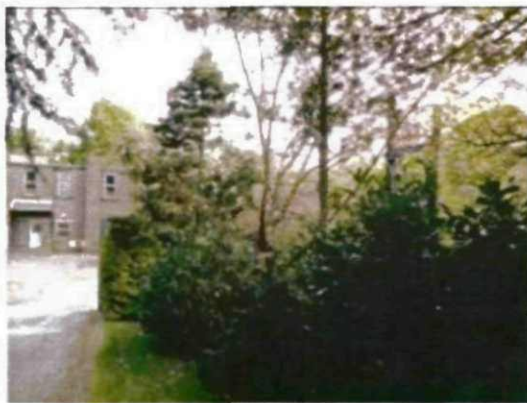
**Figure 4**

26. Within the centre of the site a thin line of planted shrubs separates an area of car parking from Saville Lane itself. Species include snowberry (*Symphoricarpos albus*), garden privet (*Ligustrum ovalifolium*), laurel (*Prunus sp.*) and Oleaster (*Elaeagnus sp.*). This planted border also contains a small number of semi-mature trees with ornamental cherry (*Prunus sp.*), copper beech (*Fagus sylvatica purpurea*) sycamore (*Acer psuedoplatanus*) and lime (*Tilia sp.*).

View of the area of shrubs viewed from the west.

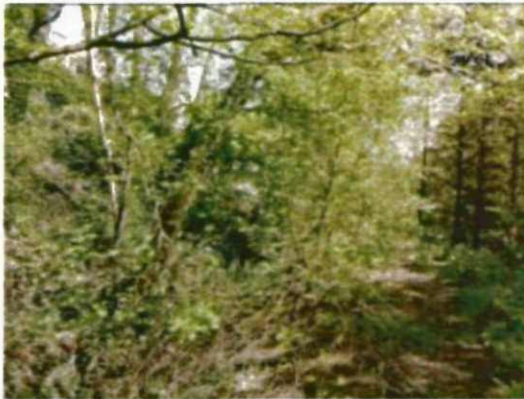
**Figure 5**

27. The site boundary extends eastward to include a narrow strip of trees which are part of a woodland corridor along the banks of the River Don. This area contains a number of semi-mature trees notably horse chestnut, sycamore and alder along with specimens of English elm (*Ulmus procera*), hazel (*Corylus avellana*), elder (*Sambucus nigra*), holly (*Ilex aquifolium*) and rowan (*Sorbus aucuparia*).
28. Additional shrubs include hawthorn (*Crataegus monogyna*) alder buckthorn (*Frangula alnus*) along with saplings of ash, sycamore and horse chestnut. The

groundflora is dominated by wood avens (*Geum urbanum*) with occasional bramble (*Rubus fruticosus* agg.), nettle, hogweed, (*Heracleum sphondylium*), wood forget-me-not (*Myosotis sylvatica*) and bluebell (*Hyacinthoides non-scripta*).

Wooded area looking east.

68. The site is predominantly made up of buildings and hard standing supporting a small range of common species poor habitats.
69. The wooded area to the east of the site which may form part of the application has a range of common shrubs and semi-mature trees. Although the loss of this small area is unlikely to have any significant impact on the wider landscape, it does contain a small number of bluebells which are listed under the local BAP. If this woodland is to be cleared, then provision should be made to move the bluebells to adjacent areas of woodland.

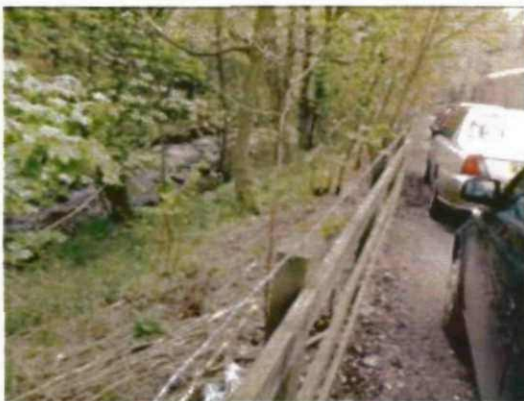
**Figure 6**

29. Where this tree line extends west along the boundary of the site, the ground falls steeply with trees limited to a row of mature alder with occasional sycamore and horse chestnut. Japanese knotweed is also established in this area and is clearly visible from the adjoining car park area.

Stand of Japanese knotweed visible alongside wooded line at southern boundary.

37. Several stands of Japanese knotweed (*Fallopia japonica*) which is listed under schedule 9 of the Wildlife and Countryside Act (1981) are located on the site (indicated on plan BE-P-1255-01).

70. The invasive plant Japanese Knotweed has been found in several locations on the site. This should be removed by a specialist contractor.
71. The following precautions are considered necessary in relation to the site's development:

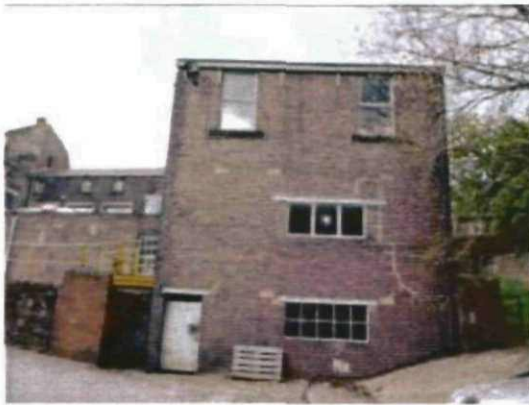
**Figure 7**

General view of industrial buildings viewed from the west.

44. The industrial buildings are arranged in an L shape with a row of single storey flat roofed units attached to a three storey section. The solid walls are all constructed from brick with a series of flat felt roofs with low parapet walls offering no features likely to give access to bats.
45. The three storey section has a brick built chimney attached to the west facing wall. This chimney has not been tied in to the external wall but sealed with a line of mortar which is missing in places giving access to a void between the brickwork.

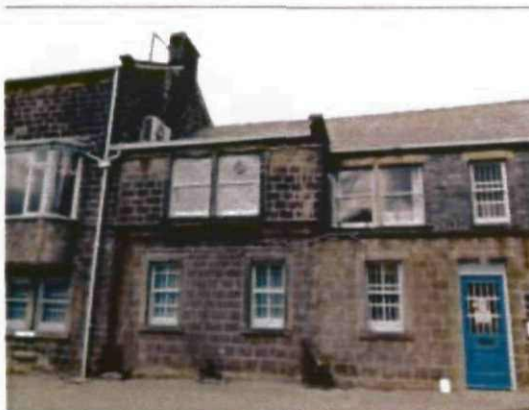
**Figure 8**

Section of existing office buildings to be affected by the proposals.

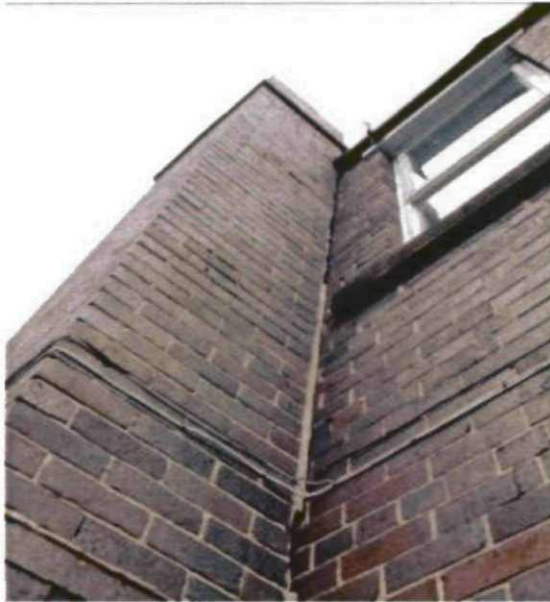
**Figure 9**

View of gaps between chimney and exterior wall.

46. According to staff on site, bats have been seen roosting within these gaps on a regular basis with four bats found within the building itself (believed to have entered via an open window). The bats have not been seen for some years and no evidence of roosting such as droppings were visible on external walls during this inspection.
47. At the north eastern elevation is a single storey extension with solid brick walls and pitched slate roof.

65. The site is assessed as having moderate bat roost potential. Bats have previously used the gaps behind the chimney as a roost and although site staff have not seen them for some years it is still possible that they may be using the space in smaller numbers which may pass unobserved. There are also a number of features within the slate roofs on the site which could provide roosting space for occasional or solitary roosting bats and potentially give access to larger spaces within the roof voids.
66. The site is located close to the River Don and areas of woodland which would provide excellent foraging for local bat populations increasing the potential that bats could use the buildings on site as a roost.
67. Emergence surveys are recommended to establish if bats are roosting on site and the client has commissioned Brooks Ecological to carry out these studies.

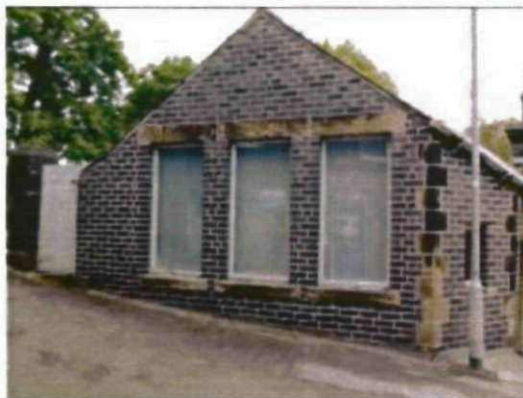
**Figure 10**

Single storey pitched roof section

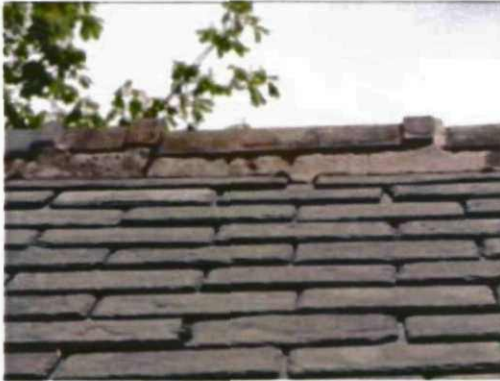
**Figure 10**

48. The solid wall construction offers little in terms of roosting potential; however, there are a number of gaps within the slate roof, where mortar is missing from the ridge, which could provide occasional roosting space. This building has no accessible loft space but a false ceiling creates a small roof void which could potentially offer larger roosting space if bats could gain access via gaps in the roof.

Close up view of slate roof showing gaps at ridge.

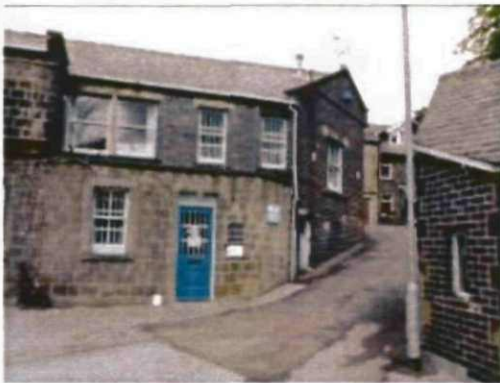
**Figure 11**

53. The office buildings at the northern end of the site are also of solid brick construction faced with stone on the southern elevation. Part of this building is to be demolished to improve vehicle access to the site.

Office building to be demolished:  
southern elevation

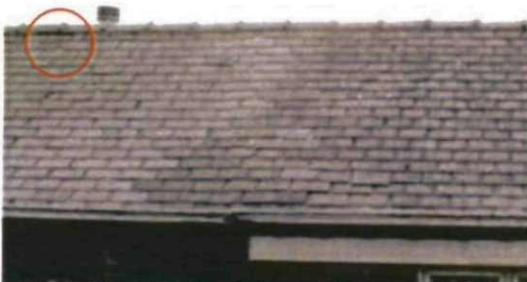
**Figure 12**

58. The stonework is in a sound condition with no clear entry points for bats while the eaves are well sealed with no visible gaps.
59. This building has a pitched slate roof which is in a variable condition, with a number of slipped slates and missing mortar at the ridge, providing potential access points for bats.

Slate roof of office building showing gaps on north facing elevation

64. An internal inspection showed all sections of the slate roof to be unlined and no evidence such as droppings was found within the accessible loft areas although the loft spaces had a heavy accumulation of dirt which meant that smaller numbers of droppings would not have been easily visible.

- Buildings on site are assessed as having moderate potential to support bats. Emergence surveys have now been commissioned by the owners and will be carried out during June 2012, the optimal time for bat surveys.
- Although the River Don has potential to support both otter and white clawed crayfish, the proposals to the existing site footprint are unlikely to have any impacts on this habitat. However, if the clearance of woodland on the banks is likely to cause direct impacts on the river in terms of debris etc. then both an otter and crayfish survey is recommended to assess the presence or likely absence of these species to ensure that wildlife legislation is not contravened.
