# **Barnsley Youth Zone Barnsley S71 1BP**

## Ground Investigation Report

J21015A  
Rev 1

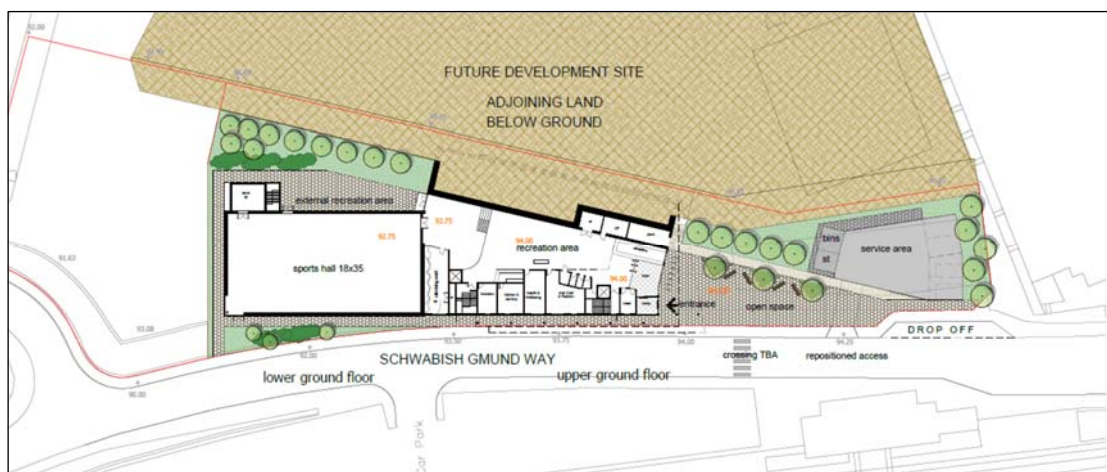
Consideration is being given to the proposed redevelopment of the site through the construction of a new youth centre. The redevelopment consists of a two-storey main facility, a sports hall and a kick pitch. Some soft landscaping will be included in the redevelopment to soften site level change from the existing site level of around 96 m OD down to 93 m OD at Schwabisch Gmund Way. It is understood that steel framed cladded buildings are proposed and that the foundation loads are likely to be moderate.
