# Fall Head Farm Silkstone

## Ecological Impact Assessment

7<sup>th</sup> February 2021

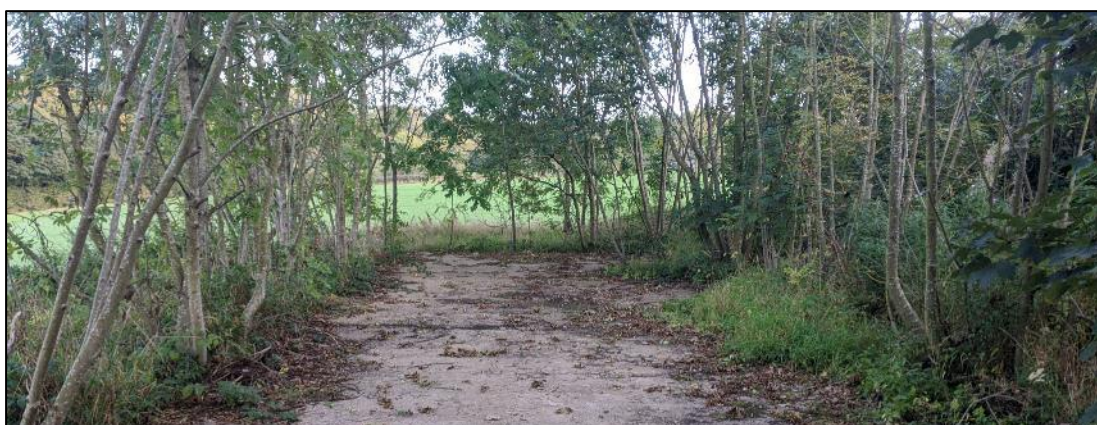
**Plate 4. Immature ash surrounding hardstanding to northwest of B3**

- 5.2.6 Scattered mature and semi-mature ash and sycamore *Acer pseudoplatanus* border the farmstead on the southeast and southwest boundaries (Plate 2), with two mature ash trees present close to either end of B3 (see TN1 & TN2 in Appendix 1; Plate 3).
- 5.2.7 Immature ash trees border an area of hardstanding to the northwest of B3 (Plate 4). At the northern end of the dwelling's garden are two immature walnut *Juglans regia* trees, whilst an apple *Malus domestica* tree is present in a rose bed to the south of the farmhouse (B10).
- 5.2.8 A treeline is present outside of the survey area to the east of the access track's southern end (Plate 5), whilst several mature sycamores and pendunculate oak *Quercus robur* trees located elsewhere on the edge of the access track.

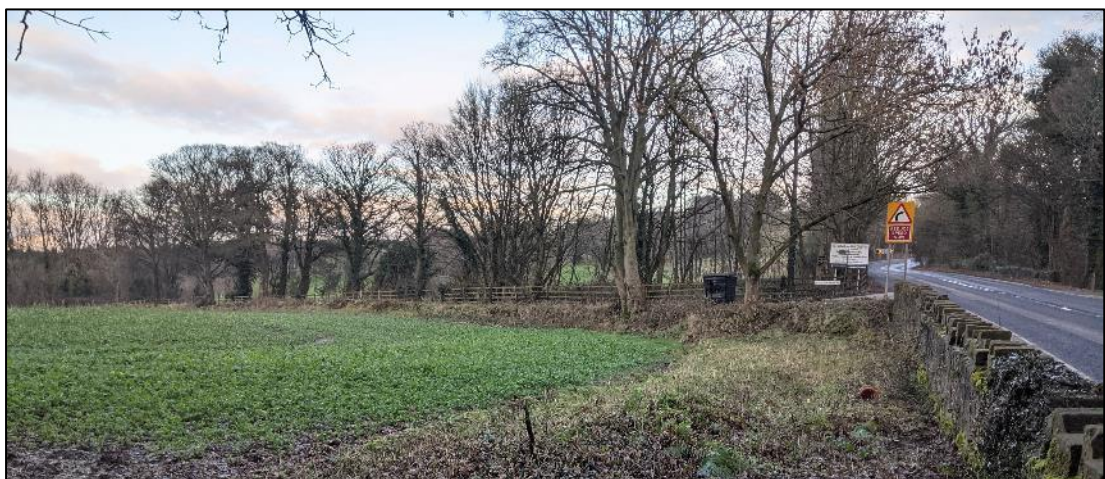
**Plate 7. Poor semi-improved grassland to north of A628 Barnsley Road**

- 5.2.9 Species poor semi-improved grassland is present within the courtyard and around many areas on the edge of site barns (Plate 6), where vegetation management/mowing has persisted. Narrow belts of this habitat type border the access track and are present to the north of the retaining wall beside the A628 Barnsley Road (Plate 7).
- 5.2.10 Grasses present within this habitat type comprise abundant cock's-foot *Dactylis glomerata* with frequent Yorkshire fog *Holcus lanatus* and occasional perennial rye grass *Lolium perenne* and rough meadow grass *Poa trivialis*. Herb species present include frequent white clover *Trifolium repens* and occasional nettle *Urtica dioica*, cow parsley *Anthriscus sylvestris*, dandelion *Taraxacum* spp., ribwort plantain *Plantago lanceolata* and cleavers *Galium aparine*.

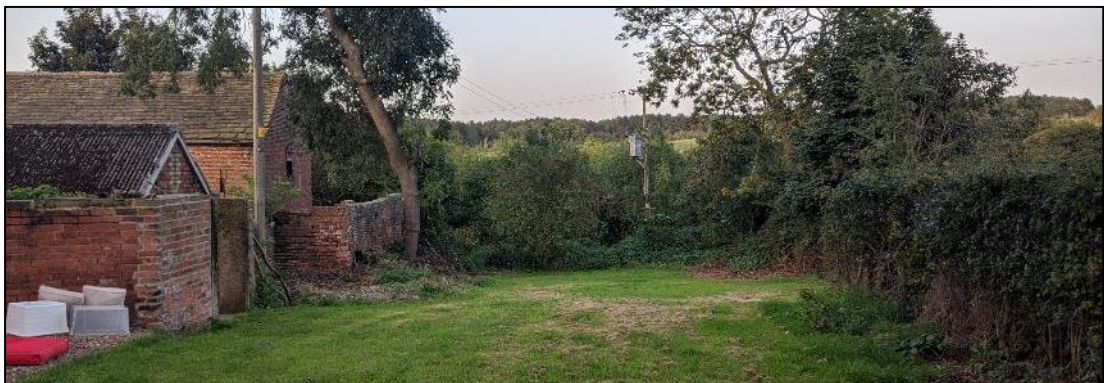
#### **Plate 8. Lawn south & east of farmhouse**

- 5.2.13 A lawn is present to the south and east of the farmhouse (B10). This habitat supports frequent cock's-foot and Yorkshire fog, together with abundant dandelion *Taraxacum* spp. and white clover and rarely occurring perennial ryegrass.

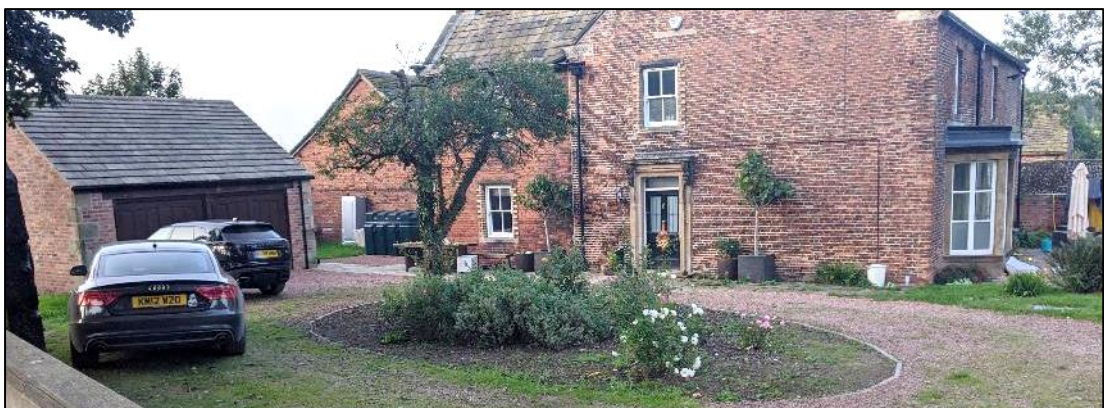
#### **Plate 9. Rose bed to southwest of farmhouse (B10)**

- 5.2.14 A small rose bed with several small shrubs and an apple tree is located to the southwest of the farmhouse (Plate 9).

- 5.2.19 An unsealed gravel drive is present to the southwest of the farmhouse (Plate 9).

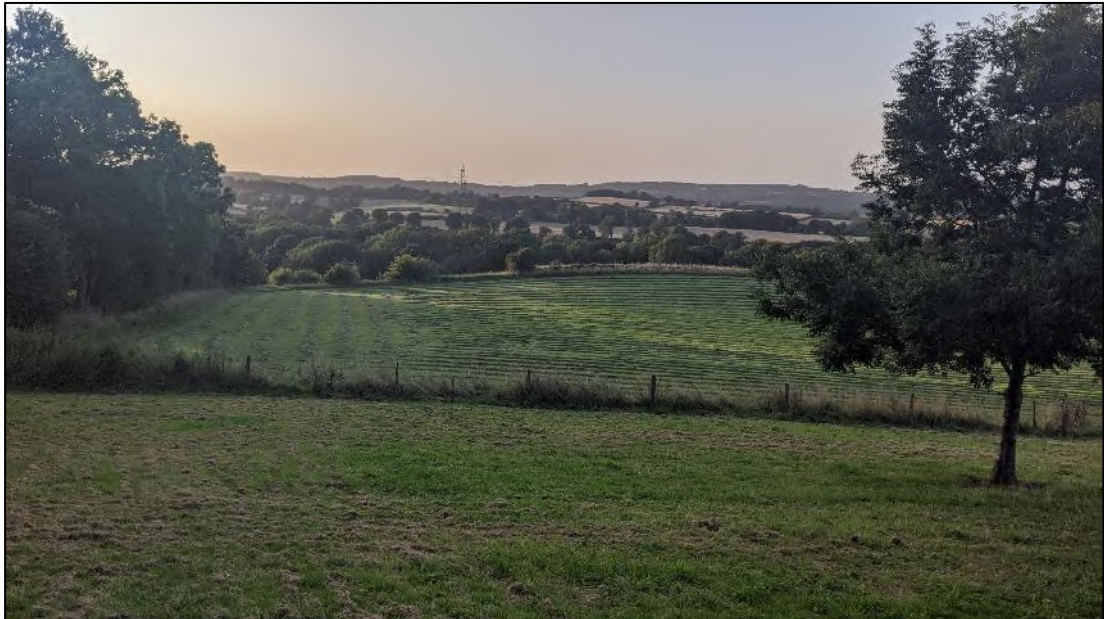
**Plate 13. Fence comprising existing northwest boundary to Fall Head Farm landholding**

- 6.2.3 The site is located between Silkstone Fall Wood LWS and Hugset Wood LWS. In order for the proposed development to deliver a net ecological gain, it has been agreed to plant a new 190m species-rich native hedgerow including tree standards, along the northwest boundary of the wider Fall Head Farm landholding, increasing ecological connectivity between the two woodlands. and once it has developed, it is anticipated this hedgerow will comprise a benefit to nature conservation of local importance. This increase in ecological connectivity between two large woodlands will be beneficial for a range of faunal species, notably including bats. These measures could be secured through a planning condition requiring an Ecological Design Strategy (EDS) to be produced for this site.

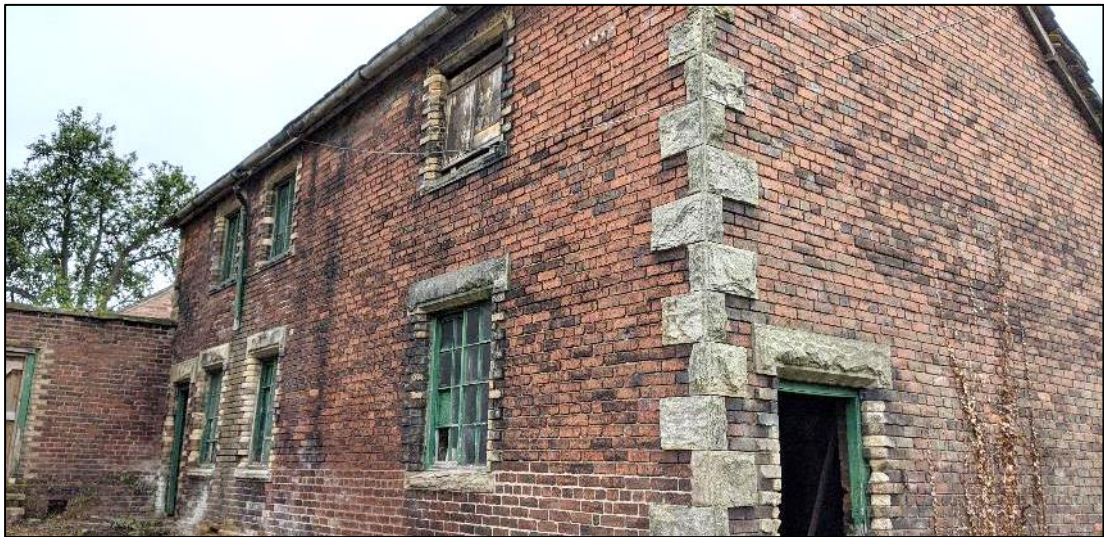
**Plate A6.1. East corner of B1**

- 7.1.6 Building 1 comprises a C19th two-storey mainly brick-built barn with stone window surrounds and quions. The roof is pitched and covered by stone slates and a clay ridge, with a central brick chimney present. The northwest roof pitch is extended to first floor height and the building is partially open-fronted on its northwest elevation. Single paned wood-framed windows with missing panes are present together with two single wooden doors. This building has lead flashing at the base of the chimney, wooden gutter boards and plastic guttering.

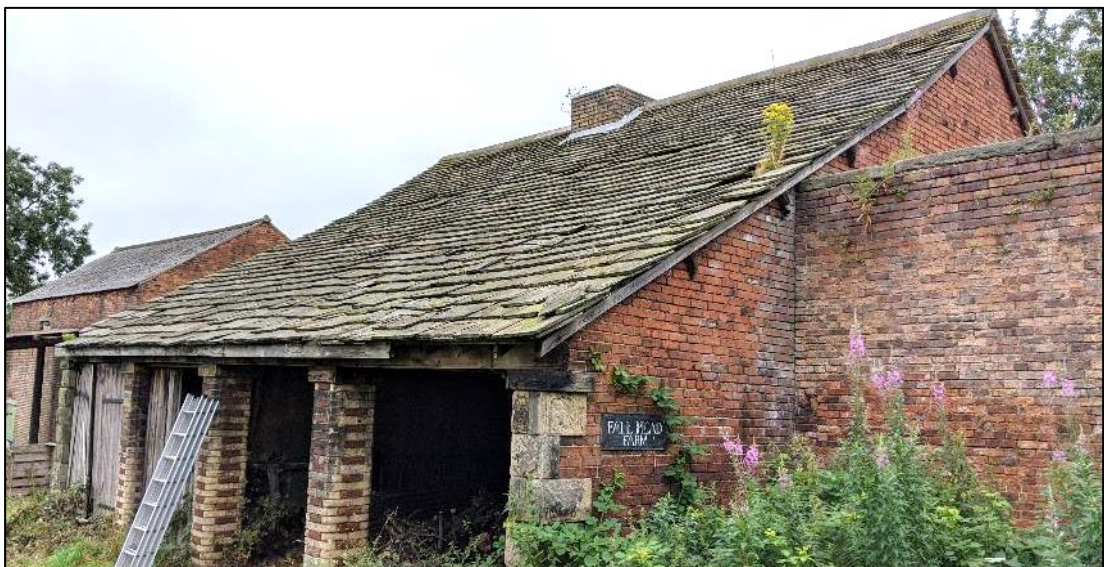
**Plate A6.2. West corner of B1**

- 7.1.7 Bats may access the interior of the building via broken window-panes on the southeast elevation, or through the open-sided section of the northwest elevation. Once inside the open-sided section of the barn bats can pass into the two-storey section of the building via two large holes in the internal southwest to northeast dividing wall.
- 7.1.8 On the exterior of B1 bats may roost in numerous locations in association with the uneven stone slates, with access to the wall top also present. Lifted flashing is also present in association with the chimney.

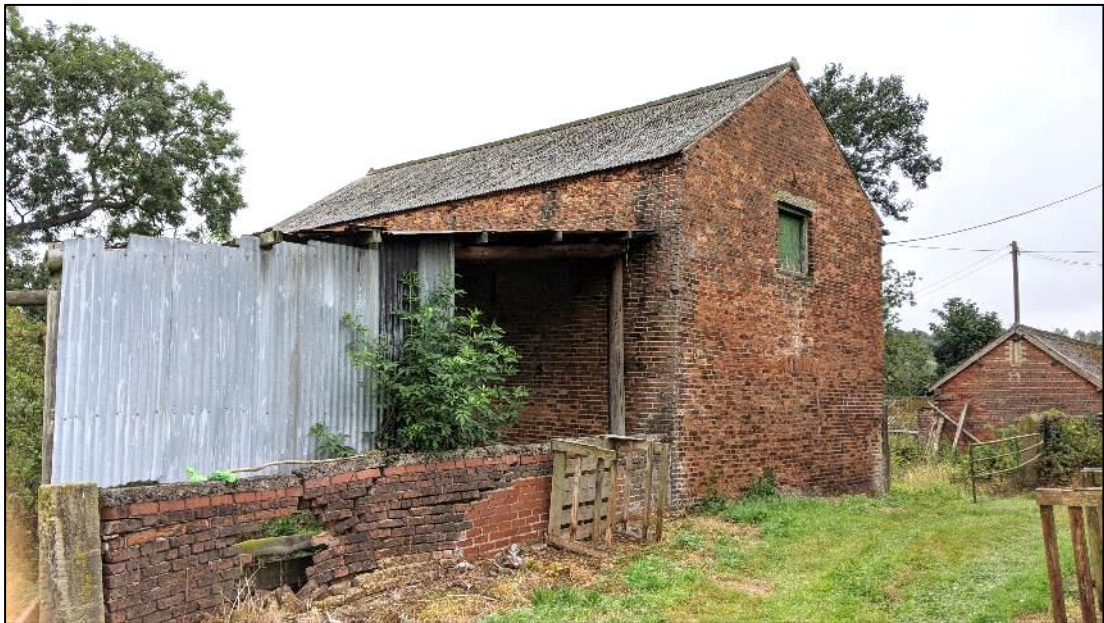
**Plate A6.7. Western corner of B2**

- 7.1.14 Bats have access to wall tops and can easily access the interior via either the ventilation slits, around the wooden hatch or via a broken window in the northeast gable.

- 7.1.15 The unlined roof of B2 is suspended on queen-post roof trusses, purlins and a ridge beam. No roof-void is present and the first floor is in a bad state of repair. Extensive open joints were recorded from the internal face of the brick walls.
- 7.1.16 Approximately 30 barn owl pellets of mixed age were recorded from the first floor of B2, mainly beneath the two trusses.
- 7.1.17 Building 2 was considered to offer a moderate to high level of bat roosting potential.

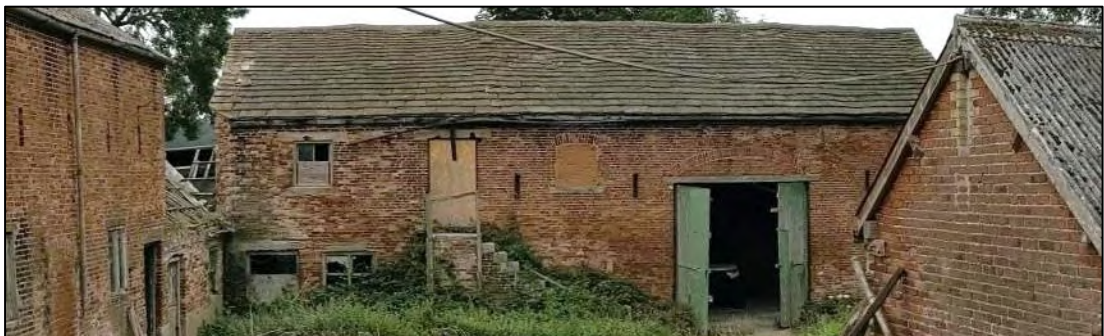
**Plate A6.9 Southwest elevation of B3**

- 7.1.18 Building 3 comprises a C19th two-storey brick-built barn with a pitched stone slate covered roof with stone ridge tiles and mortar filled verges (Plates A6.9 & A6.10). Large timber double doors are present in the southwest elevation with ventilation slits at first floor height in this elevation. Single-paned wood-framed windows are present with stone lintels above.

- 7.1.19 Bats may access the interior via ventilation slots, missing window-panes, via an unglazed window opening in the southeast gable or across the top of the double doors.
- 7.1.20 The main potential roost location present on the exterior of B3 comprises the many crevices between the irregularly shaped stone slates.

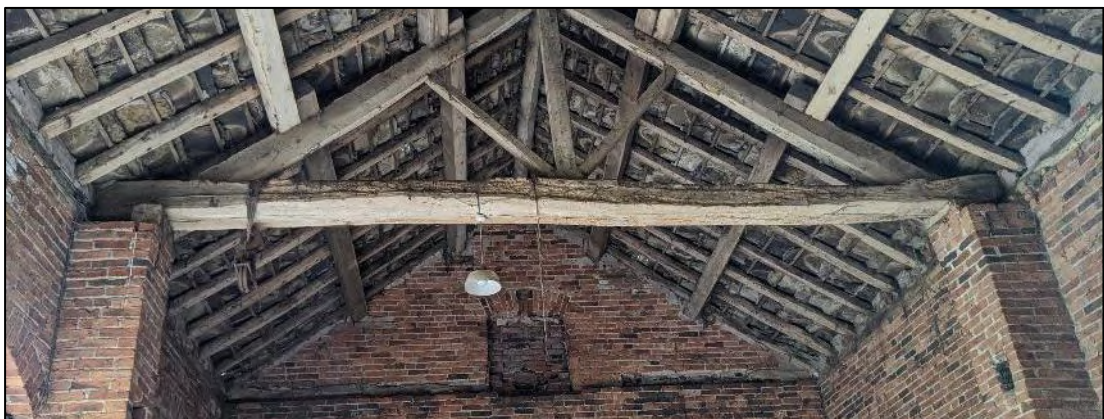
**Plate A6.11. Interior of B3**

- 7.1.21 The roof of B3 unlined and suspended on king-post trusses, purlins, a ridge beam and laths. The interior of the barn is mainly single storey (Plate A6.11) however the northwest section is two-storey, although it also lacks a roof void.
- 7.1.22 No signs of bat presence were recorded from the interior of B3, however, in the northwest section of the barn a cluster of 30 barn owl pellets was recorded beneath trusses. Three old swallow nests were also recorded from this section of B3.
- 7.1.23 Building 3 was considered to offer moderate to high bat roosting potential.

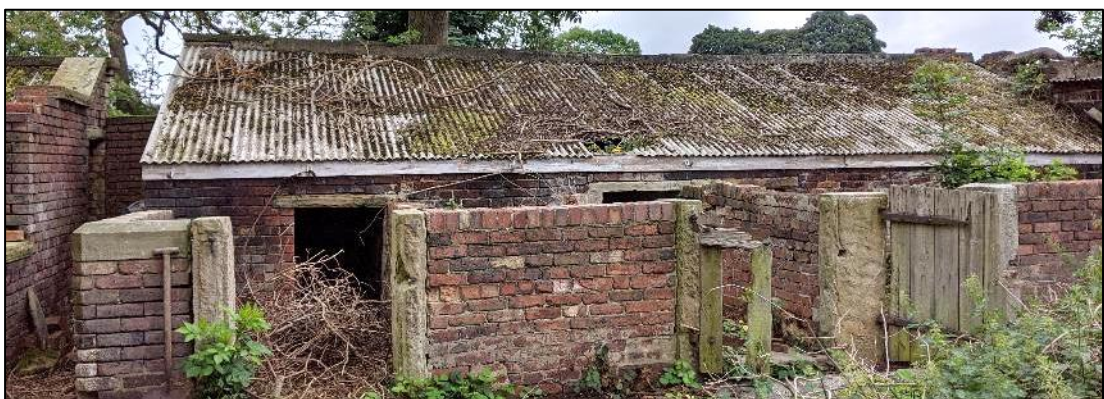
**Plate A6.13. Northwest elevation of B5, with B4 on far left of image**

- 7.1.25 Building 4 was considered to offer negligible bat roost potential.

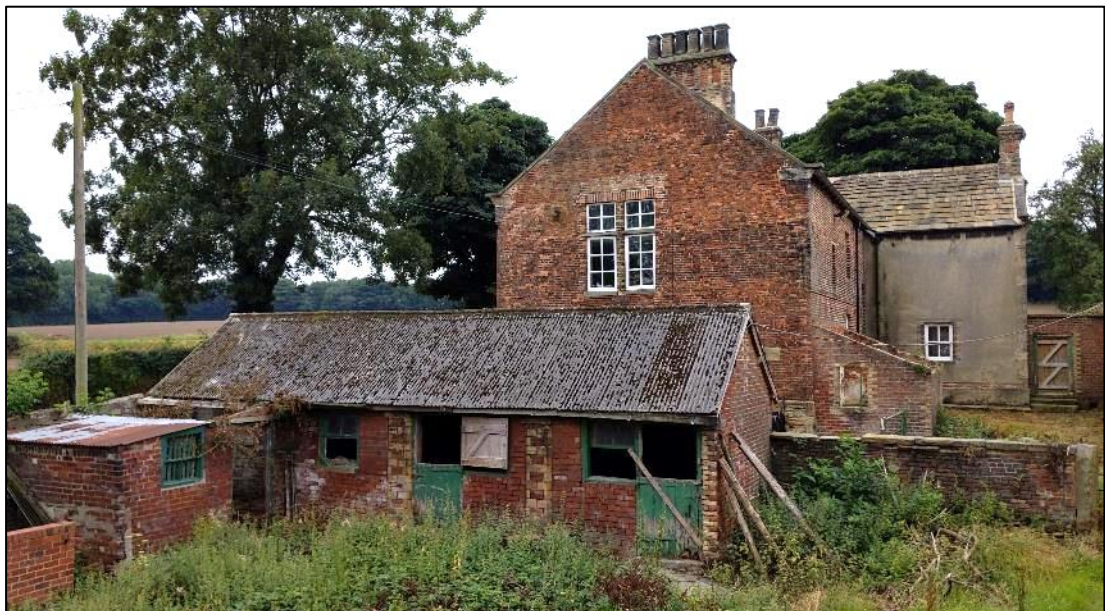
**Plate A6.14. Northeast elevation of B6 in foreground with the farmhouse (B11) in background**

7.1.29 Few clear potential roost locations were noted from the exterior of B6; however, bats have easy access to the interior.

7.1.31 Building 6 was considered to offer low potential for use by roosting bats.

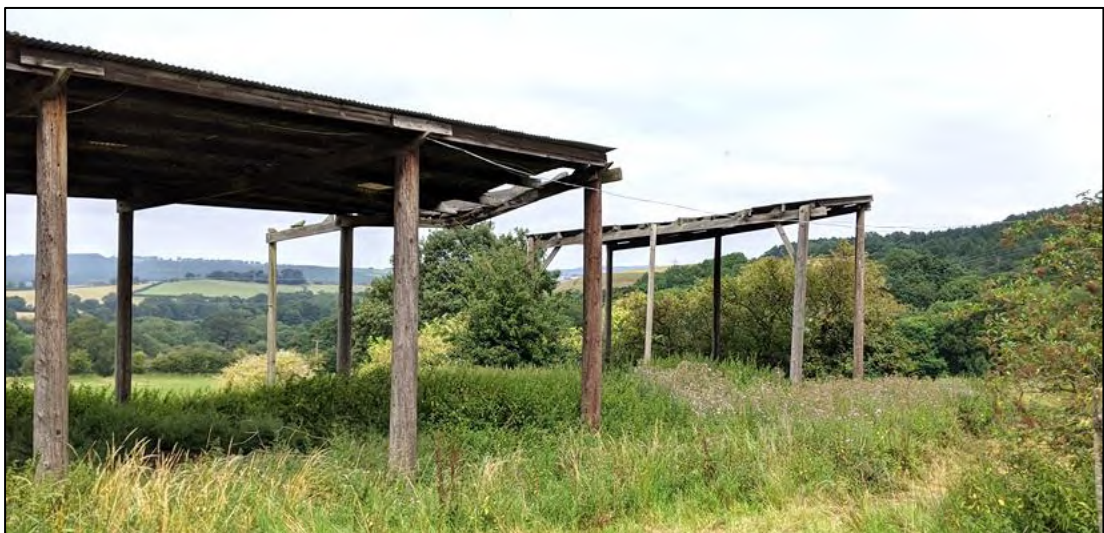
**Plate A6.16. Building 7 is located on right of image with B8 on left**

- 7.1.32 Buildings 7 & 8 comprise open-sided timber framed outbuildings with gently sloping corrugated galvanized steel sheet roofs. These structures display negligible bat roost potential (Plate A6.16).

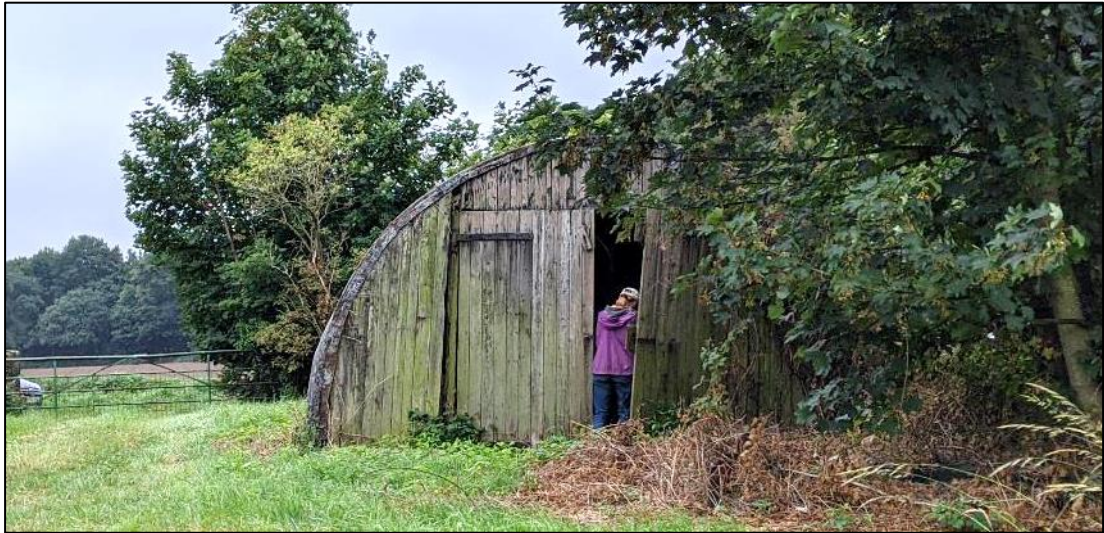
**Plate A6.17. Building 9**

galvanized metal sheet with timber doors and wood cladding on the ends. This structure was considered to offer negligible potential for use by roosting bats.

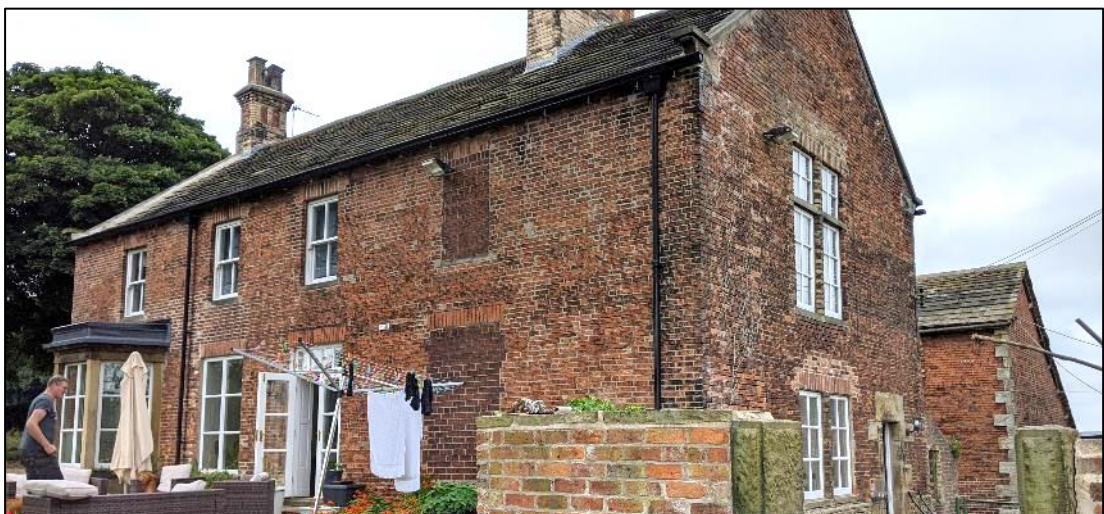
**Plate A6.18. East corner of B10**

- 7.1.34 Building 10 comprises the brick-built L-shaped two-storey farmhouse with stone-slate covered pitched roofs with stone gable copings (Plates A6.14 & A6.18). This structure will not be altered as a result of the proposed development and consequently was not subject to a detailed inspection. It was however clear this building offered numerous potential roost locations in association with the stone roof slates and this building was considered likely to offer a moderate-high level of bat roost potential.

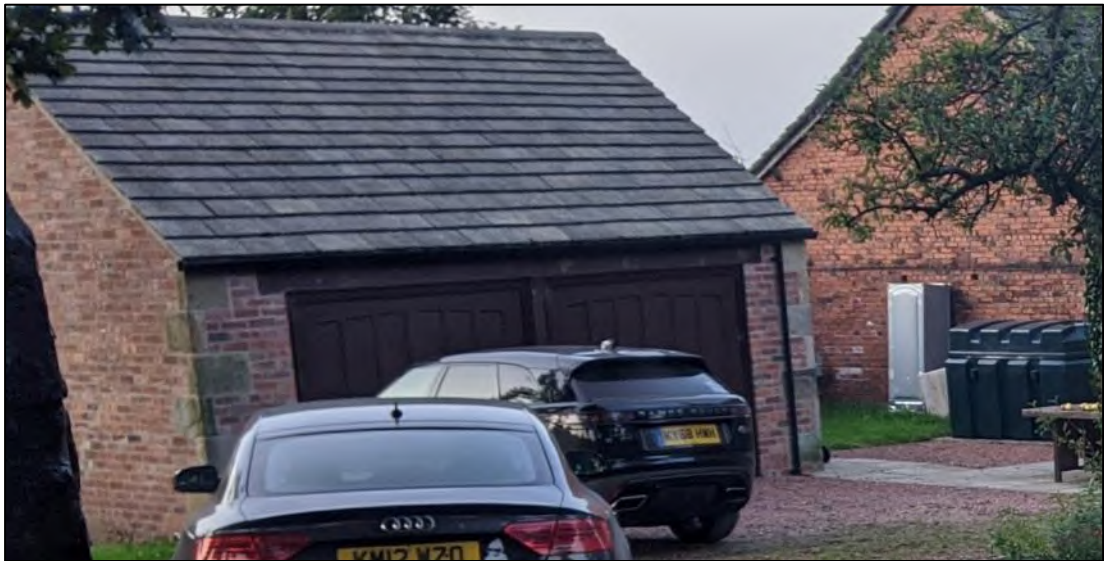
#### **Plate A6.19. Building 11**

- 7.1.35 Building 11 (Plate A6.19) comprises a brick-built single-storey garage with a pitched artificial stone-slate covered roof. This structure is linked to the farmhouse and will be retained unaltered within the development. This structure was not considered to display more than a low level of bat roost potential overall.

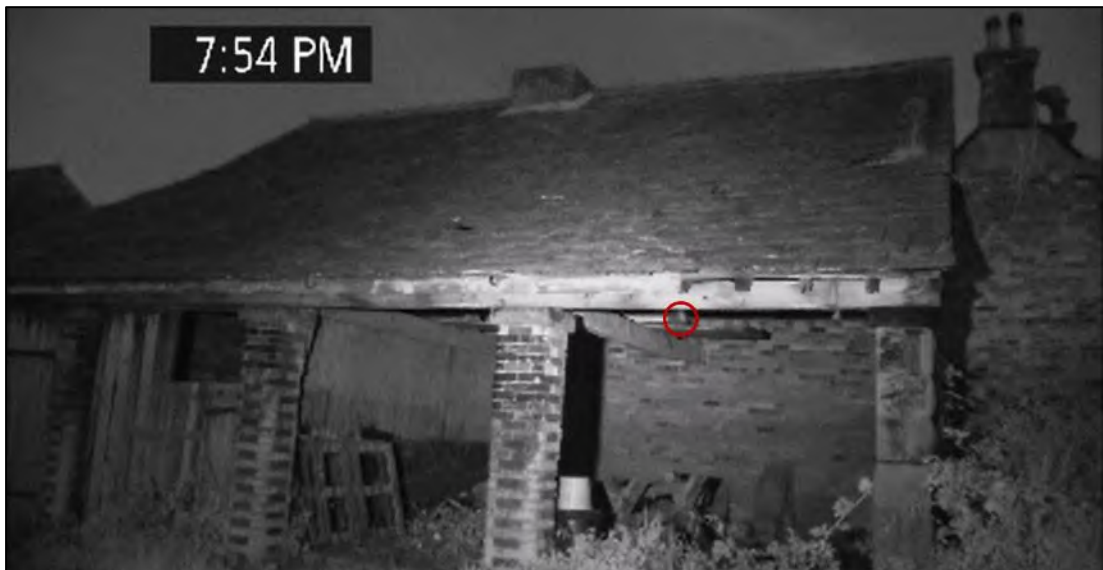
**Plate A7.3. Brown long-eared bat exiting B1 on 17<sup>th</sup> September 2020**
