Tree Survey

Whitshaw Developments Ltd.

Land at Wombwell Road,
Hoyland,
Barnsley,
South Yorkshire,
S74 9SJ

7 January 2022

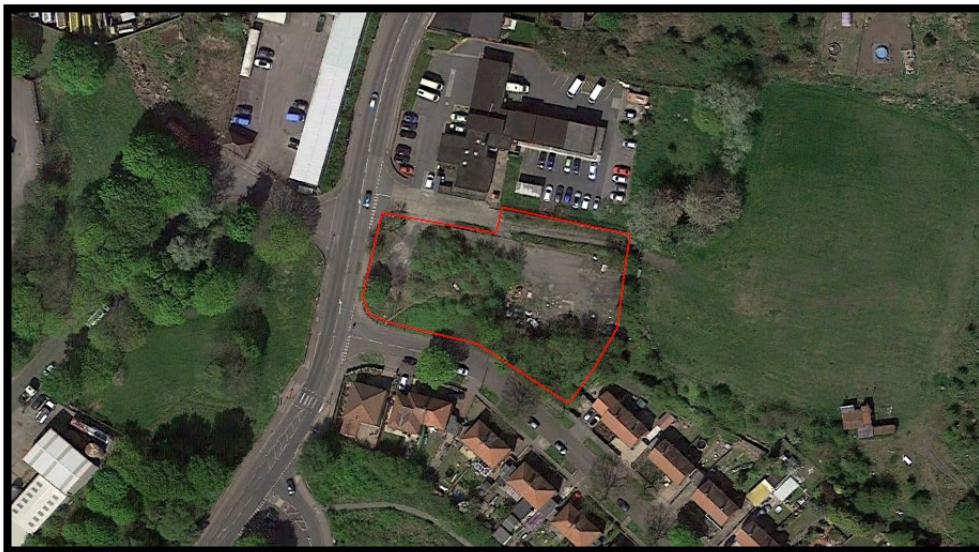
Figure 2: Aerial Image of site (Google Earth)

The site is situated at the corner of Wombwell Road and Kingswood Close. The site is currently vacant, largely comprised of hardstanding through the centre with self-seeded trees growing centrally and around the perimeter. There is a level change across the southern section of the site, which reduces in elevation towards a retaining wall where there is a lower level adjacent to Kingswood Close.

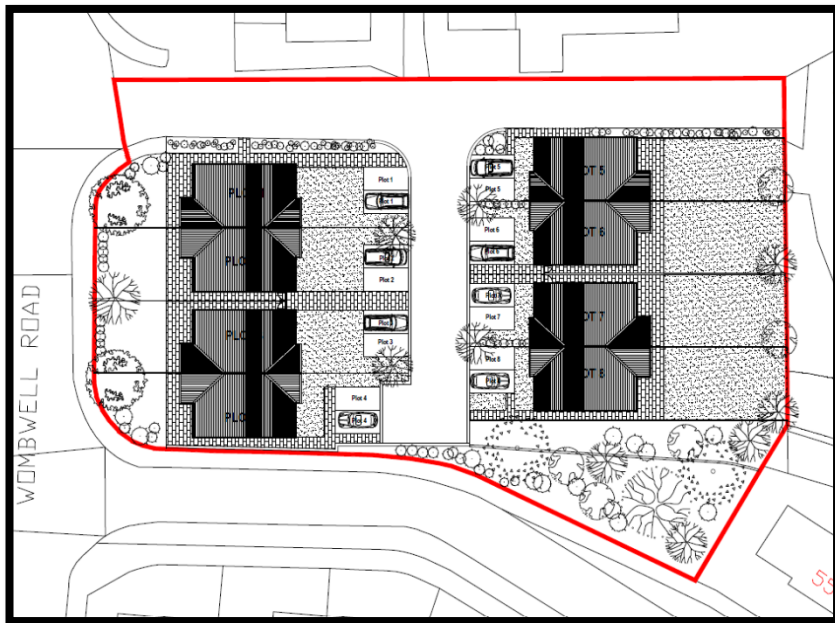
Figure 3: Proposed scheme drawing number (0094) – P500

The proposals include the construction of 8 new dwellings utilising the existing access.

It is likely that arboricultural impacts can be addressed with arboricultural methodology or minor amendments to the proposal.
