# Bat Scoping Survey to

Willow House  
High Lane  
Ingbirchworth  
S36 7GP

26<sup>th</sup> June 2023

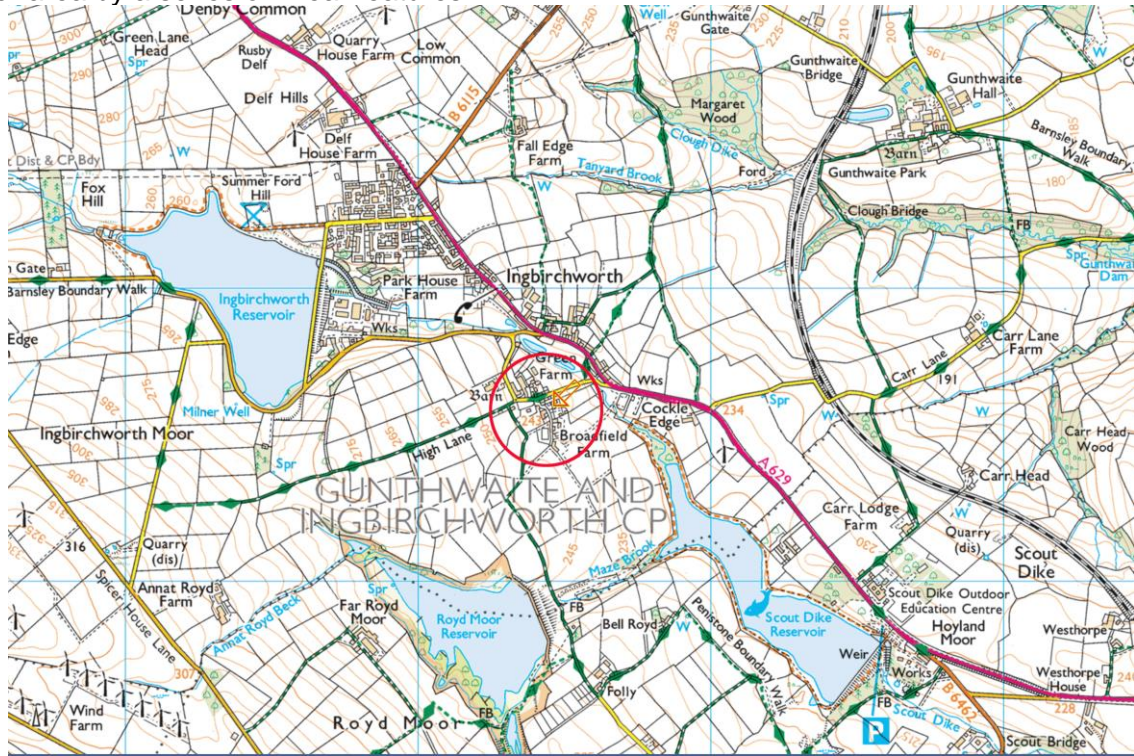
Figure 1. Site location plan

5.1 The site consists of a large garden in a rural setting just off High Lane, Ingbirchworth and is surrounded by many other period buildings all of which offer greater roosting potential. The habitat around the site is average quality in terms of foraging but the site is connected to the wider area by a series of linear features.

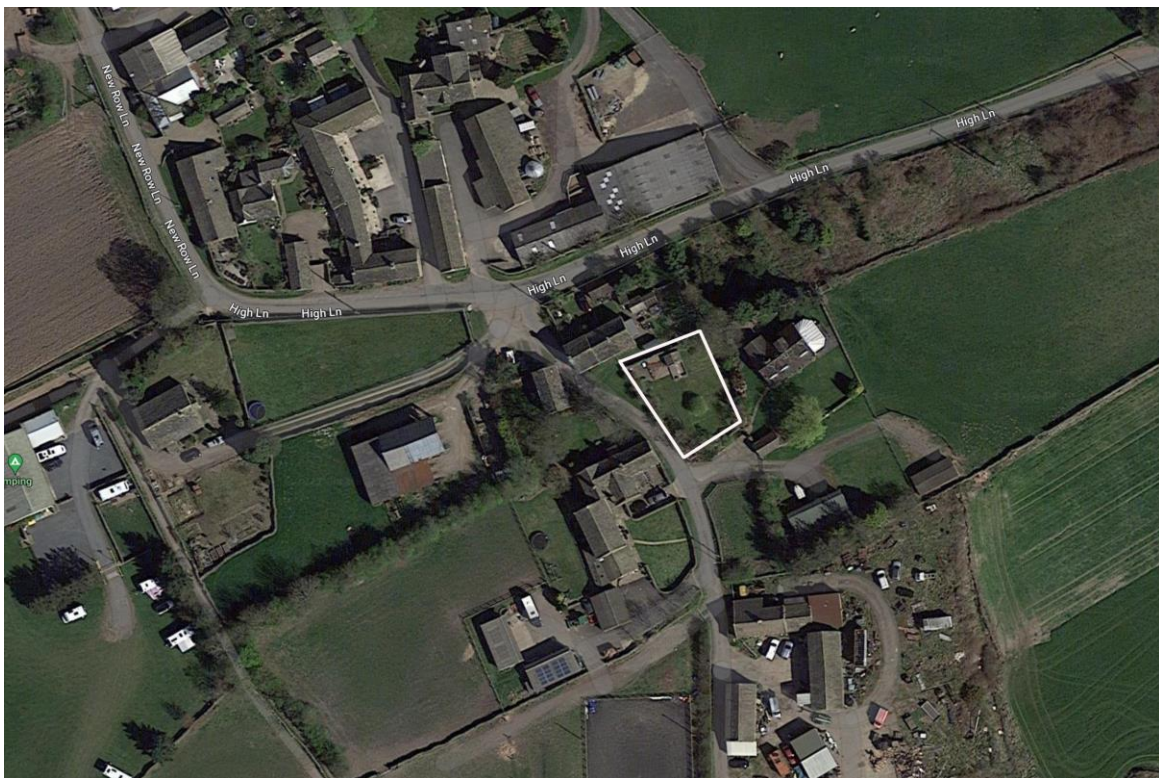
Figure 2 Aerial view of the site, surrounds and specific buildings surveyed.

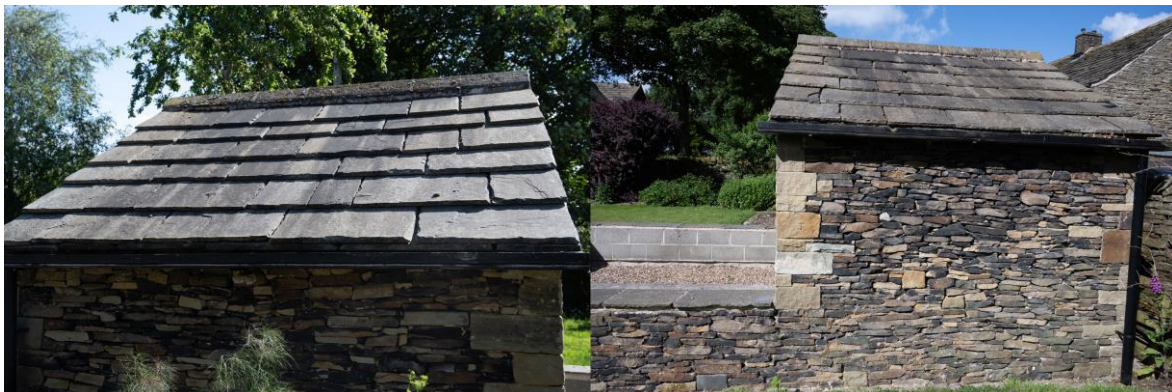
The site comprises a large garden with a lawned central section and ornamental planting to borders along the edges of the site. There is a stone garden shed located on the north edge of the site that has only been constructed recently and is a low, single storey building. The roof is covered with large stone tiles over a breathable membrane, and it exhibits the usual natural gaps associated with this style of roof. There are no obvious signs of bats and given it's low height combined with the fact that it is surrounded by much larger, period buildings all offering greater roosting potential, experience suggests that it is unlikely that bats would use this roof.

Photo1 showing the roof exterior.

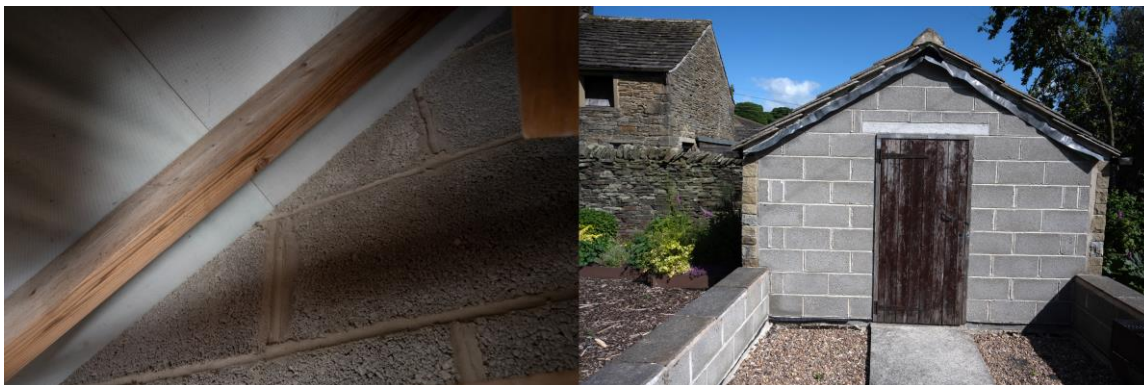
Internally, the roof is open to the ridges and is easily inspected from floor level. There are no signs of bats such as scattered droppings or prey remains. The internal apex is clean and shown no staining or other features associated with roosting bats. The ridge is covered by the breathable membrane and seems unlikely to be used by ridge dwelling species. The gable walls are as yet unfinished, and the membrane is visible and has not been trimmed or fascia boards attached. The verges are sound as would be expected on a new construction such as this and the ridge mortar is present and has no gaps that would allow access.

The side and rear walls have an outer covering of drystone walling which is attached to the blockwork with mortar and inspection shows that very few of the gaps in the walling are more than a few millimetres deep and unable to provide roosting cavities. Odd ones were slightly deeper but all were carefully inspected from ground level and showed no evidence of use by bats.

Photo 2 showing internal and external gable
