**REPORT C7481/GA  
JANUARY 2018**

**GEOENVIRONMENTAL APPRAISAL**

**of land off  
WAKEFIELD ROAD, MAPPLEWELL**

**prepared for  
LIDL UK GMBH**

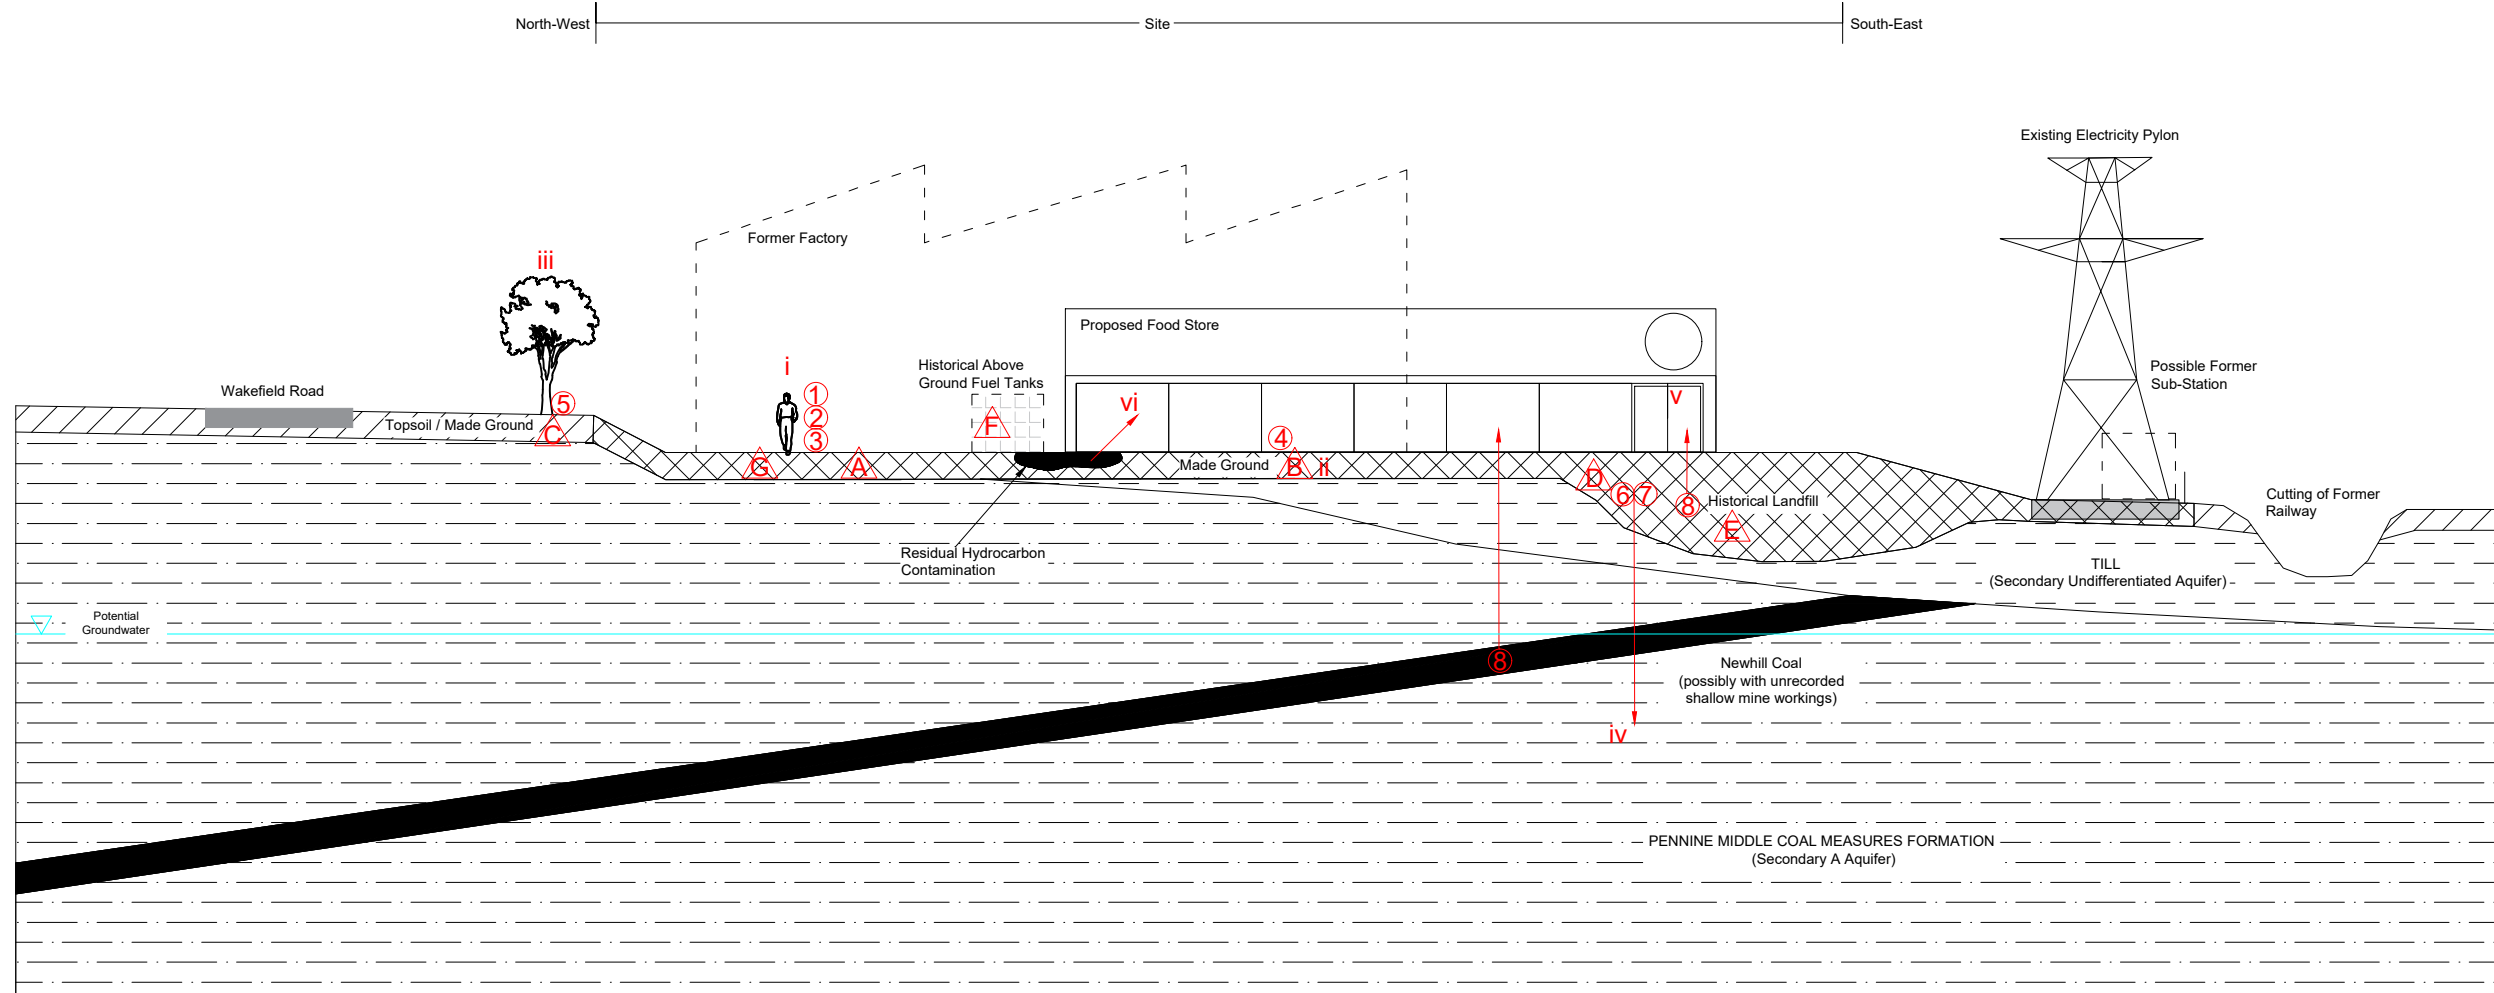
| Contamination Source | Contamination Pathway | Potential Receptors | Risk of Significant Contaminant Linkage |
| <b>A</b> - Metals, metalloids, asbestos and organic contaminants (including PAHs and petroleum hydrocarbons) within made ground and / or shallow natural soils. | <b>①</b> Direct and indirect ingestion of soil<br><b>②</b> Inhalation of contaminated particles and dust<br><b>③</b> Dermal contact | <b>i</b> - Construction workers / end-users / adjacent land users | Low to Moderate<br>Low to Moderate<br>Low to Moderate |

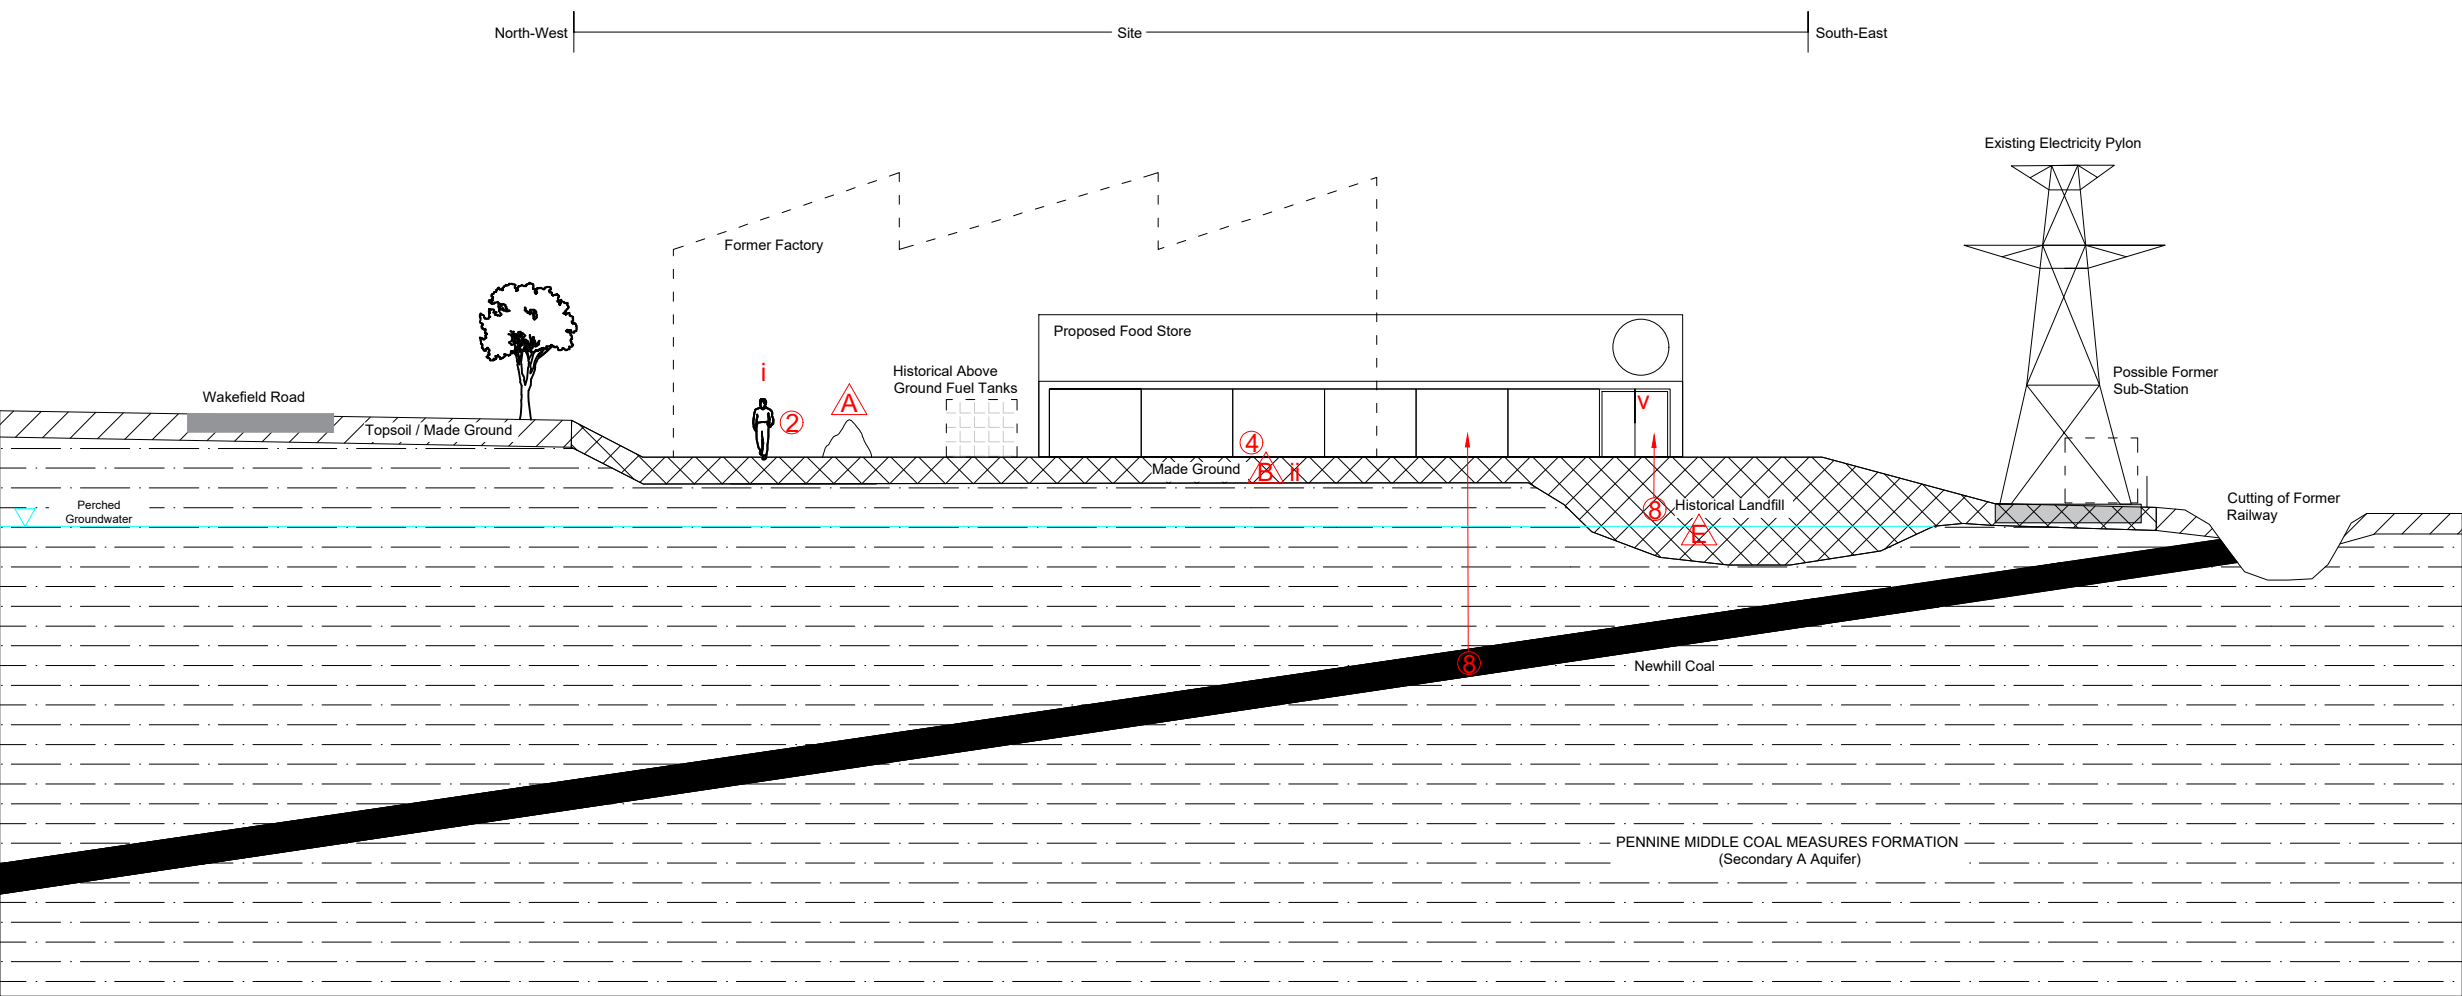
| Contamination Source | Contamination Pathway | Potential Receptors | Risk of Significant Contaminant Linkage |
| <b>A</b> – Asbestos fibres released into air by crushing ACM-contaminated stockpiles. | <b>2</b> Inhalation of contaminated dust | <b>i</b> - Construction workers / end-users / adjacent land users | Moderate |

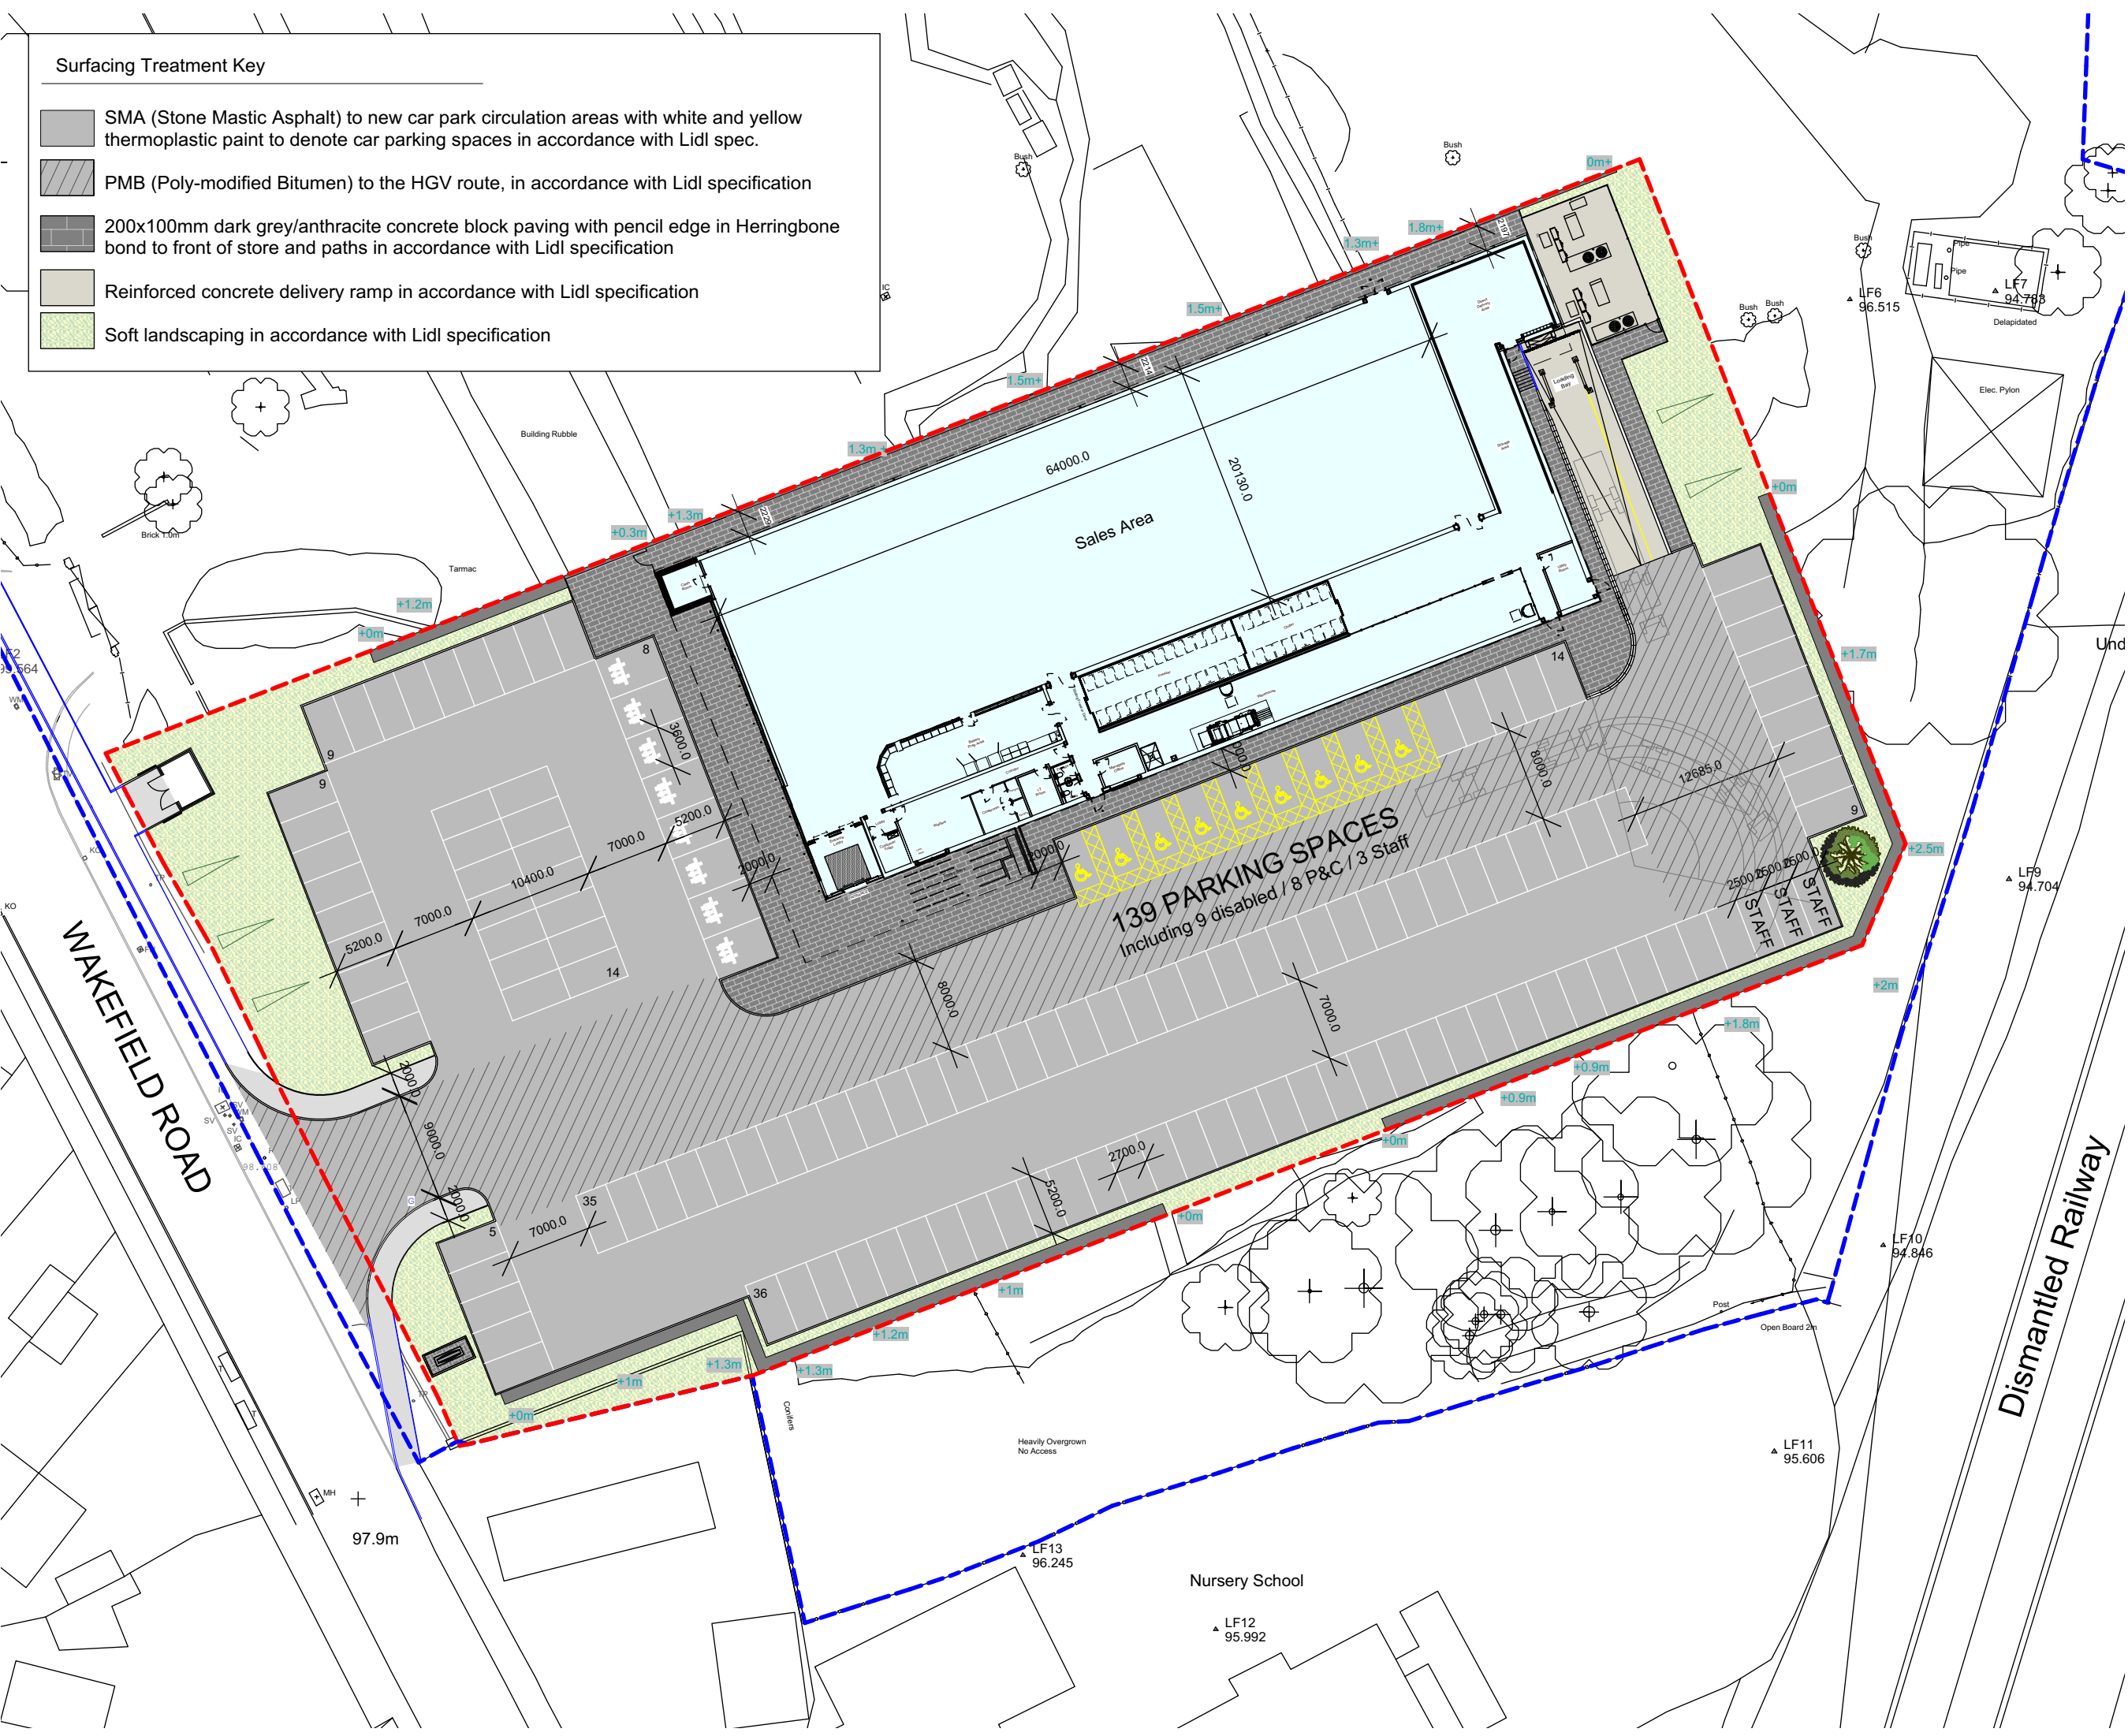
job no. 1744 dwg no. P401 rev. -

**Surfacing Treatment Key**

- SMA (Stone Mastic Asphalt) to new car park circulation areas with white and yellow thermoplastic paint to denote car parking spaces in accordance with Lidl spec.
- PMB (Poly-modified Bitumen) to the HGV route, in accordance with Lidl specification
- 200x100mm dark grey/anthracite concrete block paving with pencil edge in Herringbone bond to front of store and paths in accordance with Lidl specification
- Reinforced concrete delivery ramp in accordance with Lidl specification
- Soft landscaping in accordance with Lidl specification
