Technical Note

Project:	P17-176 Athersley RLE		
Subject:	Technical Note – Remedial works to north west area		
Prepared by:	Adam Taylor MGeol (Hons) FGS Geo-Environmental Engineer	Date:	7 Aug 2020
Authorised by:	Stewart Friel MSc BSc (Hons) MEnvSc Director	Status:	S2 - Information
Document Ref:	17176-RLE-19-XX-RP-O-007	Revision:	P02

Appendix A: NW area Remediation Works Plan

Drawing Title
NW AREA REMEDIATION WORKS PLAN

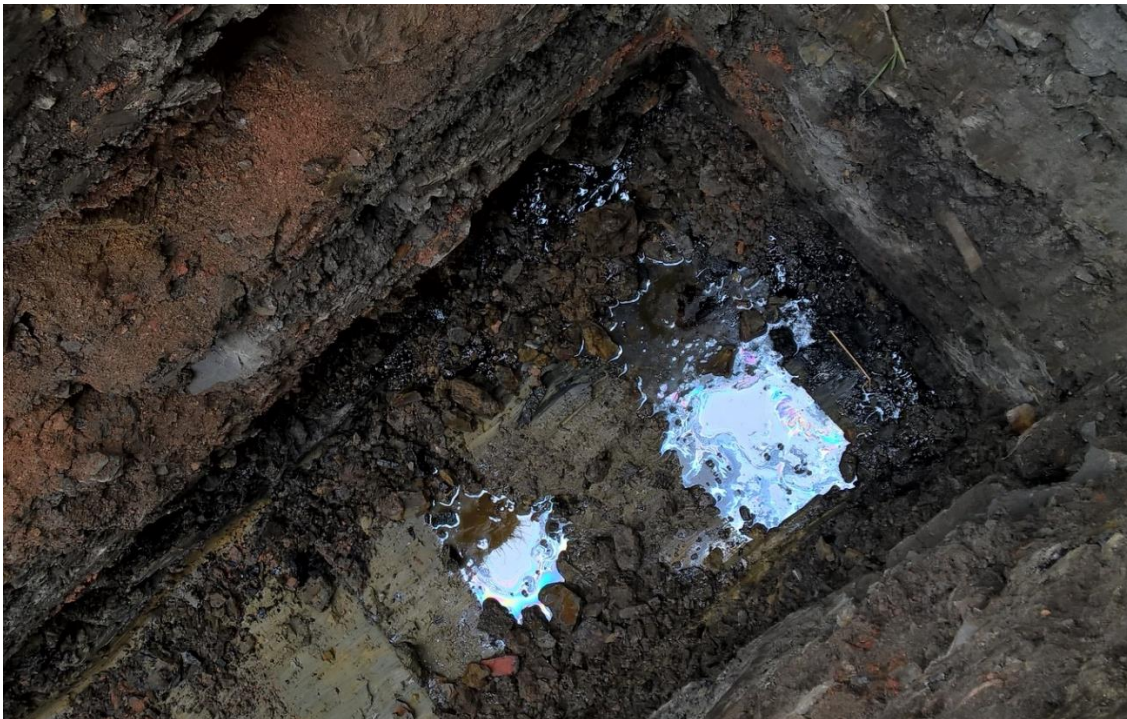
Figure 1 below shows the free product in-situ within TP102, as a small pocket of coal tar impacted material perched on impermeable natural clay.

Ground conditions comprised mixed made ground with lenses of red burnt shale gravel. Coal tar contamination was typically identified at the base of burnt shale, at the interface of the underlying natural clay. Trial pits downhill (south) of the initially identified area of contamination also identified evidence of coal tar contamination, whereas trial pits to the north, east and west generally did not. This suggests that there may be a degree of

mobilisation of the coal tar downhill to the south, likely associated with perched groundwater.

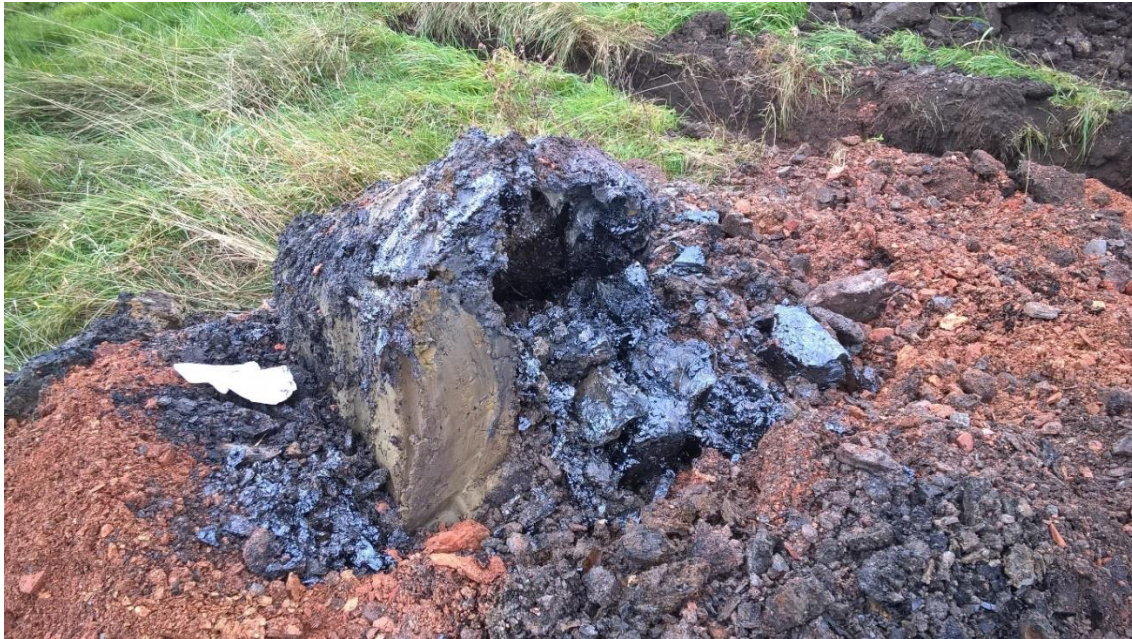
Figure 2 below shows the free-product, red shale and underlying natural clay excavated from TP102.

One contamination test was undertaken on the coal tar impacted soil taken from TT5, which identified the following:

- Total TPH concentration of 25,000 mg/kg (mostly heavy-end aromatic hydrocarbons)
- Total PAH concentration of 960 mg/kg
- Highly elevated concentrations of BTEX including benzene (280 µg/kg), toluene (2900 µg/kg), ethylbenzene (4000 µg/kg), m&p-xylene (64,000 µg/kg), o-xylene (34,000 µg/kg), 1,3,5-trimethylbenzene (41,000 µg/kg) and 1,2,4-trimethylbenzene (68,000 µg/kg).
