**Bat Survey Report**  
**Barn off Church Street, Bolton upon Dearne.**  
**30<sup>th</sup> August 2016.**

- 3.1 The site consists of an old derelict detached barn in a suburban location off Church Street at Bolton on Dearne. The building is mostly stone built but has an original brick dividing load bearing wall plus some modern concrete blocks on the east elevation. The original south section has collapsed together with a large part of the east elevation and a small part of the west elevation. The barn has what remains of a Welsh slate roof with ridge and a north gable. The building is in an extremely dangerous condition with one area in particular on the west elevation about to collapse (see plates 2, 3 & 4). Additionally, there is what remains of the southern section/barn (see plate 5).

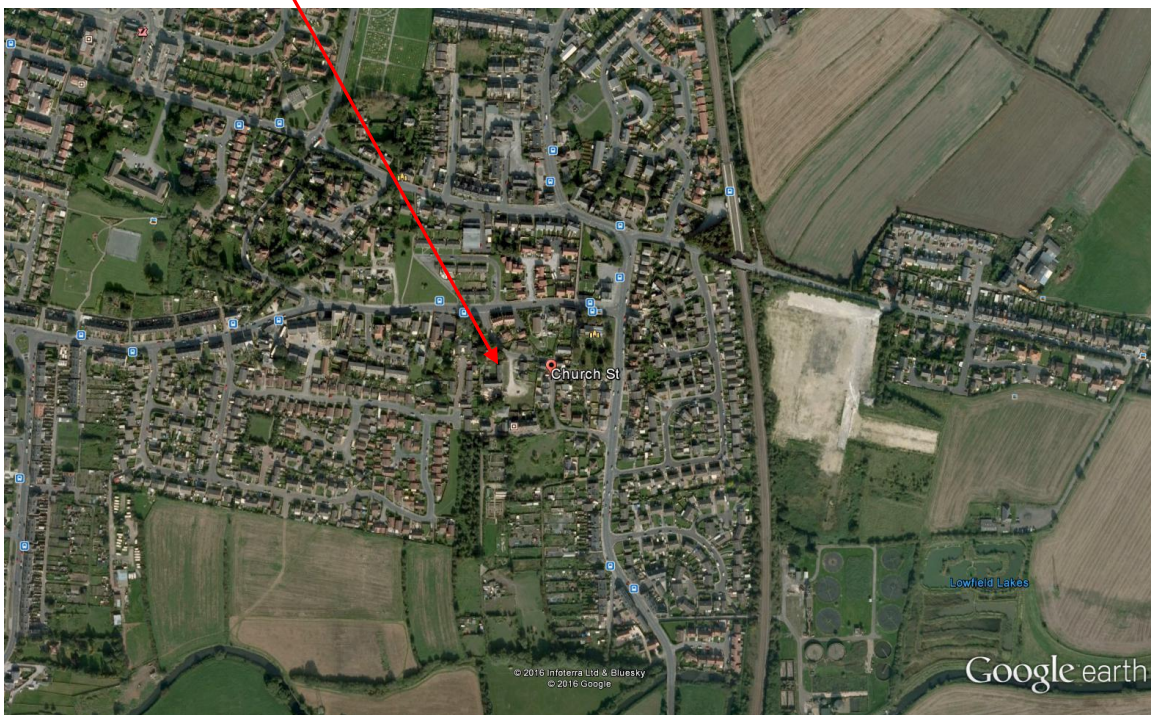
**Plate 1      The site**

or water bodies near to the application site and therefore the immediate surrounding habitat is relatively poor for bats (see plate 1). Table 1 summarises the habitats present, adjacent to and further afield to the barn off Church Street at Bolton upon Dearne.

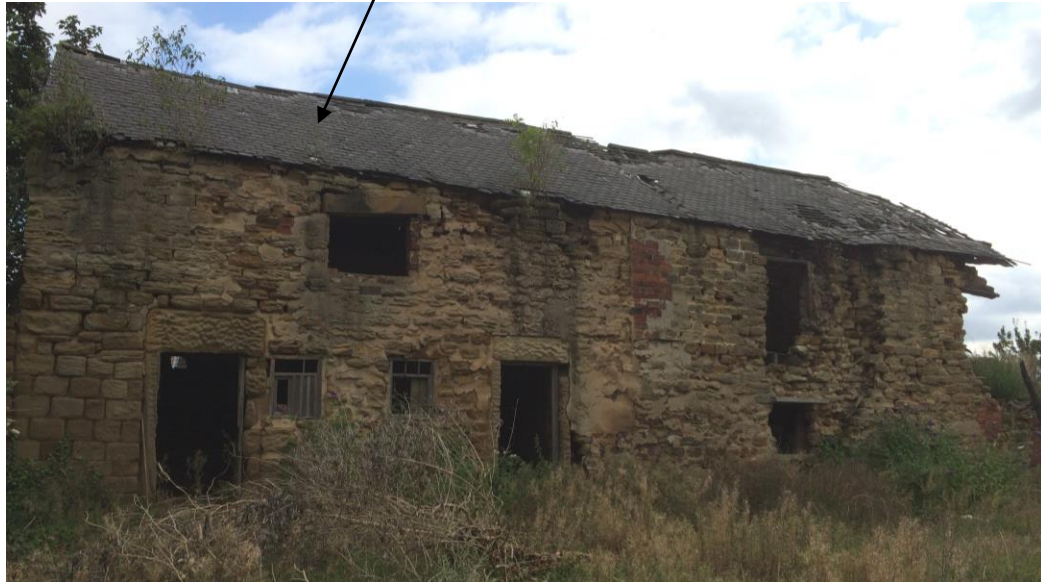
5.4.1 There is no membrane beneath the slates and therefore bats are unlikely to be found roosting under slates or ridges. The walls however have a plethora of holes that are mostly large but with several holes in mortar joints on both the west and east elevations suitable for crevice dwelling bats.

**Plate 2** West elevation with this section of roof in the best condition

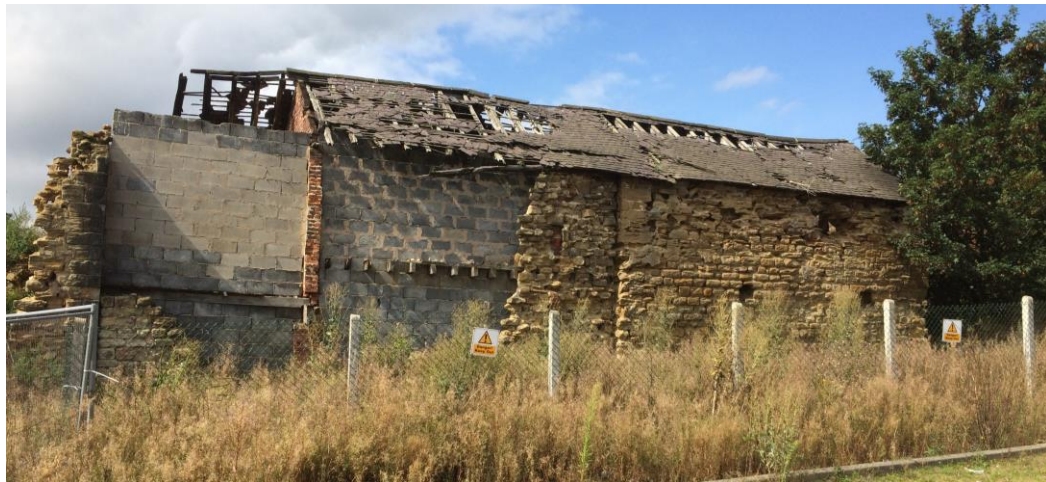
**Plate 3** East elevation

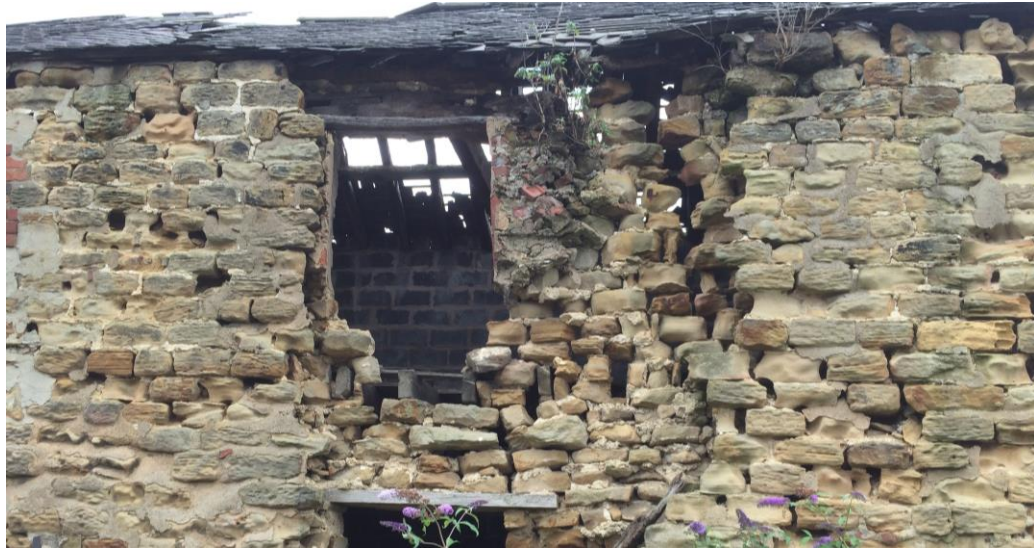
5.3.1 A proper inspection of the inside of the building was not possible for reasons of health and safety (see plate 4). However, by standing in the doorways and looking inside the presence of barn owl *Tyto alba* was immediately evident in the section where the roof is water tight on the west elevation (see plate 2). One of the king-post roof timbers was heavily streaked with white and the floor beneath was adorned with pellets. I search for bat droppings or other signs of bat occupation was not however possible because of the extremely dangerous condition of the building. Nevertheless, the inside walls will have suitable features in mortar joints with potential to accommodate bats.

**Plate 4** Very dangerous section of west elevation

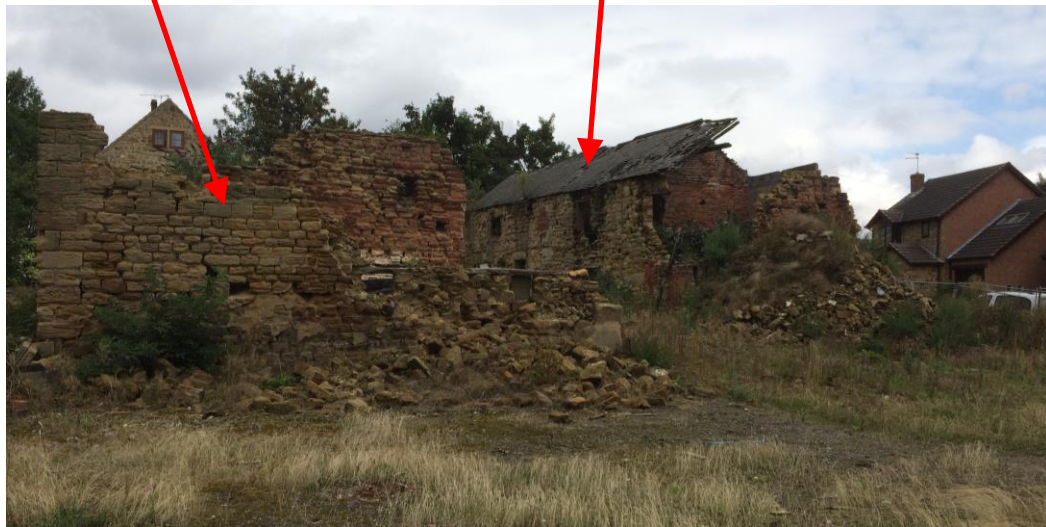
**Plate 5**

- 5.5.1 The google earth image shows an ‘L’ shaped barn complex but the southern section has gone (collapsed) with only low walls still present (see plate 5). Most of the rubble has emptied from the inner core of the walls through large holes or above windows. Furthermore, there is nothing to prevent the ingress of water even in sections where the rubble filled core of the walls are intact. Consequently, the ruins are not considered to have anything more than negligible bat roost potential.

Ruin

what's left of the remaining barn

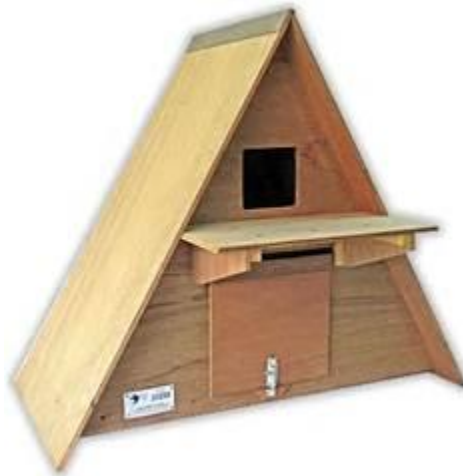
**Figure 2** Example of barn owl box

7.3 **Barn owl** – The barn has a resident pair of barn owls which are protected under schedule 1 of the Wildlife and Countryside Act 1981. Consequently, provision for the birds must be provided in the form of a barn owl box on a tree or a pole near the boundary of the site. If a tree is chosen some pruning of the tree may be necessary. The box should be installed as soon as possible in order for the owls to acclimatise themselves with it before the demolition of the barn. It should be

noted that the site is surrounded on all sides by dwellings and further development of the site may make the site less attractive to barn owls in the future. Additionally, a barn owl box may attract the attention of children, and for this reason an alternative site may be the better option in the long term. Nevertheless, there is no alternative to providing a box on site in the short term (see figure 2).

- 7.3** Most electricity or telegraph poles are suitable. Minimum length 6m. Minimum diameter 150mm. Erection normally requires specialist machinery or a digger. Bury 1.5m in the ground leaving a height of 4.5m. Wherever possible the box should be secured to the pole before erection. The position in relation to habitat features is not critical but ensure that the main entrance hole is not screened by a building or tree(s). For further information on appropriate barn owl boxes and where to install please contact Middleton Ecological Consultancy.
