**STABLE AT COOPER LANE,  
HOYLANDSWAINE**

**BAT SURVEY REPORT**

**Ref No:- 131021/1**

**Date: 29<sup>th</sup> April 2014**

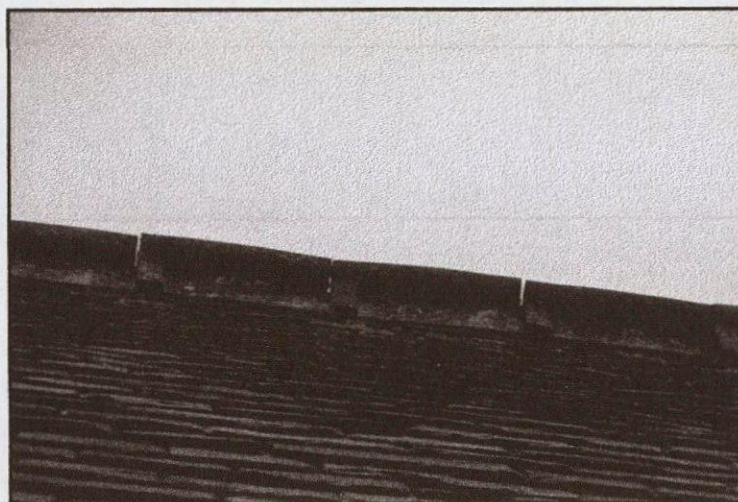
3.3.4. The building has a pitched slate roof with terracotta ridge tiles and parapets with stone coping stones at the top of each gable end. The roof is generally in good condition although there are a small number of slipped tiles and gaps under the ridge tiles which may allow access to bats between the slates and roof lining. Flashing is also present along each parapet wall at the gable ends. This is in good condition providing no suitable roosting locations for bats.

- A small number of missing tiles and/or gaps under the ridge tiles may allow access to potential roost locations between the roof tiles and roof lining.
- The timber boxed soffits are damaged in one location on the buildings southern elevation, allowing access to bats into the soffit to a potential roost location.
- A small area of missing pointing in the stonework on the southern elevation may provide access to bats to gaps between the stone facing and breezeblock walls. The gap is approximately 1.5m off the ground and therefore is not ideal as a roost access point for bats as it leaves bats open to predation on entering and exiting any roost.
- Missing stonework underneath a window on the northern elevation may allow access to bats to the interior of the building to be used as a foul weather foraging area, feeding perch or 'night roost'.
