Bat Roost Suitability Assessment

**Mount Vernon Hospital
Barnsley**

Report reference: R-3064-01

November 2017

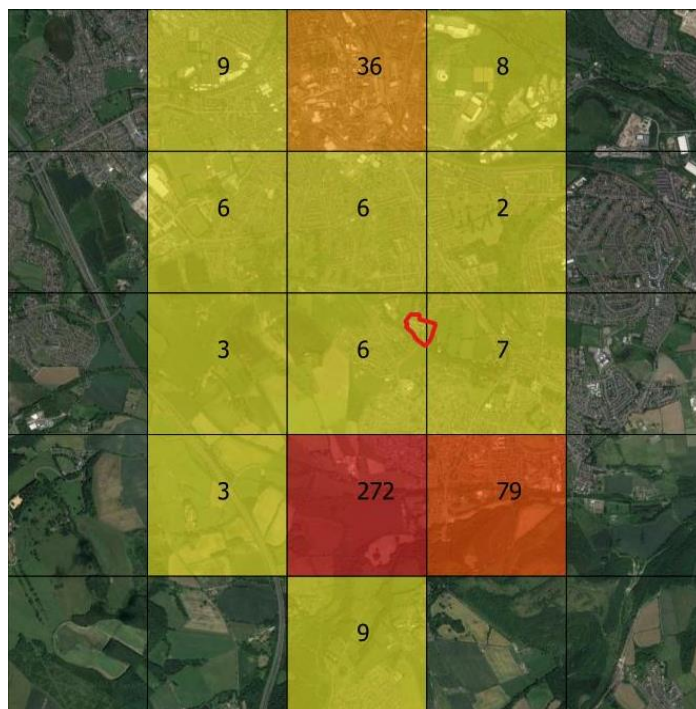
Figure 2

11. The local records provider (South Yorkshire Bat Group) were asked to provide all records from within a 2km radius of the site. A total of 446 records were returned.

Heat map showing number and distribution of bat records around the Site (red line boundary).

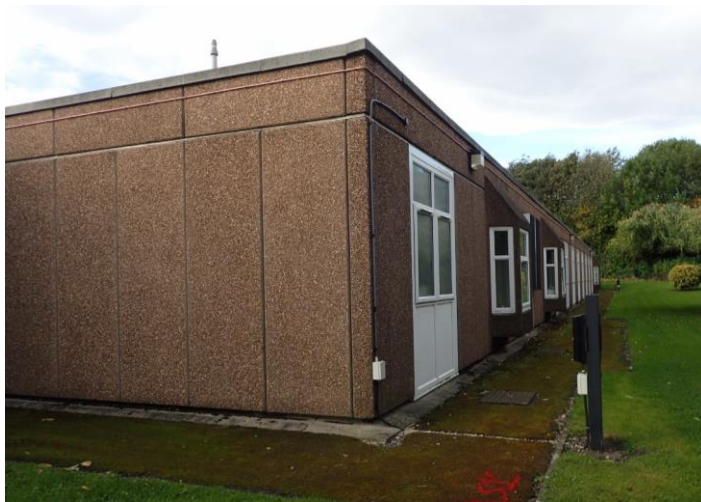
Figure 3

18. To the north west of the Site are three wards (Wards 4-6) constructed of concrete/asbestos pebbledash sheets. Between the vertical sheets is a narrow gap but this is blind and sealed with rubber.
19. The roof is flat and lined with felt which has been wrapped over the wall top and attached to wooden batons. This appeared to be flush with the wall top around most of the building, with few potential points of entry noted. The only notable exception to this was a gap in the south-west corner, where wiring enters the wall cavity.

Overview of Ward 6 showing sheet construction.

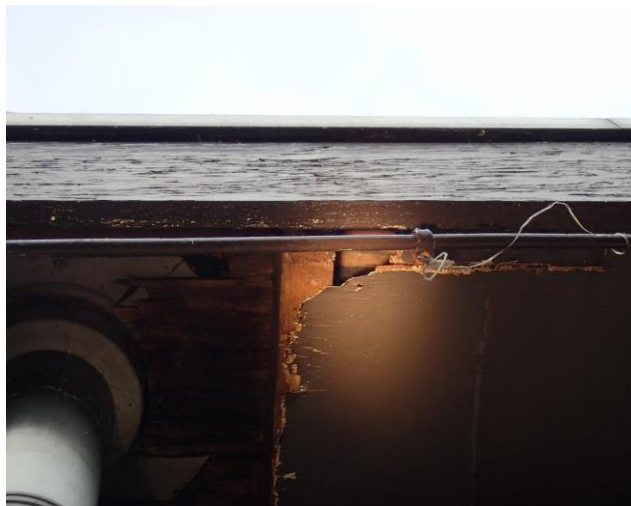
- 22. The rest of the main building (Wards 1-3, reception area and adjoining corridors) is constructed of modern brick with a combination of wood and UPVC windows, doors and panels. Brickwork is well sealed with mortar.
- 23. Where the soffit is boxed in at the eaves, woodwork is mostly intact. An exception is on the south east corner of Ward 2 where damaged ply provides potential access to this feature. However, given the damp in this area it is unlikely to be used by bats. Small gaps in the wood panelling to the front of the building were also noted, but are unlikely to be used by bats for similar reasons.

Figure 5 Missing ply under the wooden soffit box of Ward 2

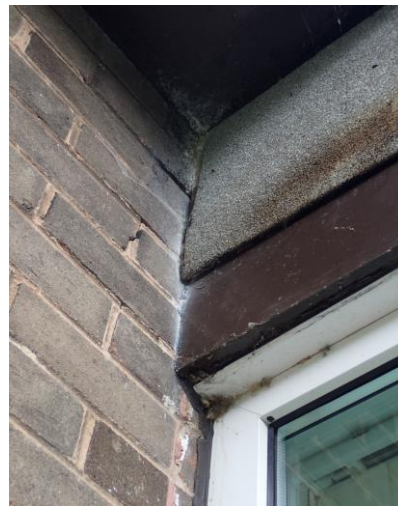
Figure 6 Narrow crack providing entry behind felt on Ward 2 annex

- 24. On the east of Ward 2 there is a small uPVC annex. A potential bat roost feature behind the felt above the window was noted in this area.
- 25. The roof is flat and felt-lined. A wooden barge board holds the gutter off the wall tops. This is generally well sealed with mortar, the exception being underneath the security light above the door between Wards 3 and 4. Similarly, there is missing mortar at the corner of the utility area to the north east of the Site.

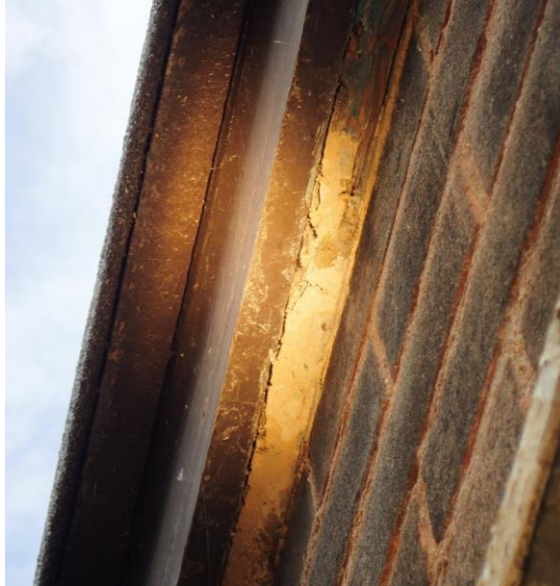
Figure 7 Mortar generally well-sealed behind barge board of brick buildings

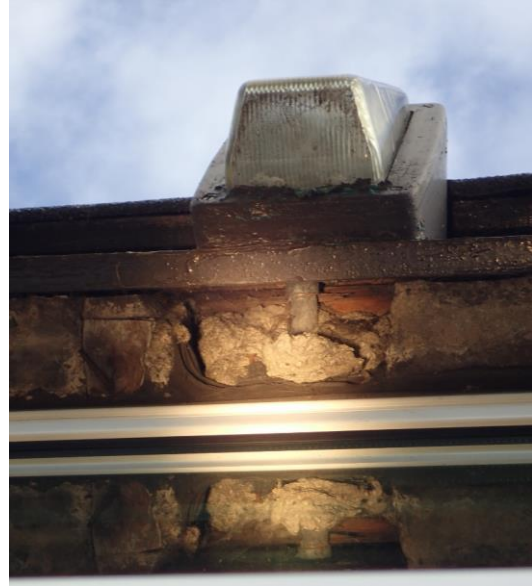
Figure 8 Cracks in brickwork under security light above door

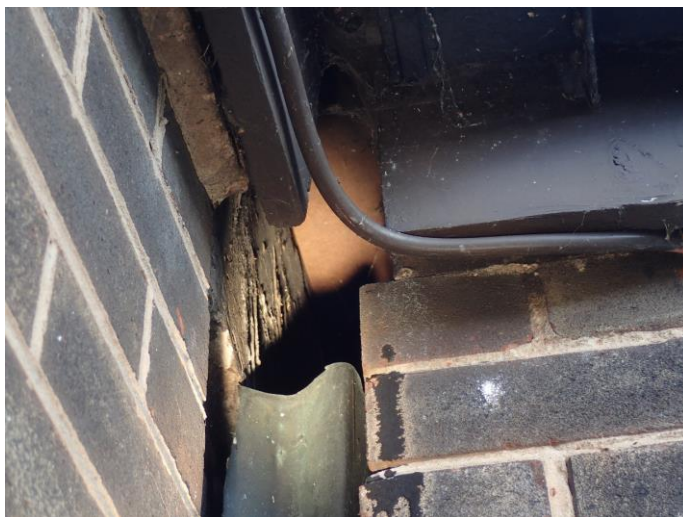
Figure 9

26. In the internal corners, where Wards 1, 2 and 3 meet the main building, there is a large gap at the eaves providing access to the wall cavity. These varied in size, and whilst the narrower gaps might be suitable for bats, these features are generally considered to be too large and draughty to support roosts.

Gap between main building and Wards providing access to wall cavity.

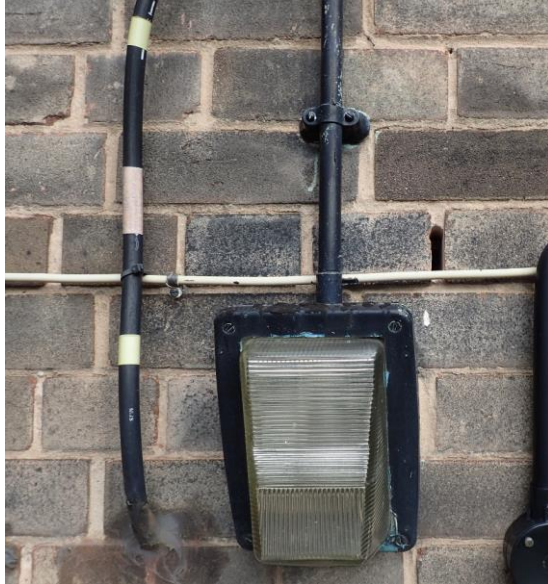
27. On the rear of the two-storey main building, immediately east of Ward 1, there is a gap in the brickwork close to the security light: this feature might provide access to the wall cavity. A small gap in the wood cladding of the adjacent wall would provide access to the roof void. These features both offer potential bat roosts.

Figure 10 Gap in brickwork on rear of main building, north east of Ward 1

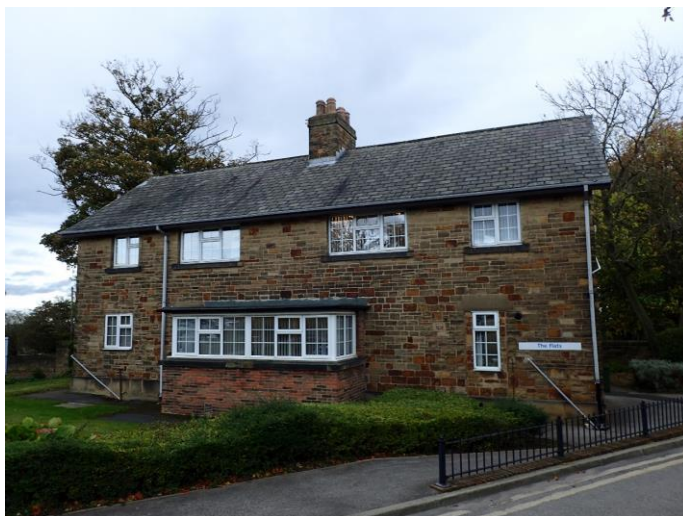
Figure 12

Overview of the front of The Flats, taken from the hospital entrance.

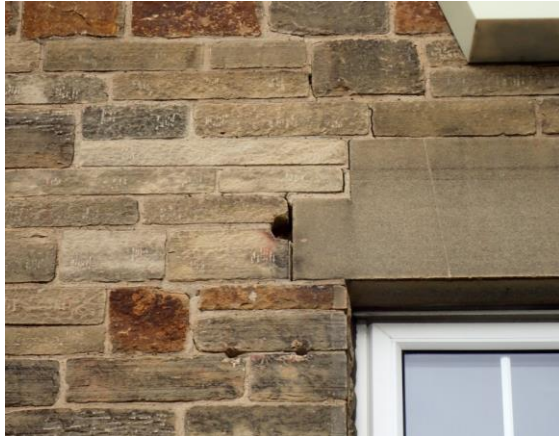
30. The building comprises a mix of stone and brickwork which is in good condition with mortar generally intact. There are however a few cracks in the masonry, notably on the southern aspect/at the side entrance. These features include a hole above the lintel to the upper left of the first-floor window, and cracks around the outflow pipe above left of the doorway, both of which could provide bats with access to the wall cavity.

Figure 13 Hole at first floor lintel

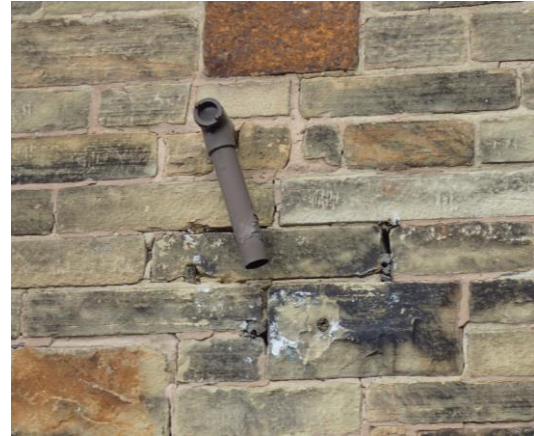
Figure 14 Crack near side entrance

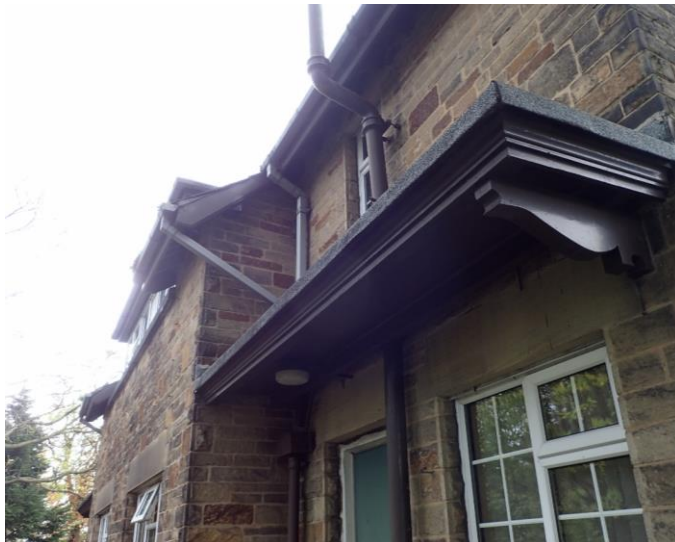
Figure 15

31. The timber soffit and fascia at the eaves are close fitting to the wall tops. The tiles on the pitched roof and the ridge appear to be well sealed with no obvious entry points for bats.
32. To the rear of the property are a pair of wooden porches. Where the roof meets the brick work there is a narrow gap although there were no signs of bats using this sheltered feature.

Porchway to rear of "The Flats".

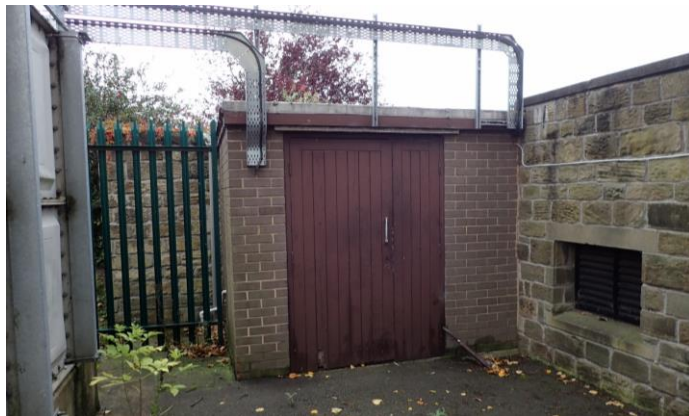
Figure 16

34. The small sandstone building located at the entrance to the Site is flat-roofed with intact mortar offering no features for bats. A smaller brick extension, also flat-roofed, does have a narrow barge board to the wall top – this appeared to be well-sealed but as the compound was locked a close inspection could not be made.

Utilities area as viewed from hospital driveway (looking north) showing brick extension and sandstone building.

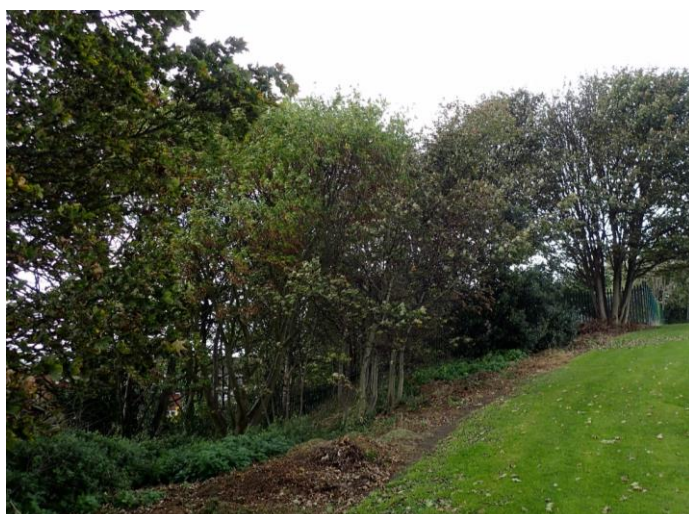
Figure 17

35. To the rear (south west) of the Site, is a belt of deciduous woodland comprising a number of mature and semi-mature trees dominated by sycamore (*Acer pseudoplatanus*).
36. A dense ground flora of nettle (*Urtica dioica*) and bramble (*Rubus fruticosus* agg.), as well as the steep slope, made access difficult. Many of the trees, including some standing deadwood, were covered in a thick layer of ivy (*Hedera helix*). This made it difficult to discern any features that might be used by roosting bats, though ivy itself can provide cover for day roosting bats.

Overview of deciduous woodland to rear (south west) of the hospital complex.

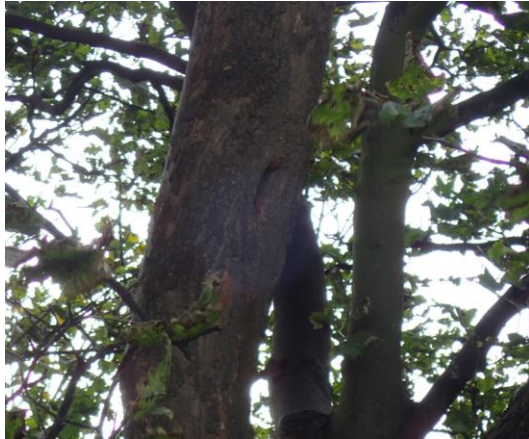
- T1 Mature sycamore with a small crevice evident half way up main trunk.
- T2 Mature sycamore with a small gash in a subsidiary limb.
- T3 Mature oak; dense covering of ivy obscuring any potential features.
- T4 Large, mature sycamore densely covered in ivy.

Figure 18 Crack in main trunk of T1

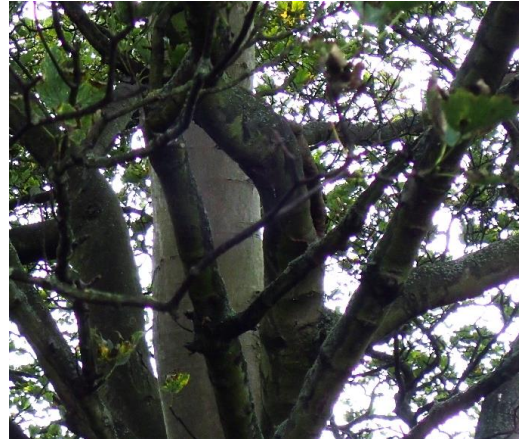
Figure 19 Crevice in subsidiary limb of T2

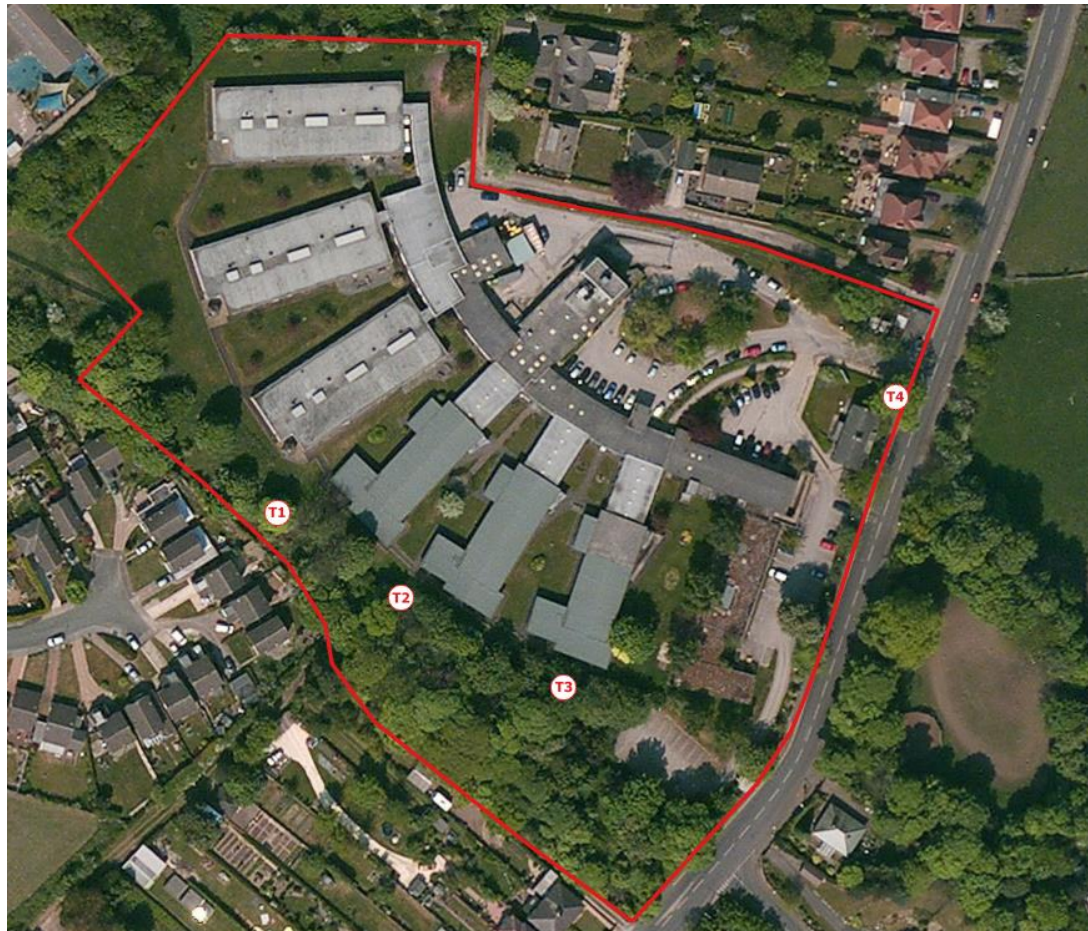
Figure 20 Trees with limited roost potential.

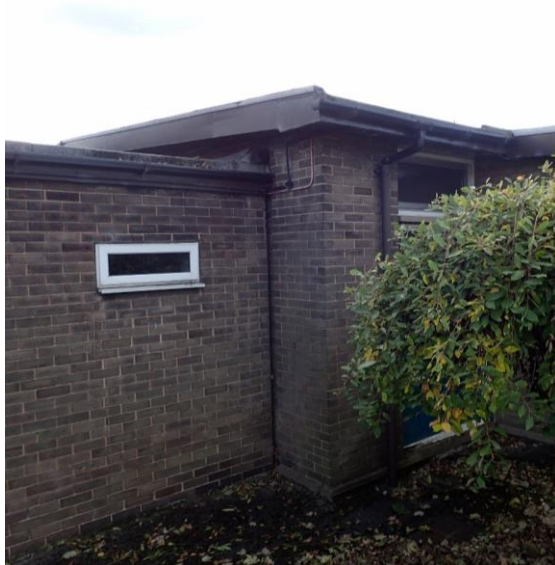
46. Several birds' nests were noted within the walls of the main building, these being associated with the change in wall construction between the wards and the main building. These are marked indicatively on plan D-3064-01.2 (Appendix 2).
47. Destruction of active bird nests is prohibited by law. Survey of the trees and outbuildings will be needed prior to Site clearance only if carried out during the period March - August (inclusive). This would allow and active nests to be identified and protected.

Figure 21 Location of birds' nest in gap between walls (Ward 3 - western aspect)
