**LAND AT HIGHSTONE LANE,
WORSBROUGH, BARNSELY,
SOUTH YORKSHIRE,
S70 6SD**

PHASE 2 COAL MINING RISK ASSESSMENT

Report Ref: 24319/P2CMRA/1

Dated: March 2025

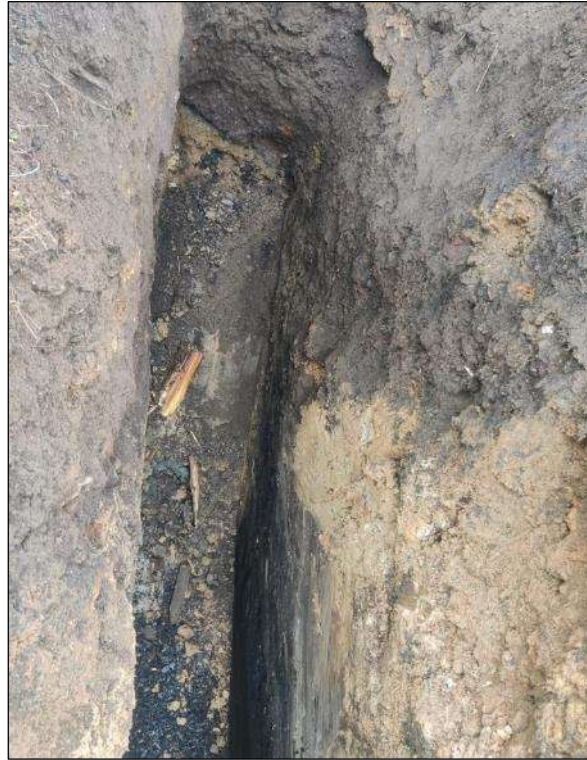
Evidence was found of the adit which was proven to a thickness of 1.15m.

Photo 1: TP01 – Large wood fragments found within adit 14.

Consideration may be given to grouting some of the adit locations, should mine gas monitoring prove a potential hazard. If adits are encountered they should be sealed in accordance (and consultation) with Coal Authority (Mining Remediation Authority) requirements.

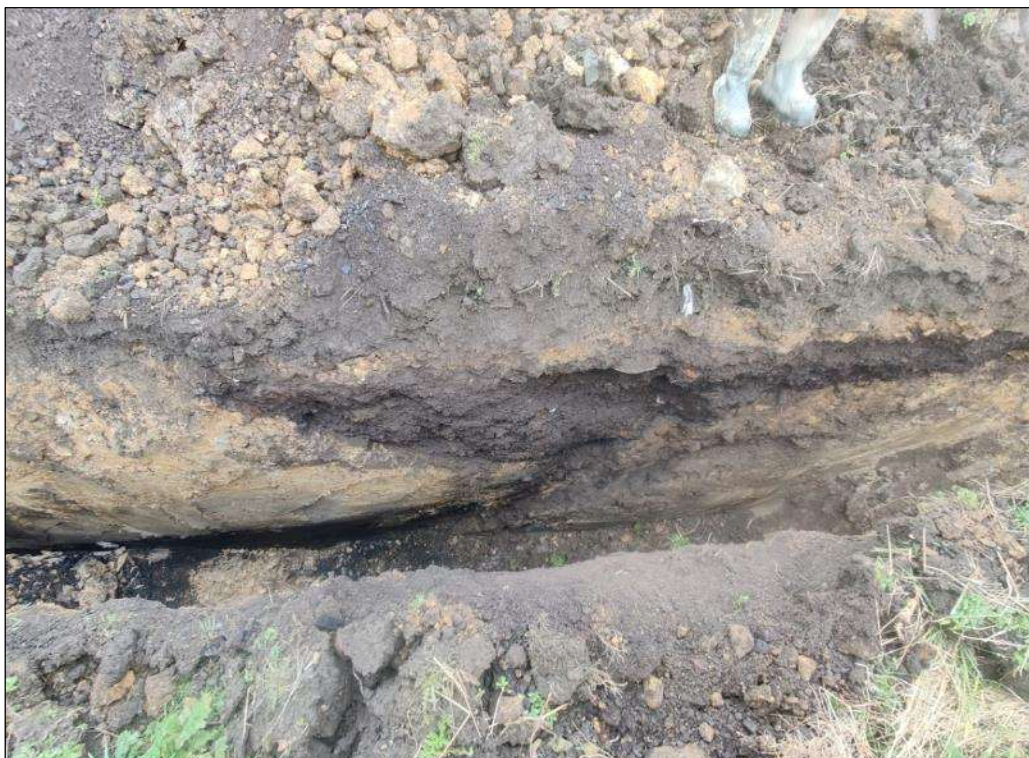
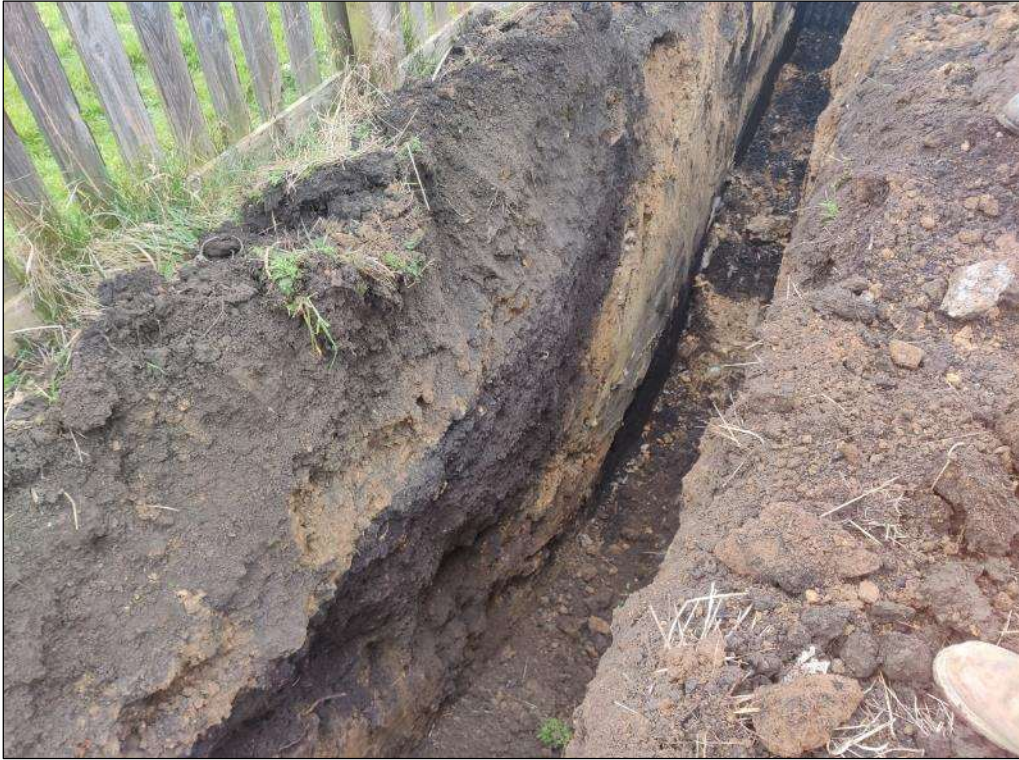
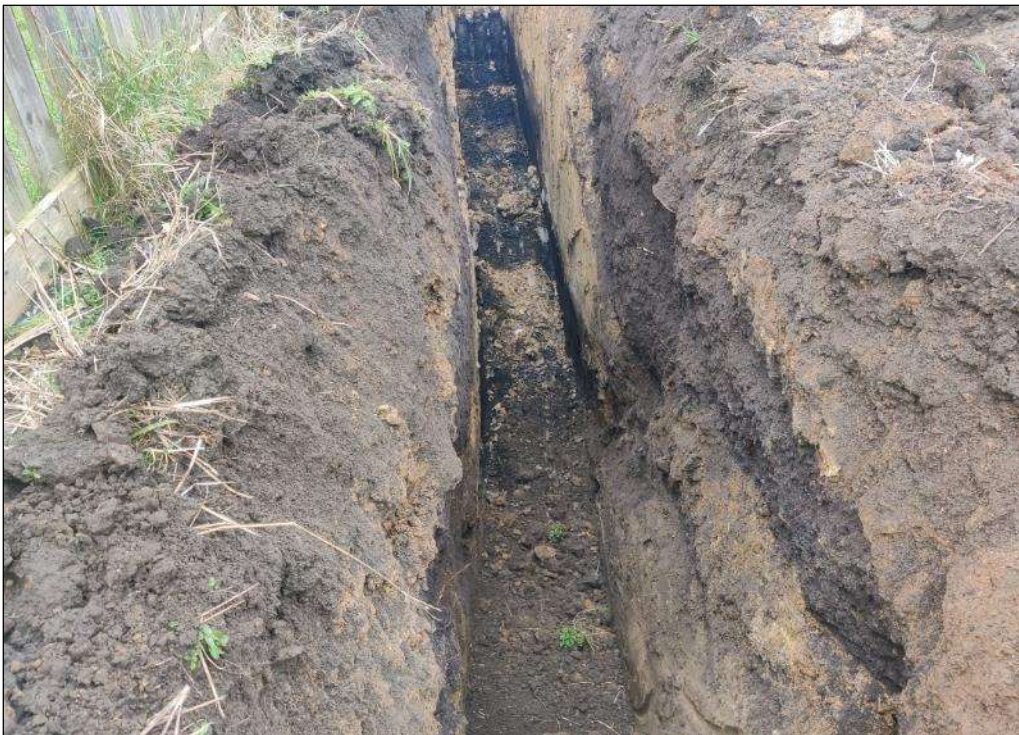
Photo 2: TP01 – Dark coloured infill material within the natural light brown strata.

Photo 3: TP01 – Dark coloured infill material within the natural light brown strata.

Photo 4: TP01 – Dark coloured infill material within the natural light brown strata.

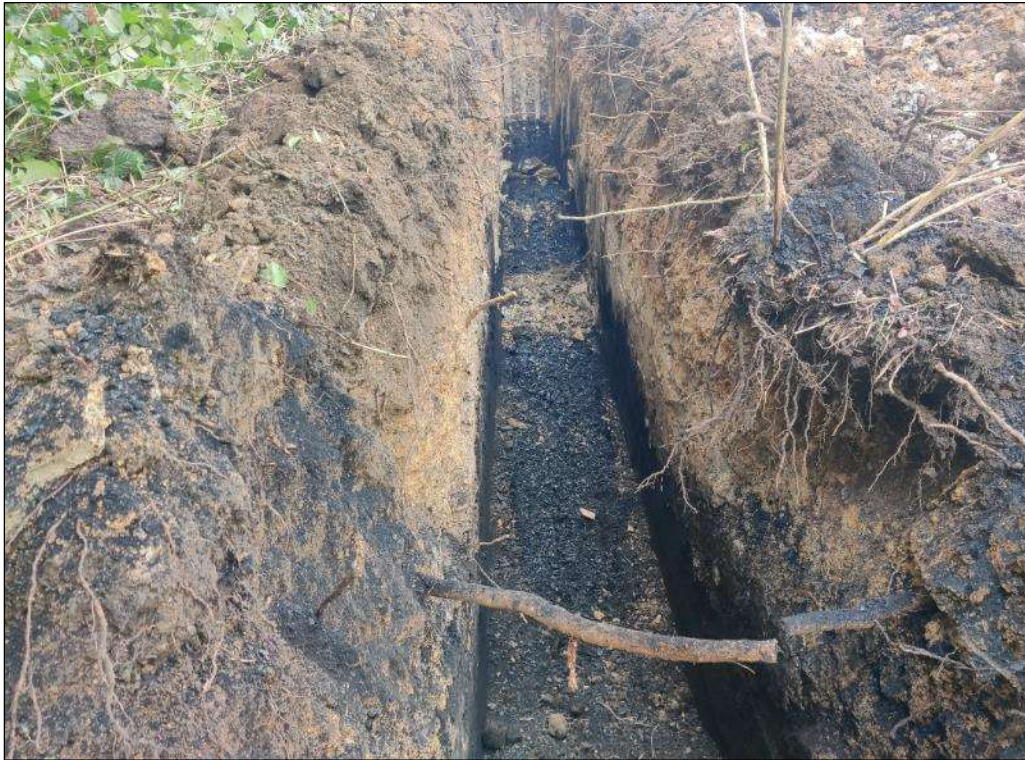
Intact COAL.	0.60+
Adit 434404-13 not encountered.

Photo 5: TP02 – Overview of the trial pit.

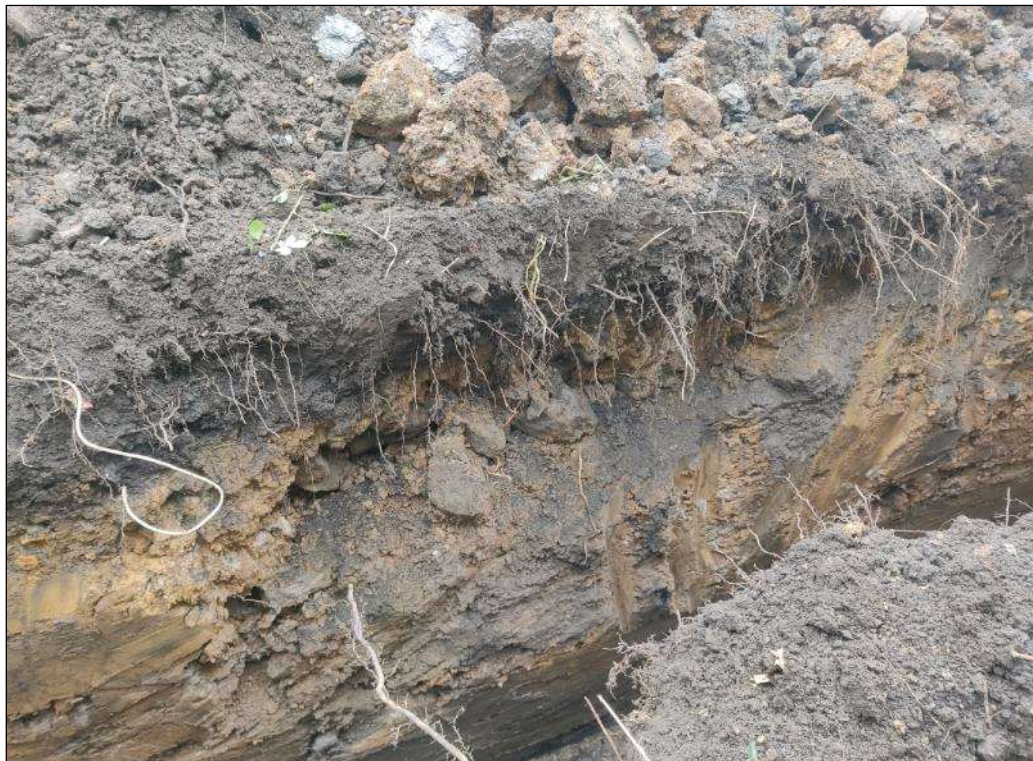
Evidence was also found of adit 434404-05 which was proven to a thickness of 1.30m and 1.40m width. The adit was backfilled with light grey sandy gravelly CLAY with boulders of angular sandstone. The gravel consisted of fine to coarse subangular sandstone, coal and brick.

Photo 6: TP03 – Large sandstone boulders and light grey backfill (adit 05) within the light brown natural strata.

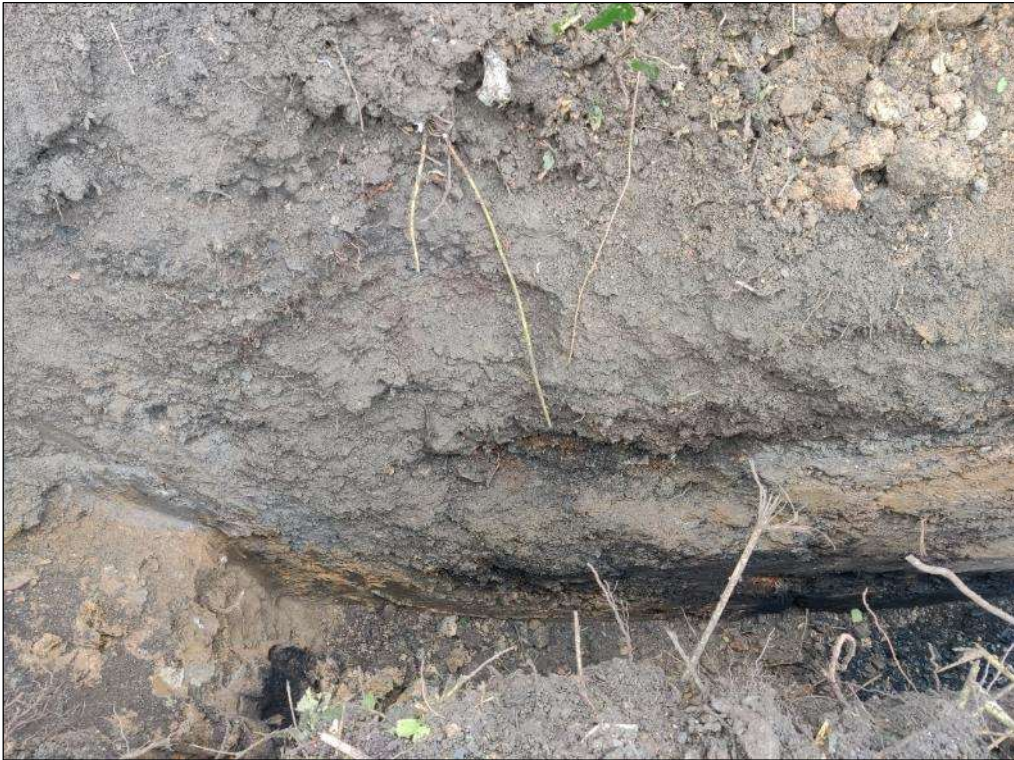
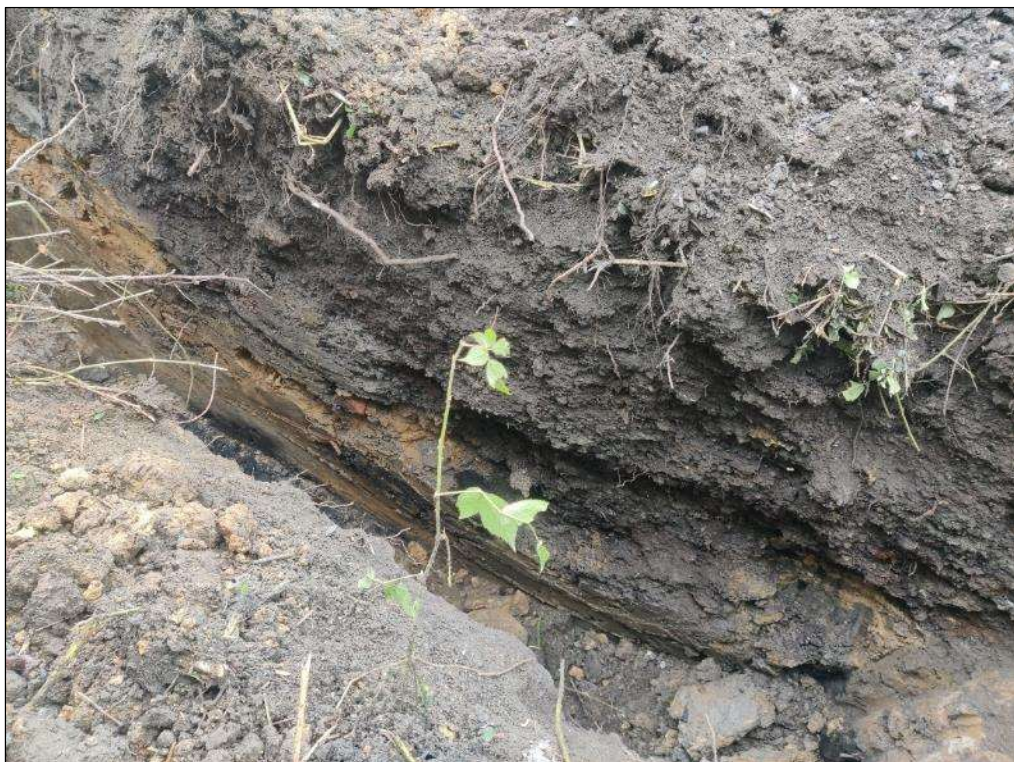
Evidence was found of adit 434404-16, which was proven to a thickness of 1.90m and 1.50m width. The adit was backfilled with dark grey slightly sandy gravelly CLAY. The gravel consisted of fine to coarse subangular sandstone, mudstone and brick.

Photo 7: TP03 – Darker coloured backfill material with fragments of brick (adit 16) within the light brown natural strata.

Photo 8: TP03 – Darker coloured backfill material with fragments of brick (adit 16) within the light brown natural strata.
