Beever Street - view A-A

Victoria Street East - View B-B

**align** PROPERTY PARTNERS  
 White Rose House (2nd Floor), Northallerton Business Park,  
 Thurston Road, Northallerton, DL5 2NA Tel: 01609 797373  
 Client: Barnsley Metropolitan Borough Council  
 Project name: Goldthorpe Public Realm  
 Drawing Title: Alleyway improvements  
 Alleyway 1 - Beever Street / Victoria Street  
 Purpose: Preliminary  
 Scale: NTS  
 Original Size: A1  
 Date: MARCH '24  
 Drawing Number: BC2301-APP-ZZ-DR-A-000110  
 Version: P1

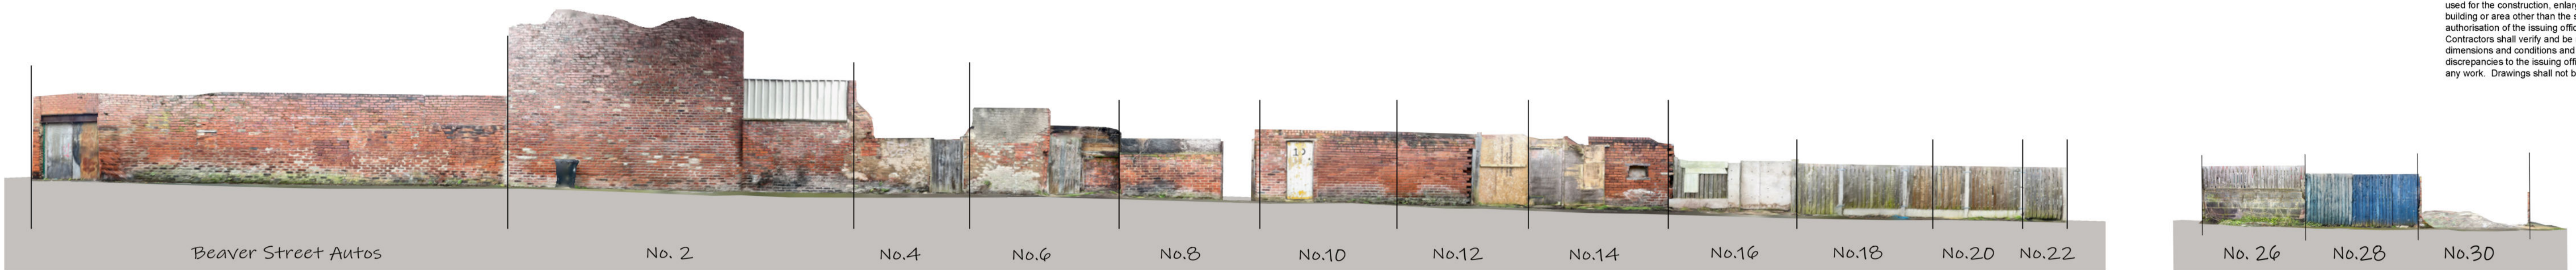
Beever Street rear alleyway - View A-A			
House no.	Existing Condition	Proposed improvements	Notes
Beaver Street Autos	Approx 3m high brick wall	Clean and re-point brickwork	
2	Approx 2m high brick wall with metal clad fencing on top	Clean and re-point brickwork, replace metal fencing with new timber fence to top of wall	No gate - add gate?
4	Approx 1.6m high brick wall. Timber gate access.	Clean and re-point brickwork, repair top of wall, build up to 1.8m high and add capping, replace timber gate with new 1.8m high timber gate	
6	Rear outbuilding brick wall approx. 2.5m high brick wall. Timber gate and low brick wall to side (1.2m high) with timber boarding on top.	Clean and re-point all brickwork. Repair any damaged areas of brickwork. Remove timber boarding to top of low wall and replace with new timber fence fixed down to wall, approx 600mm high. New 1.8m high timber gate	
8	approx 1.4m high brick wall, with painted chipboard on top, gate missing	Clean and re-point brickwork. Remove painted chip board and replace with new timber fence fixed down to wall. New 1.8m high timber gate

10	Approx 2.2m high brick wall with brick on edge to top and timber access gate	Clean and re-point brickwork, repair any damaged areas. Replace timber gate with new.	
12	Approx 2.2m high brick wall with brick on edge to top. Rear boundary partly boarded with osb board	Clean and re-point brickwork. Remove osb boarding and rebuild brick work wall across rear boundary allowing space for new 1.8m high timber gate. Fit new timber gate.	
14	Approx 2.2m high brick wall with brick on edge to top and cut out from previous window. Rear boundary partly boarded with osb board and gate access	Clean and re-point brickwork. Remove osb boarding and rebuild brick work wall across rear boundary allowing space for new 1.8m high timber gate. Fit new timber gate. Infill existing window opening with brickwork to match existing wall.	
16	Approx 1.6m high timber fence to part of rear boundary, with cement panels affixed to bottom of fence and additional cement panels used to make up remaining boundary finish	Remove entirety of existing rear boundary. Fit new timber fence 1/8m high with concrete posts and space for new 1.8m timber access gate.

18	Approx 1.8m high timber fencing with concrete posts and timber gate, concrete base	check condition of existing fence and gate and retain as is if possible	
20	Approx 1.8m high timber fencing with concrete posts and concrete base	check condition of existing fence and retain as is if possible	no gate - add gate?
22	Approx 1.8m high timber fencing with concrete posts and timber gate, concrete base	check condition of existing fence and gate and retain as is if possible	
26	Approx 1.2m high concrete blockwork wall with approx 0.6m high fencing on top. To side stree approx 1.8m high timber fence with timber gate.	Check condition of blockwork wall, re-point and paint. Check condition of timber fence and gate to side boundary, retain as is if possible.	
28	Approx 1.8m high timber fence and gate - painted blue	check condition of existing fence and gate and retain as is if possible	Re-paint fence to match others?

30	Rear boundary missing entirely.	Rebuild rear boundary, install new 1.8m high timber fence with concrete posts including new 1.8m high timber gate.

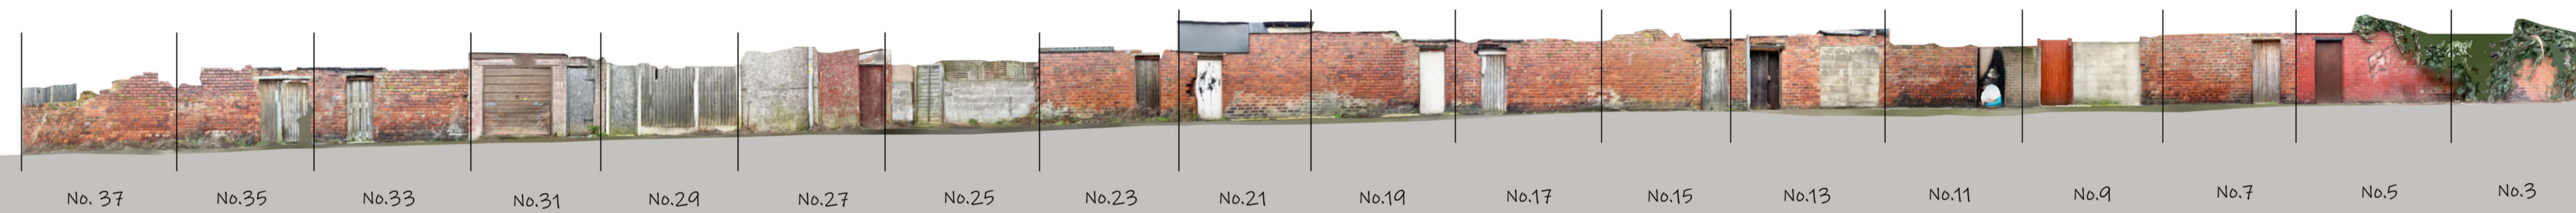
Victoria Street rear alleyway - View B-B			
House no.	Existing Condition	Proposed improvements	Notes
3	Approx 1.6m high brick wall to rear and side, timber access gate to side, overgrown planting	Clean and re-point brickwork, repair any cracks / damage where necessary. Cut back overgrown planting, replace timber gate with new.	
5	Approx 1.8m high brick wall with timber access gate, overgrown planting	Clean and re-point brickwork, repair any damage where necessary, cut back overgrown planting, replace timber gate with new.	
7	Approx 1.8m high brick wall with timber access gate	Clean and re-point brickwork, repair any damage where necessary, replace timber gate with new.	
9	part brick wall, part rendered blockwork wall, timber access gate	Clean and re-point brickwork, repair any damage where necessary, replace timber gate with new. Check condition of rendered wall, either repair and repaint or demolish and rebuild as brickwork wall to match existing

11	Approx 2.2m high brickwork wall with damaged timber access gate	Clean and re-point brickwork and capping, repair where necessary, remove damaged gate and fit new timber gate.	
13	Approx 2.2m high brickwork wall with old garage access infilled with blockwork. Timber access gate	Clean and re-point brickwork and capping, repair where necessary, fit new timber gate. Remove existing blockwork and infill with brickwork to match existing	
15	Approx 2.2m high brickwork wall with timber gate	Clean and re-point brickwork and capping, repair where necessary, fit new timber gate	
17	Approx 2.2m high brickwork wall with timber gate	Clean and re-point brickwork and capping, repair where necessary, fit new timber gate	
19	Approx 2.2m high brickwork wall with timber gate	Clean and re-point brickwork and capping, repair where necessary, fit new timber gate	
21	Approx 2m high brickwork wall with gate, wall topped with metal panelling	remove metal panelling to top of wall, clean and re-point brickwork and repair where necessary, fit new timber gate.

23	Approx 2m high brickwork wall with timber gate	Clean and re-point brickwork. Replace timber gate with new	
25	Approx 1.2m high blockwork wall with approx 0.6m high trellis on top and timber gate	Remove entirety of rear boundary, rebuild new 1.2m high brickwork wall, tie into rear wall of No.23. Top with new 0.6m fence and fit new 1.8m timber gate	
27	Rear boundary is boarded with painted osb chipboard with timber gate fitted	Remove entirety of existing rear boundary. Fit new timber fence 1/8m high with concrete posts and space for new 1.8m timber access gate.	
29	Approx 1.8m high timber fence with concrete posts and chipboard gate	Check condition of existing fence, repair broken panels. Fit new timber gate to match	
31	Existing garage with door and chipboard gate built into brickwork wall	Clean and re-point brickwork. Replace garage door with new and replace metal gte with new timber gate.	Check if access to garage is still needed from alleyway, if not, could brick up garage door to match existing wall

33	Approx 2m high brick wall with capping on top, timber gate.	Clean and re-point brickwork and capping, repair broken brick wall to rear boundary. Remove timber infill panel and brick up to match existing wall, fit new timber gate	
35	Approx 2m high brick wall with capping on top, timber gate and timber fence infill panel.	Clean and re-point brickwork and capping, repair where necessary. Remove and replace timber gate with new timber gate.	
37	Approx 1.2m high brick wall with approx 0.6m high fence on top to rear and side boundary, chipboard gate to side boundary.	Clean and re-point brickwork, repair broken brick wall to rear boundary. Remove and replace timber fence with new, fit new timber gate to side boundary.
