# Preliminary Ecological Appraisal and Roost Assessment

New Inn, Bridge Street, Penistone, S36 7AH

*Conversion of Derelict Out-Building(s) including Construction of Extension into Guest Accommodation & to be used in-conjunction with the existing public house.*

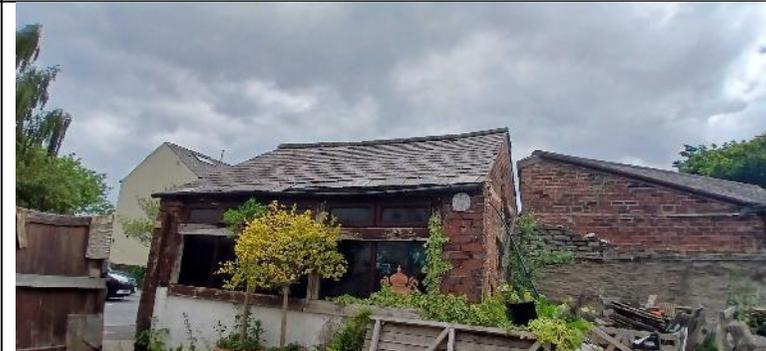
B1 is situated to the northeast of the site boundary. B1 is a brick built, single storey gabled outbuilding with glass windows on the western elevation and a slate tiled roof. The northern elevation of B1 is rendered. B1 is subject to conversion and a southern extension. The building has **moderate habitat value**.

| | <p>Two bat emergence/re-entry surveys are required on B1 and B2 during the active bat season (May – September) to confirm presence/likely-absence of bats roosting in or on the building. These survey visits should be completed during the optimal survey period mid-May to August inclusive. The survey visits should be at least three weeks apart. Five surveyors equipped with infrared cameras are required to provide full coverage of the building’s elevations to look for emerging/re-entering bats. Lighting mitigation may be required based on the outcome of the night bat survey(s). If any bat roosts are confirmed from this survey schedule, a bat licence would be required to demolish the buildings as it would involve the destruction of roosts. This is applied for with the help of a class 2 licensed bat ecologist after planning permission is granted, but before commencement of works.</p> <p><b>Foraging and commuting habitat</b><br/>No further surveys are required.</p> <p><b>Artificial lighting</b><br/>A low impact lighting strategy will be adopted for the site during post-development which outlines the areas of the site that will be retained as dark corridors. Parameters can be found on the Bat Conservation Trust website:<br/><a href="https://www.bats.org.uk/our-work/buildings-planning-and-development/lighting-2">https://www.bats.org.uk/our-work/buildings-planning-and-development/lighting-2</a></p> <p><b>Suggested biodiversity enhancements</b><br/>Enhancements are dependent on the outcome of further surveys.</p> |

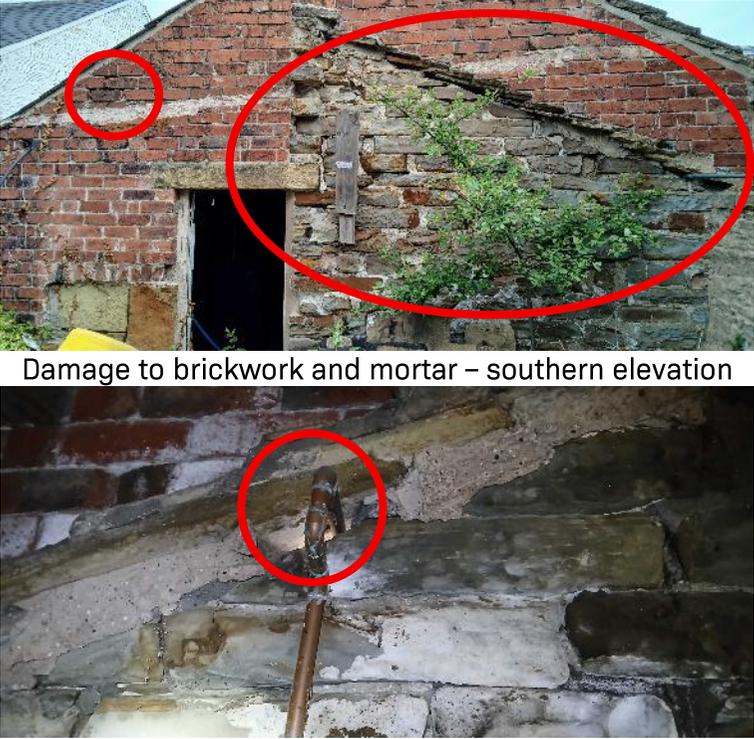
| Feature | Materials | Condition/description/suitability | Photograph(s) |
|---|---|--|--|
| Walls | Brick | <p>The walls of B1 are brick built and non-rendered apart from the northern elevation which has white rendering. There is significant damage to the brickwork and mortar on the southern elevation of B1. These crevices are suitable to support individual crevice dwelling bat species for a transient period. There is a void on this elevation where a pipe has been thread through the brick. There appears to be missing mortar beside this pipe which has weathered away leaving a small gap large enough to permit ingress into the internal for both crevice and void dwelling species.</p> | <p>Damage to brickwork and mortar – southern elevation</p> <p>Gap in brickwork of B1</p> |

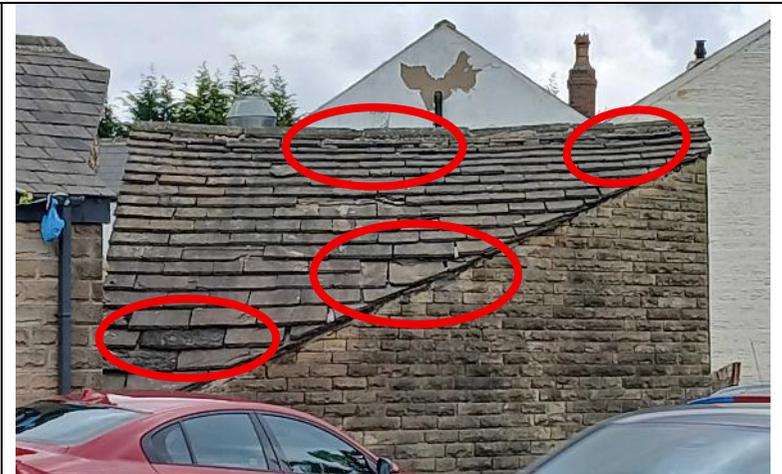
| <p>Roof</p> | <p>Slate tiles</p> | <p>The roof of B1 is comprised of slate tiles of which several are lifted, slipped or missing entirely. Such features are suitable to provide roosting habitat for crevice dwelling species. The missing tile on the eastern elevation permits daylight into the internal void and is suitable ingress point for void dwelling species.</p> <p>There is a gap beneath the gable apex on the northern elevation. This is suitable for crevice dwelling species.</p> |

Missing and lifted tiles on eastern elevation of B1

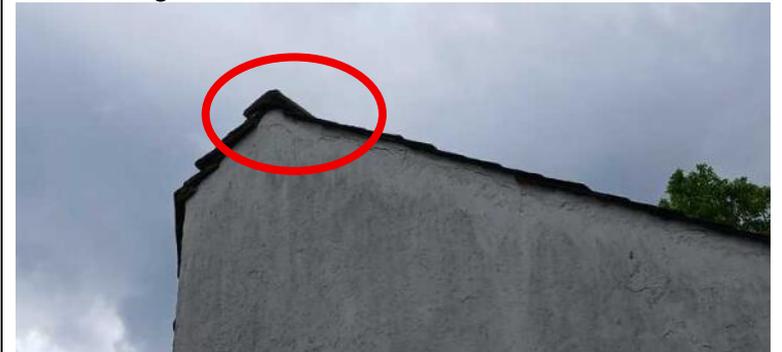
Gap beneath gable apex on northern elevation

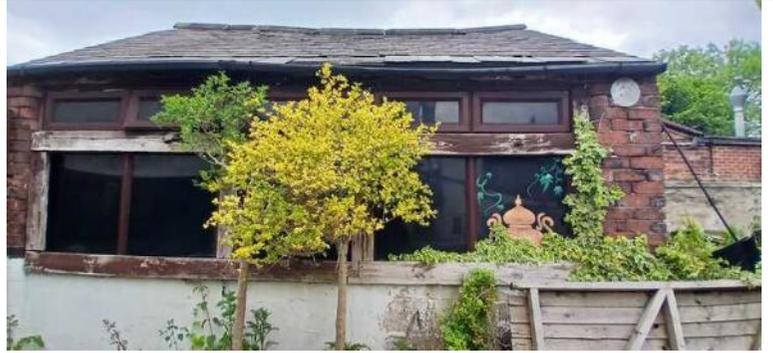
| <p>Window/doors frames and lintels</p> | <p>Glass and PVC trimming</p> | <p>There are windows on the western elevation. Apart from some cosmetic damage the trimmings and frames were in good condition with no damage.</p> | <p>Windows on western elevation of B1</p> |

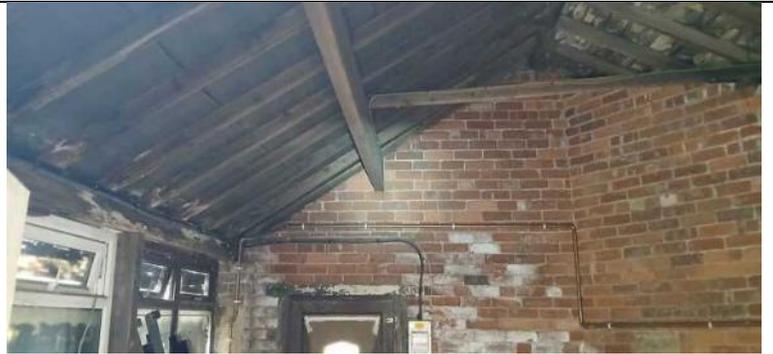
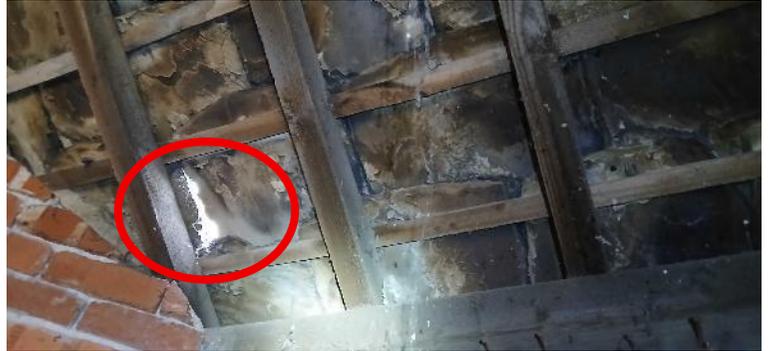
| <p>Internal voids</p> | <p>Timber rafters, non-permeable lining and clay insulation</p> | <p>B1 has no loft void, and the roof is visible from the ground level. The western aspect of the roof is lined with non-permeable membrane which has suffered rot damage. The eastern aspect of the roof has no lining and instead the clay insulation is bare and visible. The absence of lining on this aspect reduces the suitability of the internal void for crevice dwelling species. The roof is supported by a timber beam structure which, like the lining, has suffered rot damage. There is a missing tile on the eastern elevation which allows daylight to permit into the internal void. This gap is suitable access point for void and crevice dwelling species. The interior dimensions of the void are 5m L x 5.4m W x 3.7m H and the following internal conditions were recorded; 16.7°C and 58% relative humidity. No evidence of bats such as live animals, droppings, foraging remains were identified within B1.</p> | <p>Interior of B1</p> <p>Missing tile on the eastern roof aspect of B1</p> |

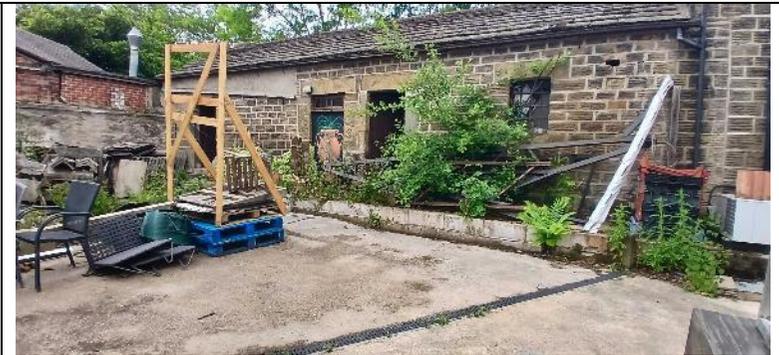
B2 is situated to the south of the site boundary. B2 is a brick built, single storey gabled outbuilding with a slate tiled roof. B2 has wooden soffit boards along the northern elevation. B2 is separated into two internal voids. B2 is adjoined to another building via the western elevation. A walkover of this building was conducted to assess its habitat value for roosting bats and details can be provided on request. B2 is subject to conversion and a southern extension. The building has **moderate habitat value**.

B2 – northern elevation

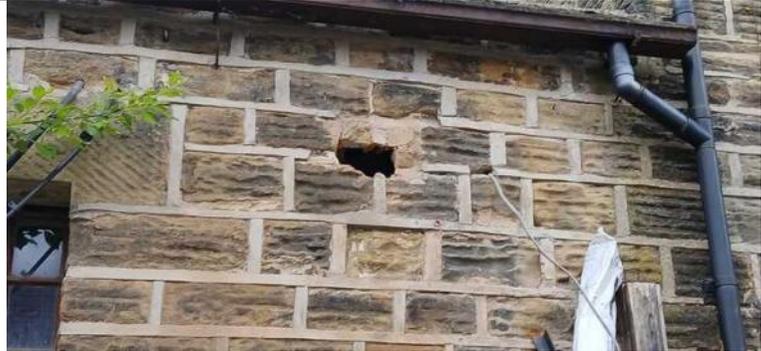
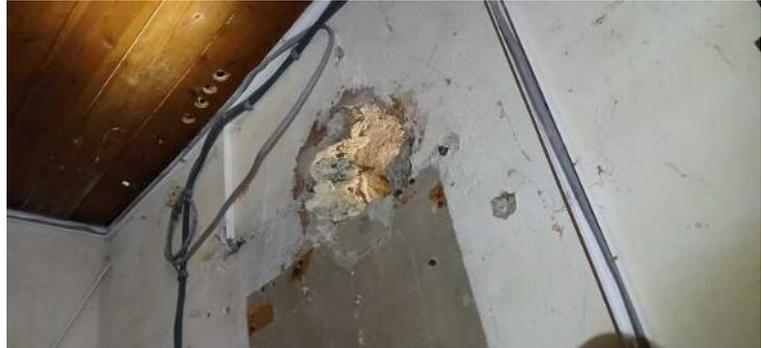
| Feature | Materials | Condition/description/suitability | Photograph(s) |
|---|---|--|--|
| Walls | Brick built | The walls of B2 are in good condition for the most part with minimal areas of damage or missing mortar. There is one gap in the brickwork on the northern elevation which leads into the internal of B2. This gap is suitable to allow access into the internal for crevice and void dwelling bat species. | <p data-bbox="1384 1018 1921 1050">Gap in brickwork on northern elevation of B2</p> |

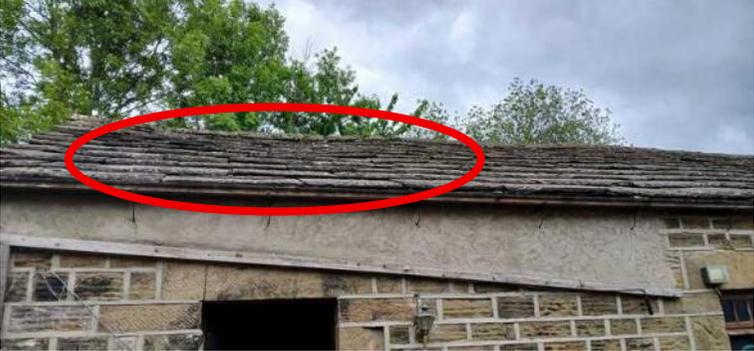
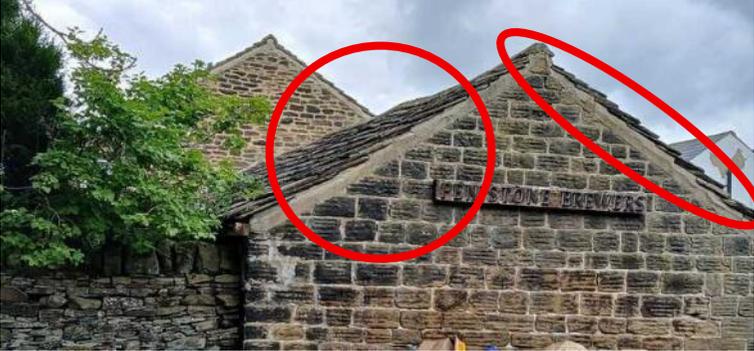
| <p>Roof</p> | <p>Slate tiles</p> | <p>There is a high volume of lifted tiles on both the northern and southern roof aspect. All of these features are suitable for crevice dwelling bats to roost within. There is a gap underneath the eastern gable apex which is also suitable for crevice dwelling bat species.</p> | <p>Showing gap extends into the interior of B2</p> <p>Lifted tiles on northern elevation</p> <p>Lifted tiles present on southern elevation</p> |

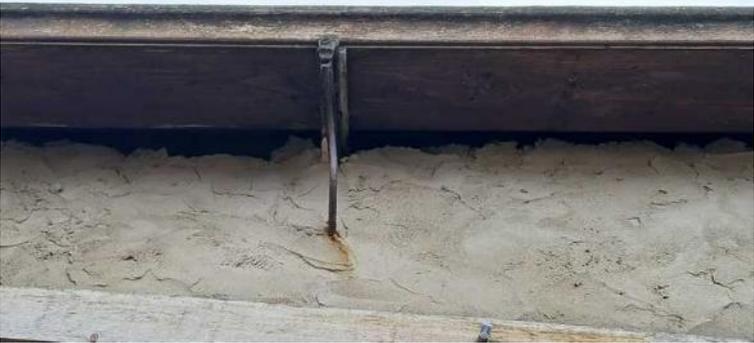
| <p>Barge boards/fascia boards</p> | <p>Wooden soffit boards</p> | <p>There is a section of wooden soffit boards on the northern elevation. There is a gap behind this soffit board for a significant stretch of the northern elevation. This gap is considered suitable for crevice and void dwelling bat species to gain access into the interior of the structure.</p> | <p>Gap beneath soffits on northern elevation</p> |

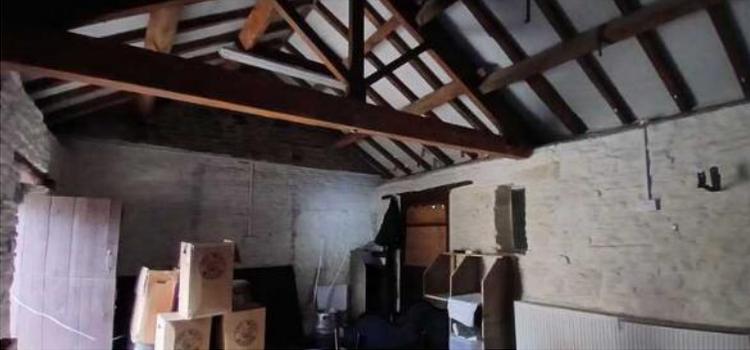
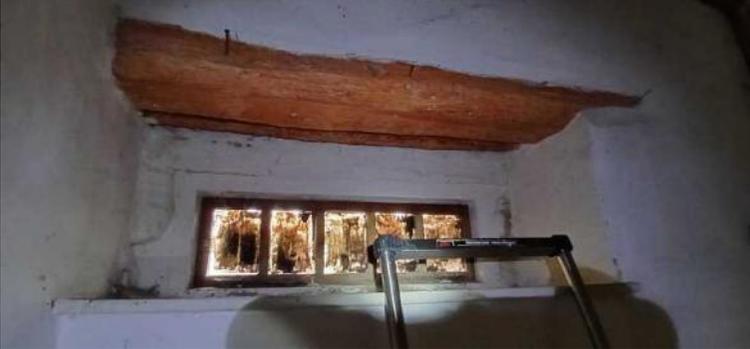
| <p>Internal voids</p> | <p>Timber rafters, non-permeable lining</p> | <p>B2 has no loft void, and the roof is visible from the ground level. The tiles are lined with a non-permeable membrane which is in excellent condition with no areas of tearing or sagging. The roof is supported by a timber beam truss structure. The timber beams are in good condition and are suitable for void dwelling species to roost against. Within the void there are two timber lintels situated over a small window and ledge. There is a linear gap between the two lintels which extends ~10cm deep. This feature is considered suitable for crevice and void dwelling species to roost within. The interior dimensions of the void are 11m L x 4.2m W x 3.9m H and the following internal conditions were recorded; 17.9°C and 54% relative humidity.</p> <p>No evidence of bats such as live animals, droppings, foraging remains were identified within B2.</p> | <p>Interior void of B2</p> <p>Feature between timber lintels within interior of B2</p> |

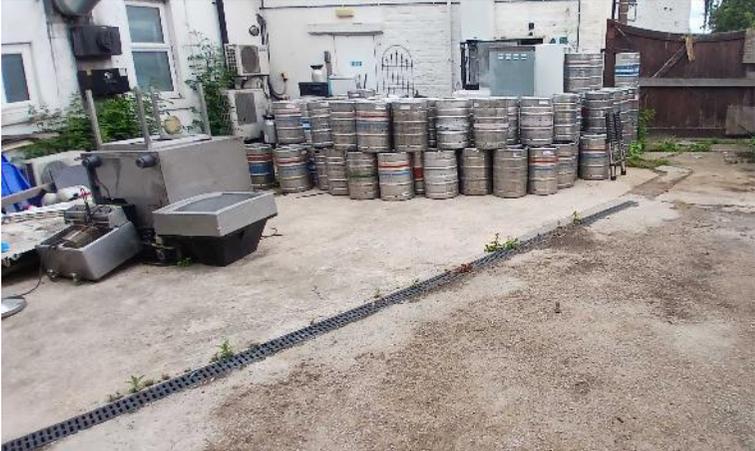
| Buildings | |
|---|--|
| | Figure 1: Hardstanding on site. |

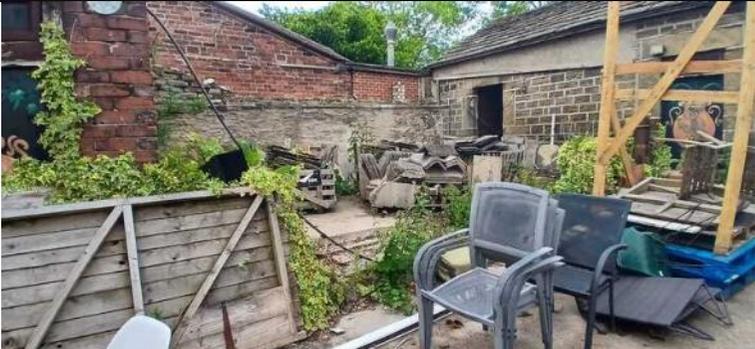
| Buildings | |
|---|--|
| | Figure 2: Showing sparsely vegetated land. |
