# **River Dearne, Smithies - Habitat Creation Feasibility Study**

**Final Report**

**June 2015**

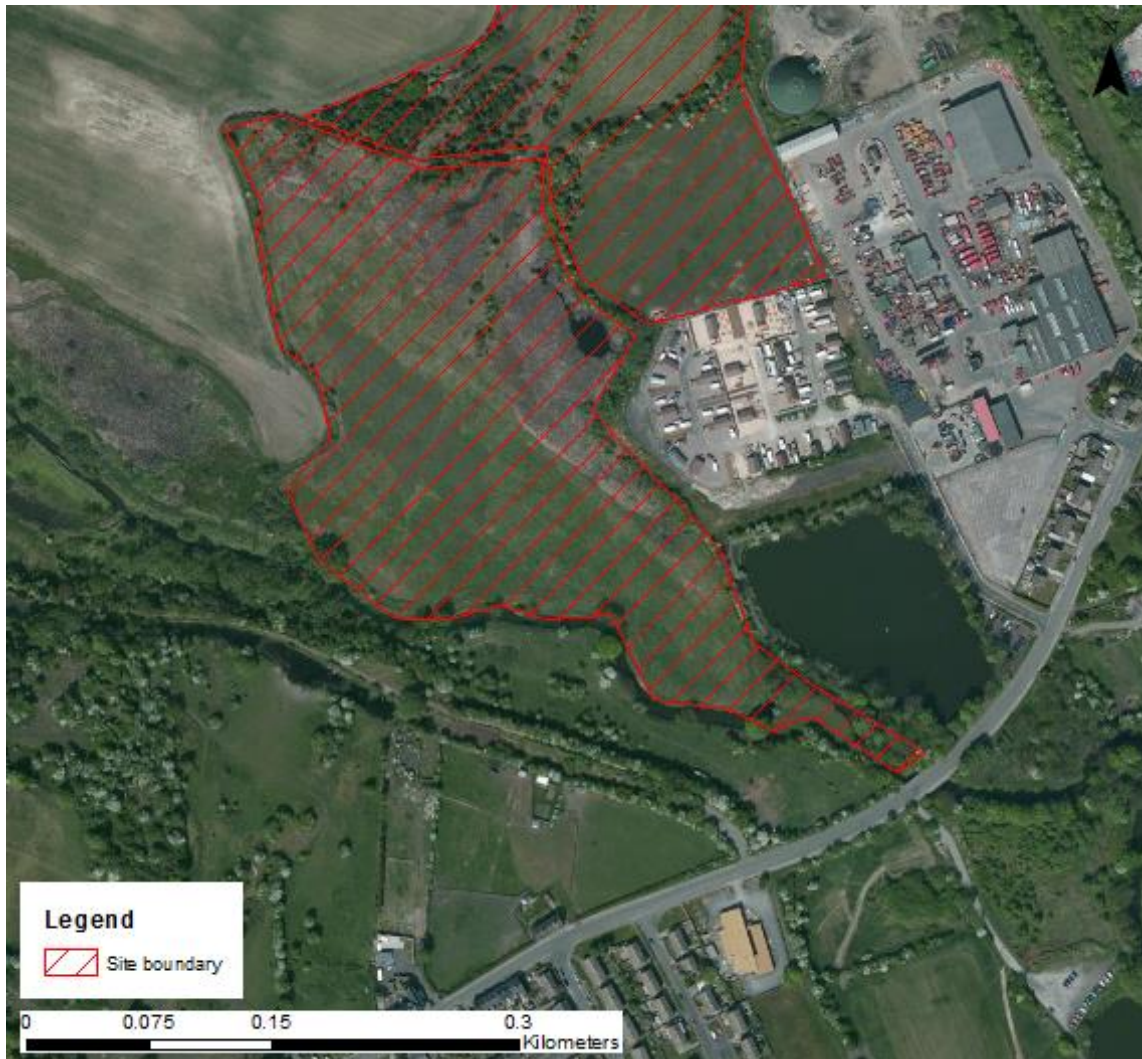
Figure 2-3: The River Dearne in the vicinity of the proposed site boundary

The approximate length of the hydromorphic field audit study reach is shown in Figure 2-3 below. Wider catchment processes have been assessed as part of this desktop study. The River Dearne is a low-gradient channel throughout the majority of the hydromorphic audit study extent.

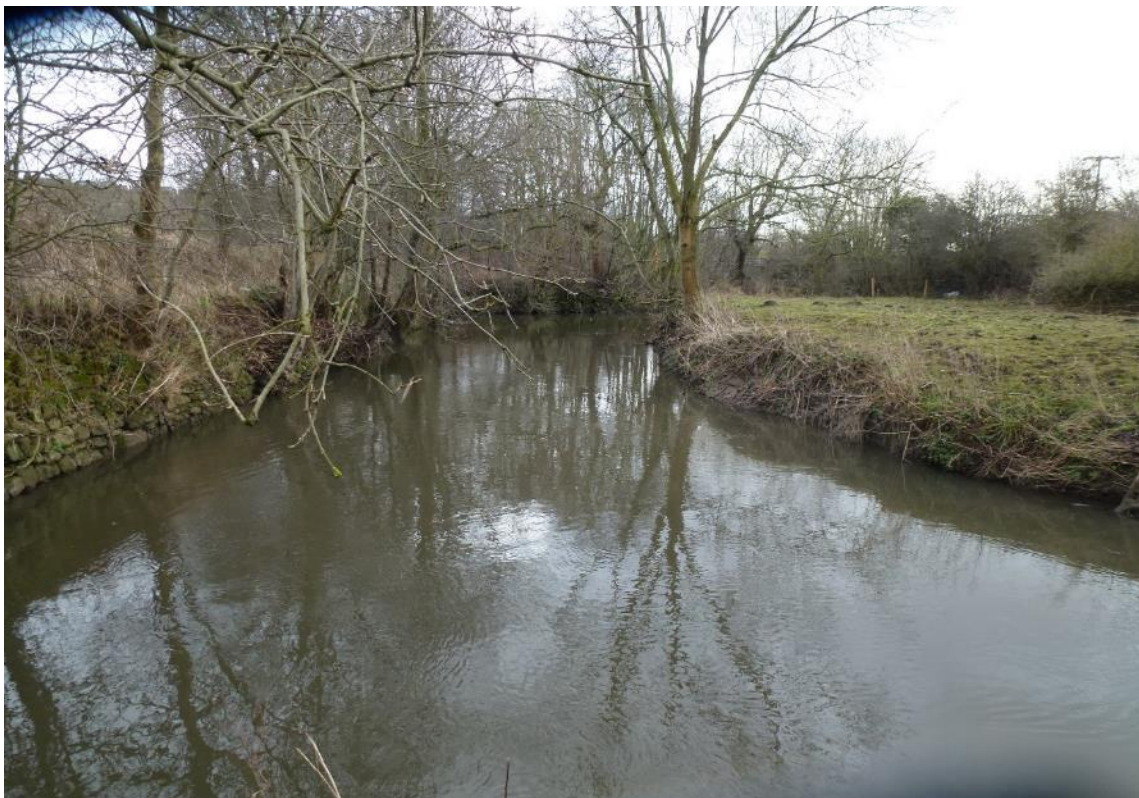
- a. the bed is primarily composed of gravel, partially infilled with fine sediment in places due to the oversized nature of the channel in this section, and;
- b. under normal flow conditions this section will contain some embryonic/ limited riffled sections and deeper pool areas, with glide biotopes also common in areas where there is a monotonous flow depth.

Figure 2-4: Downstream section of the River Dearne, to the west of the Smithies Lane road bridge

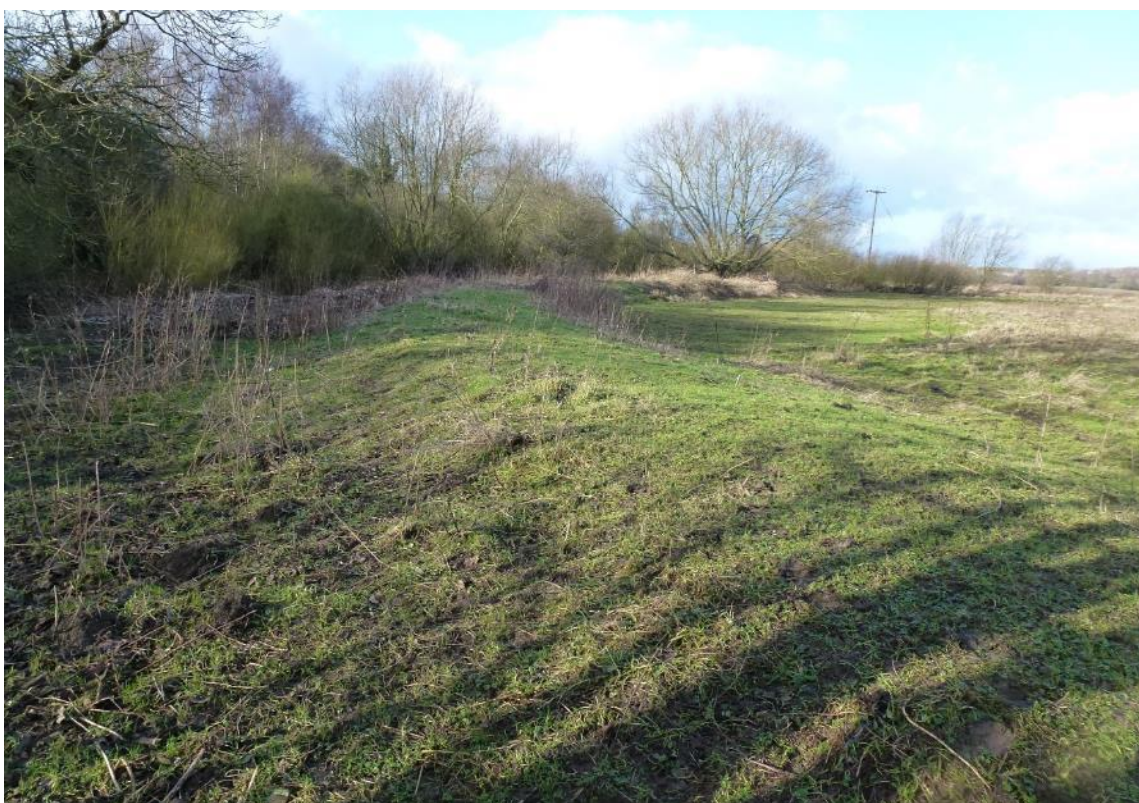
To the south-west corner of the site boundary, a flood embankment on the left bank is reducing floodplain connectivity (Figure 2-5); this is currently protecting agricultural land.

Figure 2-5: Left bank flood embankment to the southwest of the site

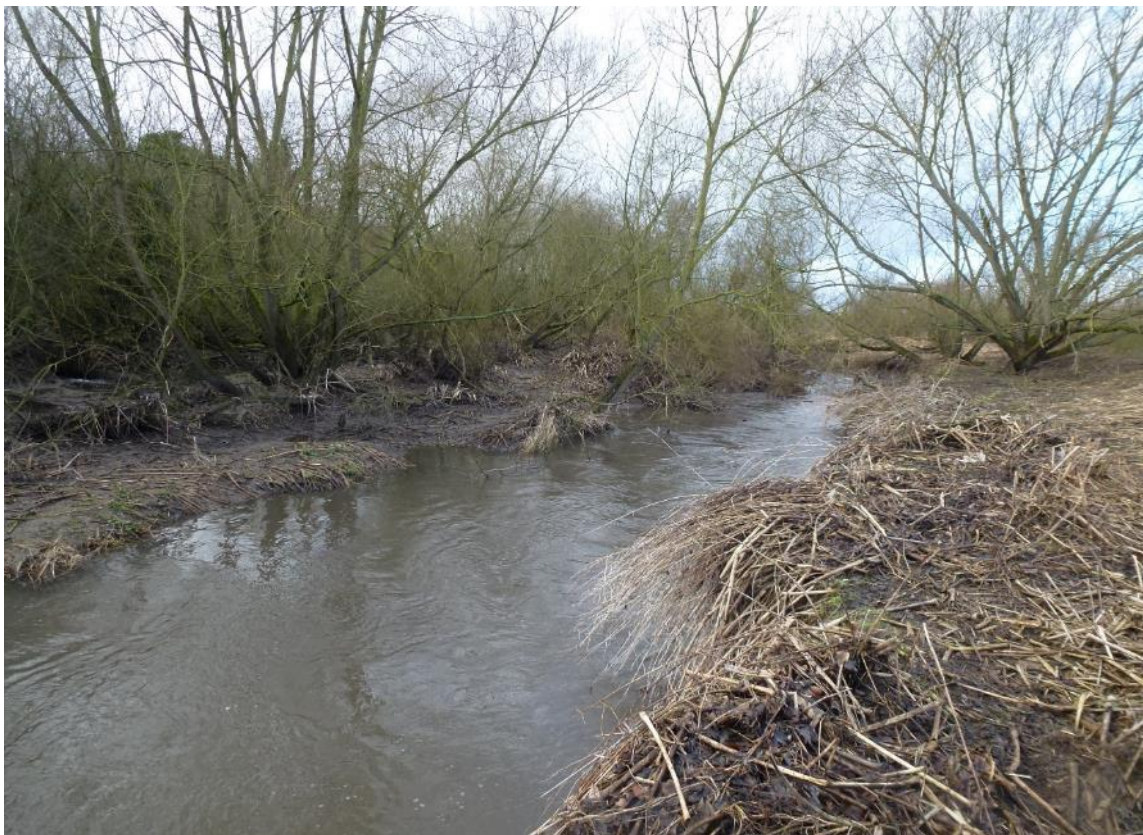
Further upstream, there is better flow and bed diversity in the wet woodland section that is well connected to the main channel (Figure 2-6). Here the channel takes on a semi-anastomosed nature, where the river is composed of multiple channels that divide and reconnect, separated by semi-permanent, cohesive banks. At higher flows, the various sub-channels of the anastomosed system are activated, spreading flow across a wider surface area, creating stable flow and channel conditions. This river type is assisted by the frequent presence of woody debris in the channel, that creates locally elevated water levels behind the features, improving the frequency of connection of the anastomosed channels. The main channel is narrower compared to the downstream section and there is better connectivity to the right bank floodplain. Woody debris is frequent, causing local narrowing of the channel, increasing flow velocity and allowing the exposure of some gravel beds, as a result of locally heightened energy levels that promote transport of fine sediment rather than deposition.

Figure 2-6: Wet woodland section

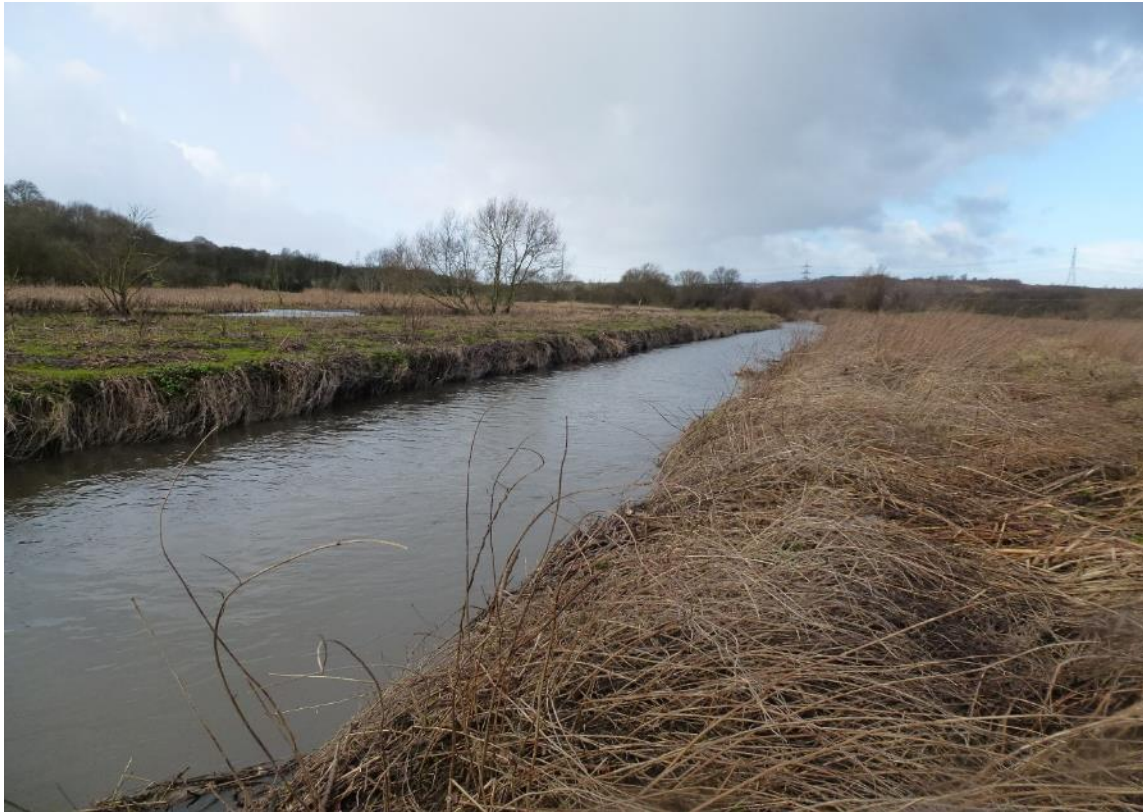
Further upstream of the wet woodland section, the straightened section is a monotonous glide with bank slumping due to incision and/ or overdeepening (Figure 2-7).

Figure 2-7: Glide biotope upstream of the Smithies site

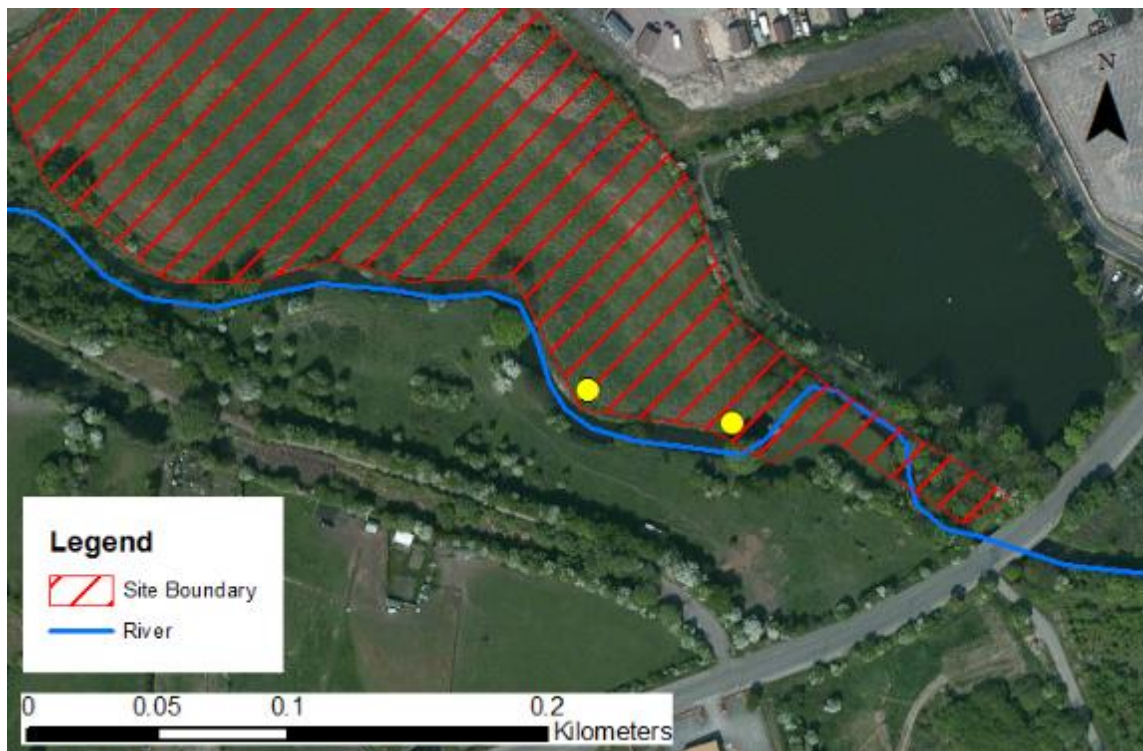
Figure 2-8: Possible locations for creation of a point bar at the downstream end of the site

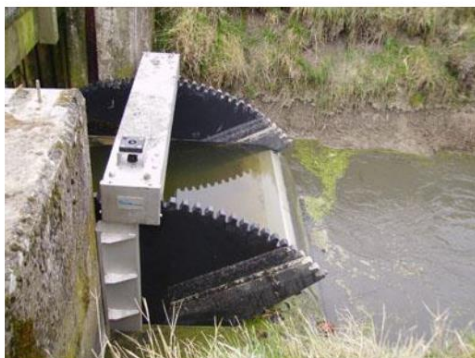
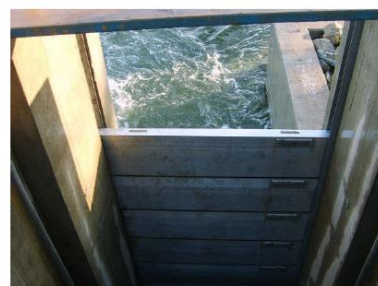
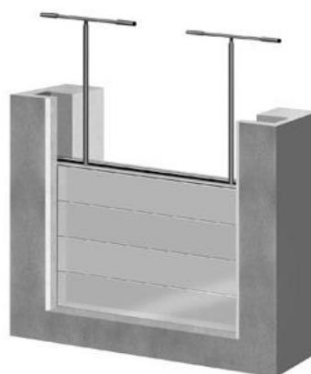
Tilting Weir

Stop Log

Figure 7-5: Example of drain control structures

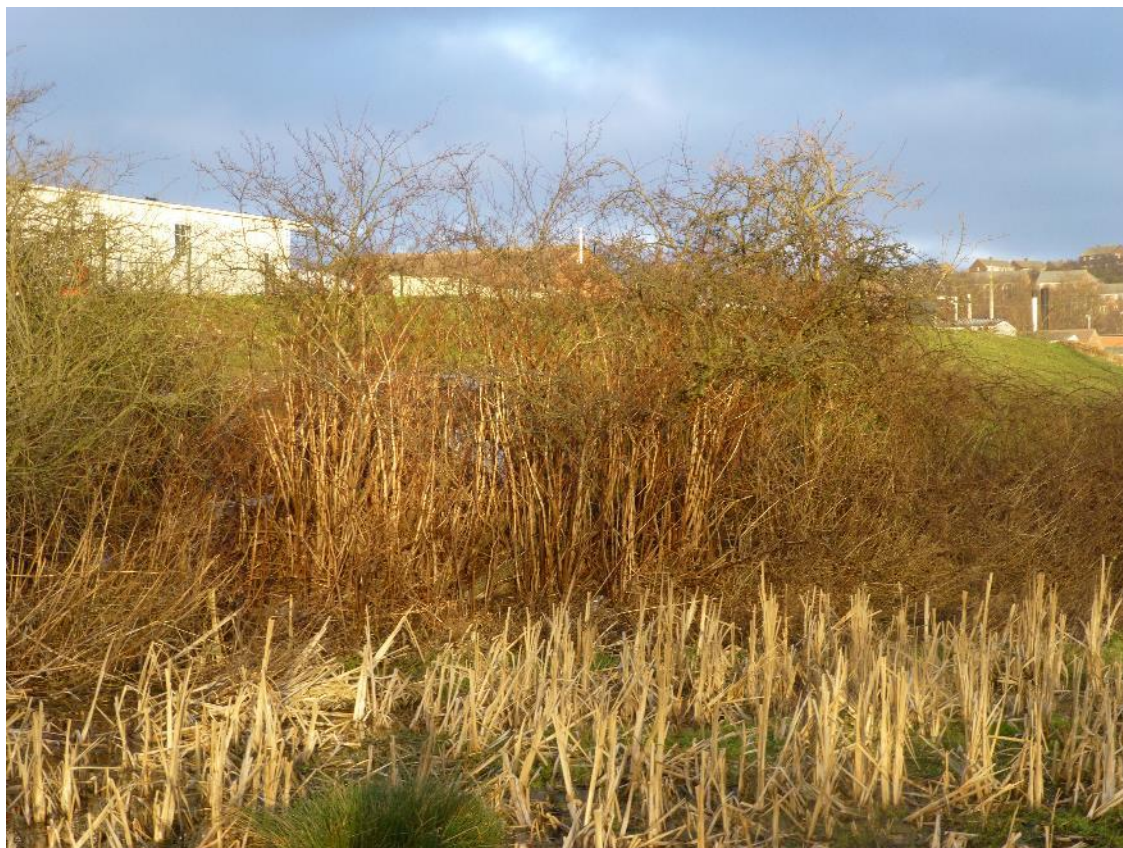
Figure D-1-2: Japanese Knotweed Stand on eastern site boundary

The presence of the non-native invasive species Himalayan Balsam *Impatiens glanulifera* and Japanese Knotweed *Fallopia japonica* on the site was identified from the data provided and also the site visit. Japanese Knotweed is present on the left drain bank, running along the eastern boundary, between the site and the traveller site. Himalayan Balsam is frequent, in particular in the south-west of the site, in the wet woodland area.

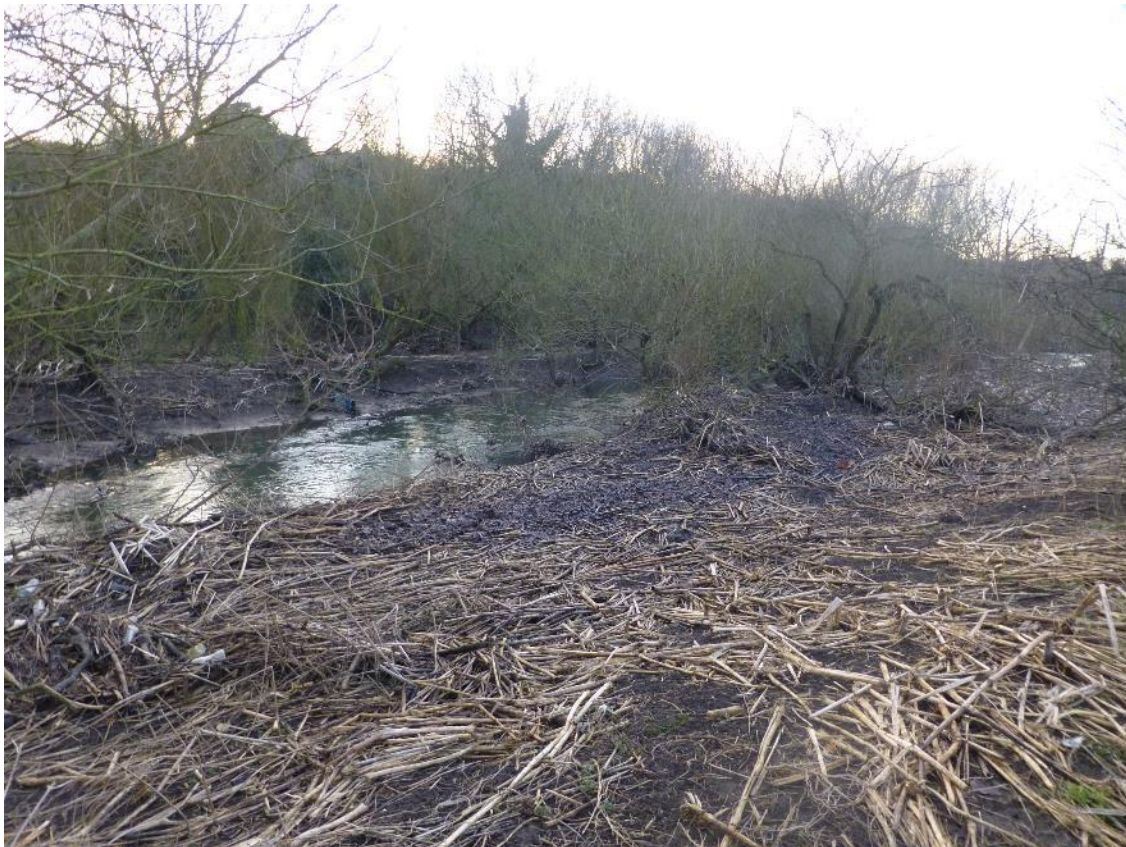
Figure D-1-3: Evidence of Himalayan Balsam infestation in south-west of site, evident from numerous dead canes on the ground

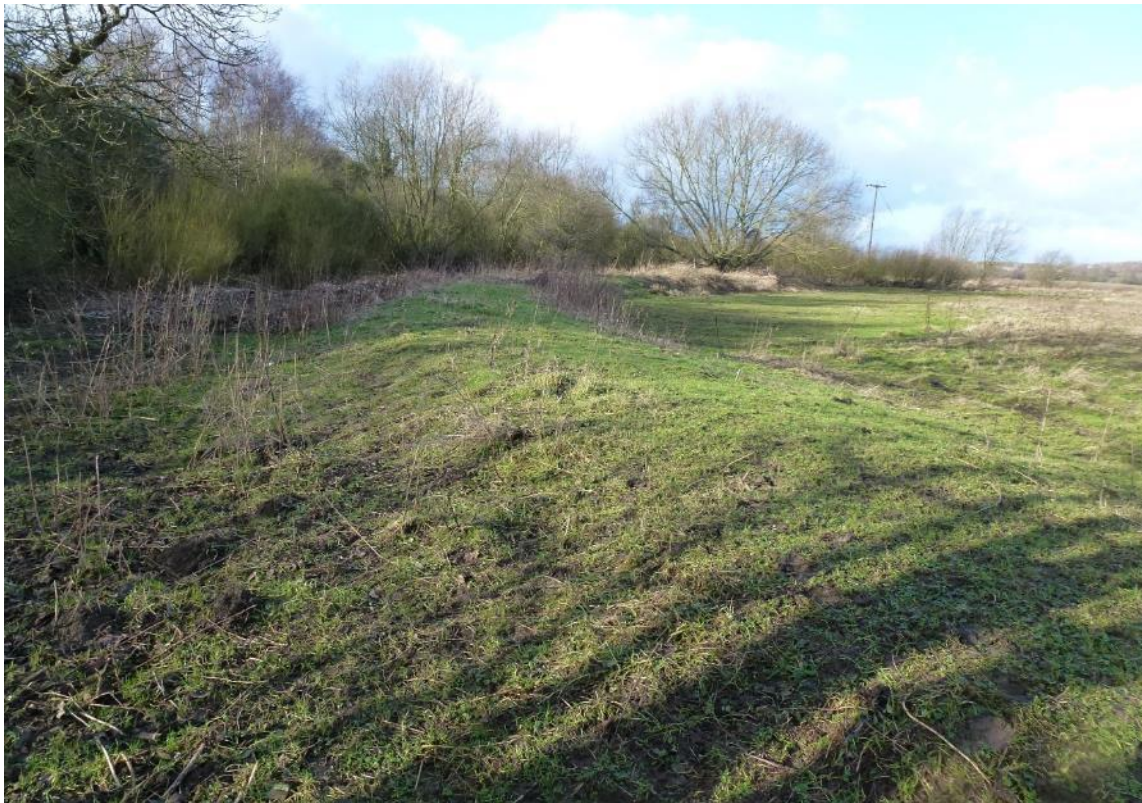
Figure 1-2 also shows an area of flood defences on-site. The site walkover identified sections of flood defences on-site (see Figure 1-3), but these did not relate spatially to those shown on Figure 1-2.

**Figure 1-3: Flood Defence on Site**
