**Whitcher Wildlife Ltd.  
Ecological Consultants.**

**1 CHURCH HILL, ROYSTON.**

**PRELIMINARY ROOST ASSESSMENT.**

**Ref No: 240402.**

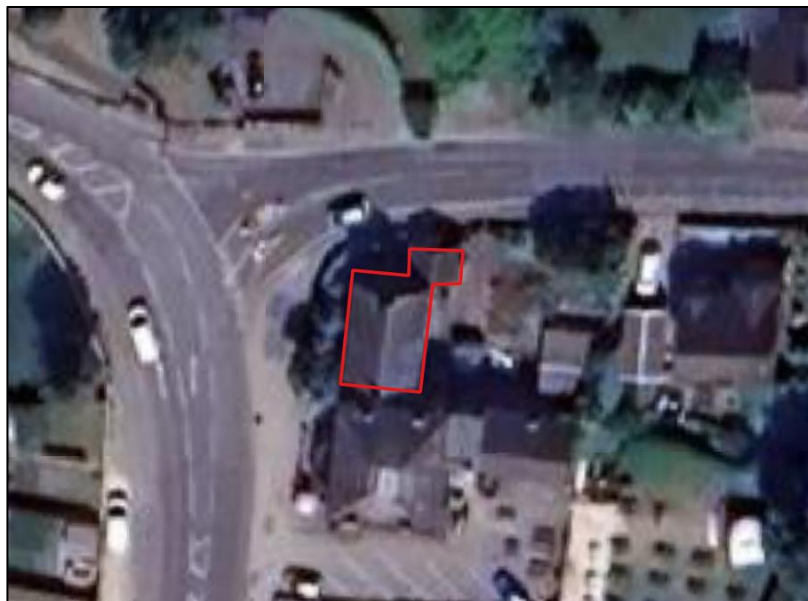
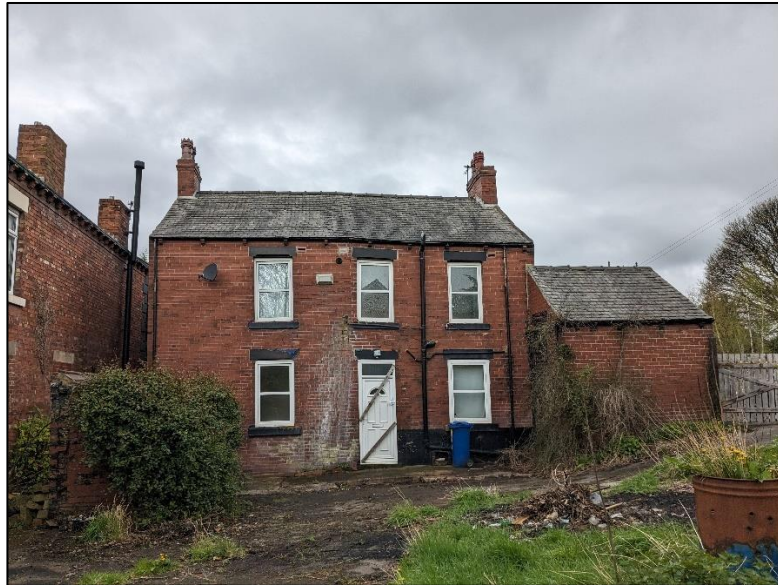
3.2.3. The survey area comprises a two-storey residential dwelling with a single-storey extension which has been used as a commercial premises. The building surveyed is outlined in red in the aerial map below.

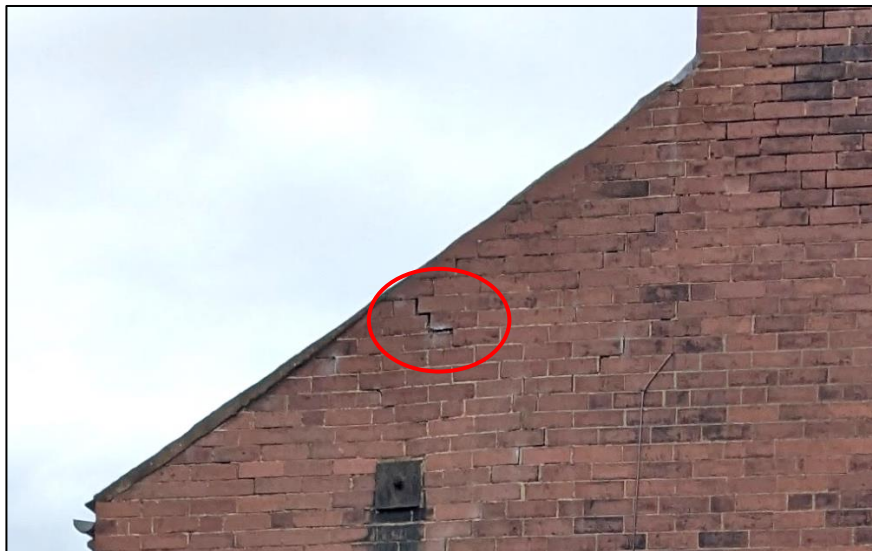
3.3.1. The building comprises a brick-built two-storey residential dwelling with a brick-built single-storey extension. Most areas of the walls are in good condition with no cracks, gaps or crevices suitable for roosting bats. However, on the northern-facing gable end wall, there is a fracture in the brickwork with an open gap which provides potential access into the loft space.

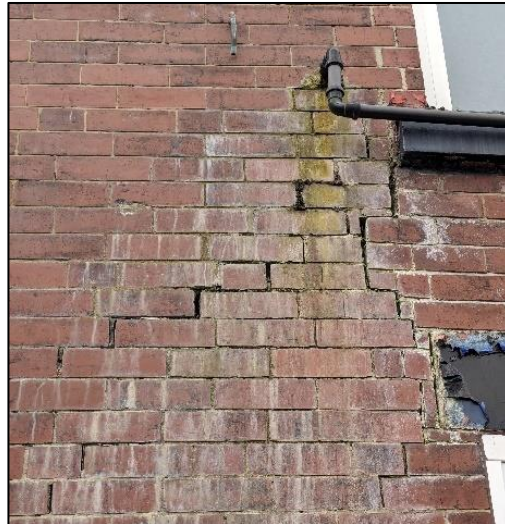
3.3.2. On the east-facing wall there are cracks and areas of missing mortar, but these are shallow. A pipe entering the wall just above these defects is leaking, causing water to drip down the wall, causing the staining seen in the photograph below. The water has likely caused the mortar in this area to perish faster than other areas, and is

also likely to result in the defects being consistently wet. These defects are therefore unlikely to be used as a potential roost feature by bats as they are too wet and too shallow. The windows and doors were also well sealed with no potential for roosting bats.

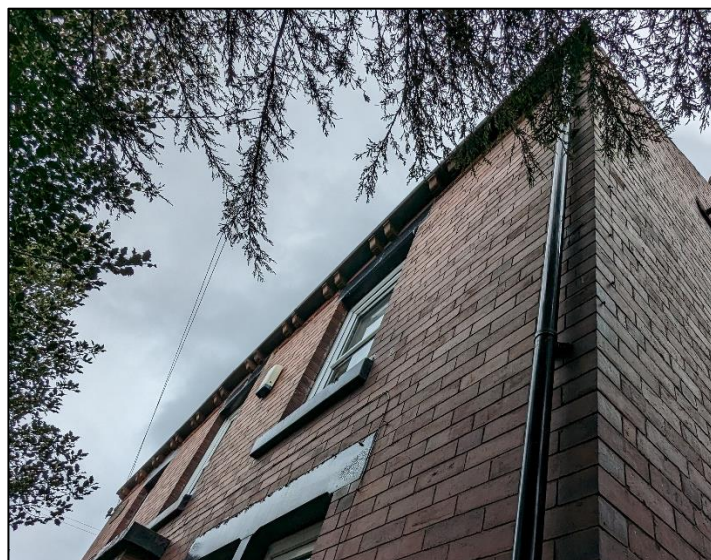
3.3.3. There are no soffits or fascias anywhere around building, but there is guttering on the western and eastern facing walls which could hide any potential access points in the eaves.

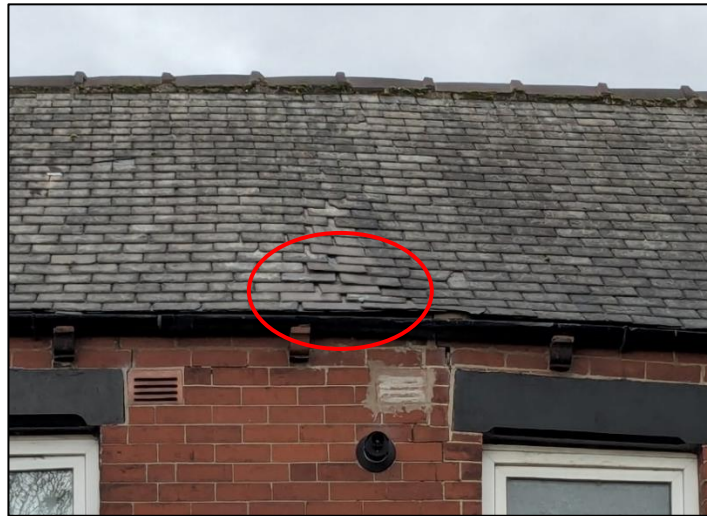
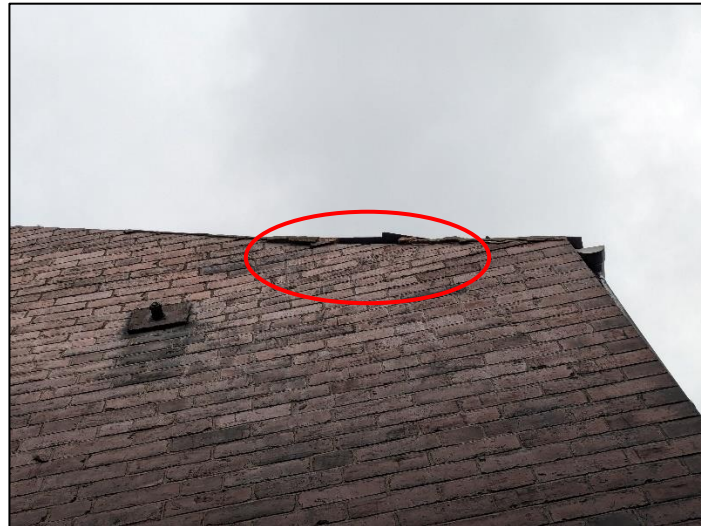
3.3.4. The roof of the two-storey building is a pitched roof, with gable end walls at the northern and southern ends. The roof is covered in slate tiles, which are mostly intact and in good condition. There is a section in the middle of the roof where there are slipped tiles, providing potential access into the roof space for bats, shown in the

photographs below. There is also a section of missing mortar underneath the tiles on the southern gable end, also shown in the photographs below.

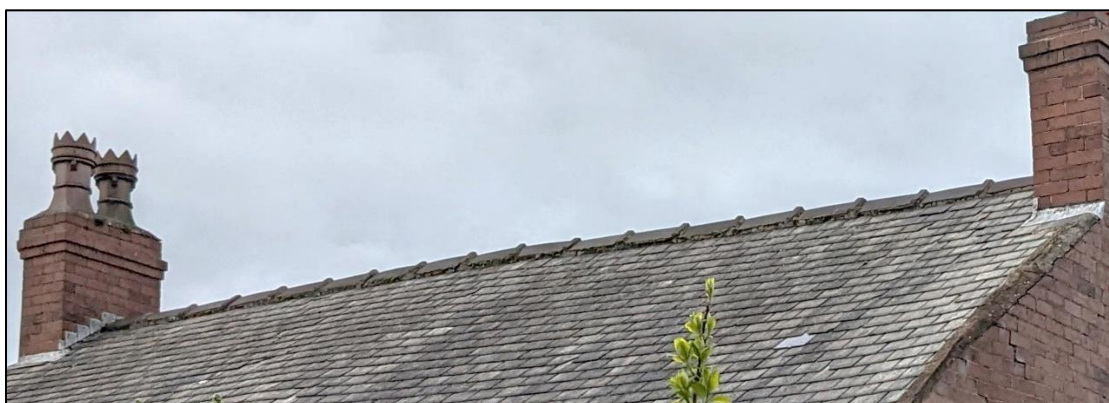
3.3.5. The ridge tiles on the two-storey part of the building are in good condition with no areas of missing mortar or gaps between the tiles.

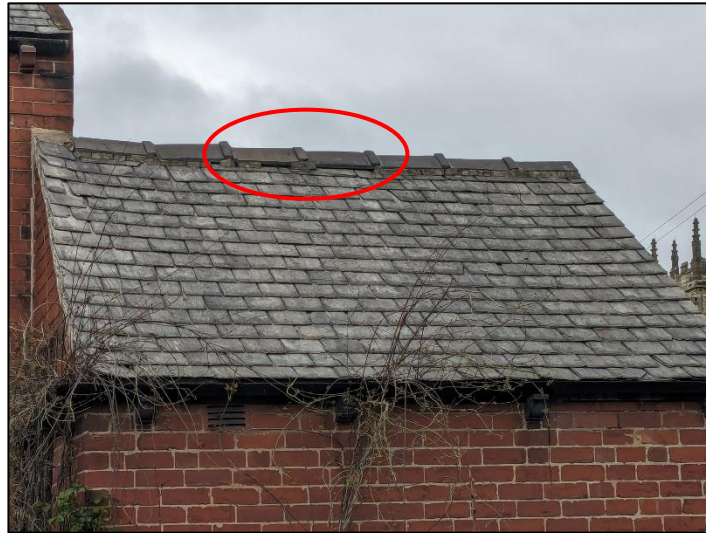
3.3.6. The roof of the single-storey extension is also a pitched roof covered by slate tiles which are in good condition, with no damaged or slipped tiles. However, the ridge tiles have areas of missing mortar which could provide potential roosting opportunities for bats.

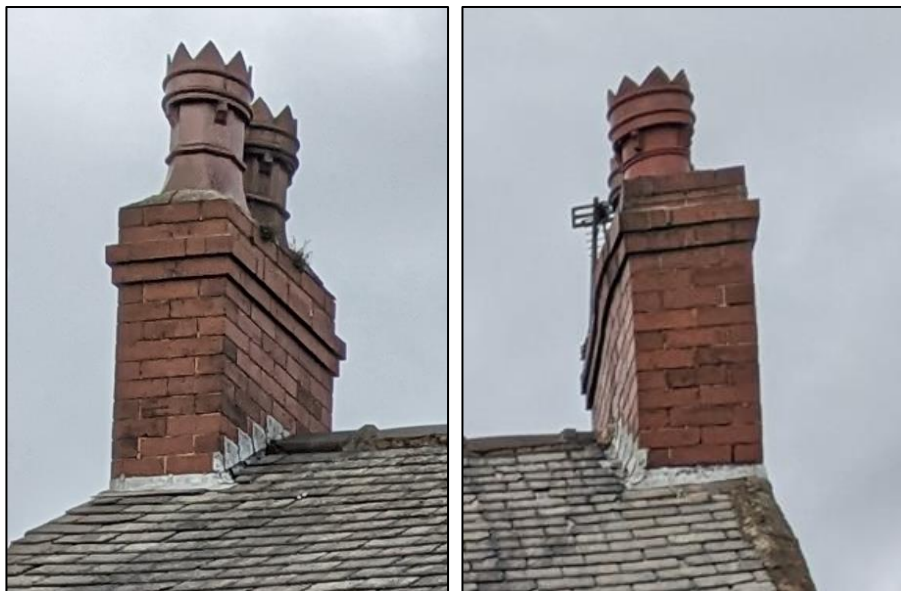
3.3.7. The chimneys are in good condition with no defects in the brickwork. The lead flashing is also in good condition with no areas of lifting.

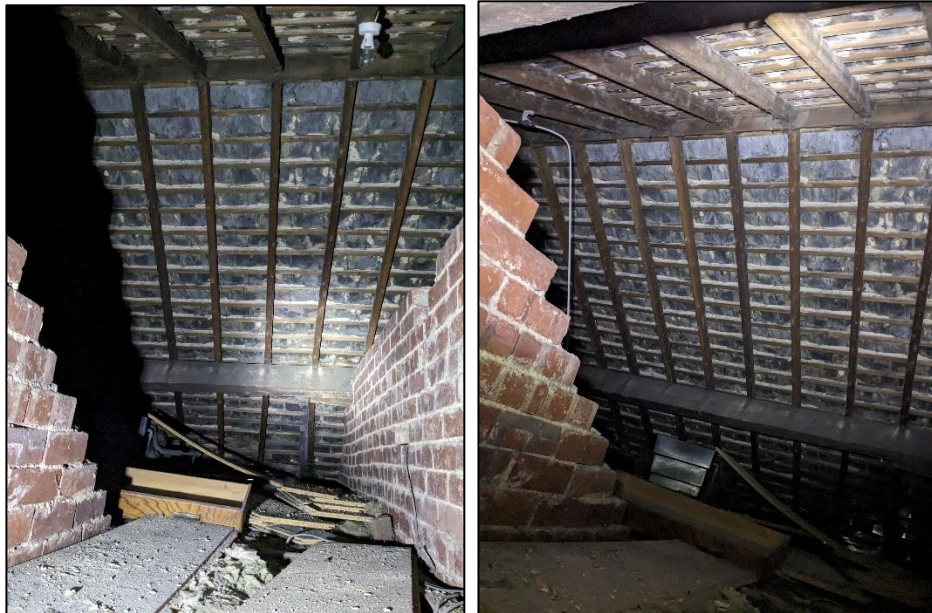
3.3.8. The loft space was accessed within the two-storey section of the building, but this could not be thoroughly inspected due to brick walls separating parts of the loft space, and lack of safe access into the separated areas. The inside of the single-storey extension could not be accessed during this survey, so it is unknown whether there is

any loft space in this part of the building. The photographs below show the typical nature of the loft in the two-storey part of the building.

3.3.9. The roof is supported by modern roof timbers and is unlined. No daylight was visible in the parts of the roof viewed. However, as previously identified, there could be access into the roof from defects on the gable ends or from other areas of slipped tiles not visible at this location within the roof space.

3.3.10. No bats or bat field signs were found within the accessible areas of the roof space.

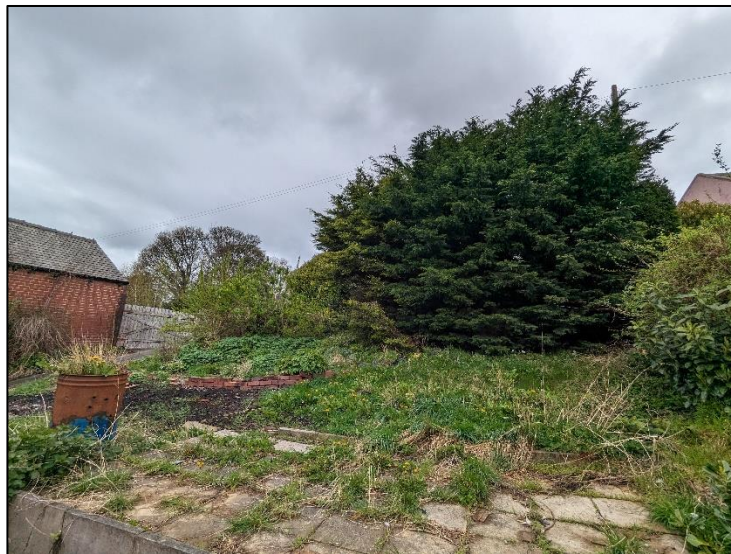
3.3.13. No evidence of nesting birds was identified within the building. However, the access points into the roof space could provide potential nesting habitat for birds. Furthermore, there are a small number of garden shrubs and mature conifers in the gardens which could provide potential nesting habitat for birds.

5.3. It is recommended that where possible the demolition and any external works are carried out outside of the nesting bird season. Where this is not possible, it is recommended that they are immediately preceded by a nesting bird survey to identify if there are any nesting birds present. If any active nests are found, a buffer zone around them should be left and no works should be carried out that will disturb the nest or prevent the birds from accessing to and from the nest, until the young have fledged.
