**PHASE 2 GEOTECHNICAL AND  
GEO-ENVIRONMENTAL SITE INVESTIGATION REPORT**

**LAND AT UPPER HOYLAND ROAD,  
BARNSELY**

**LOW FARM PROPERTIES**

41677-001

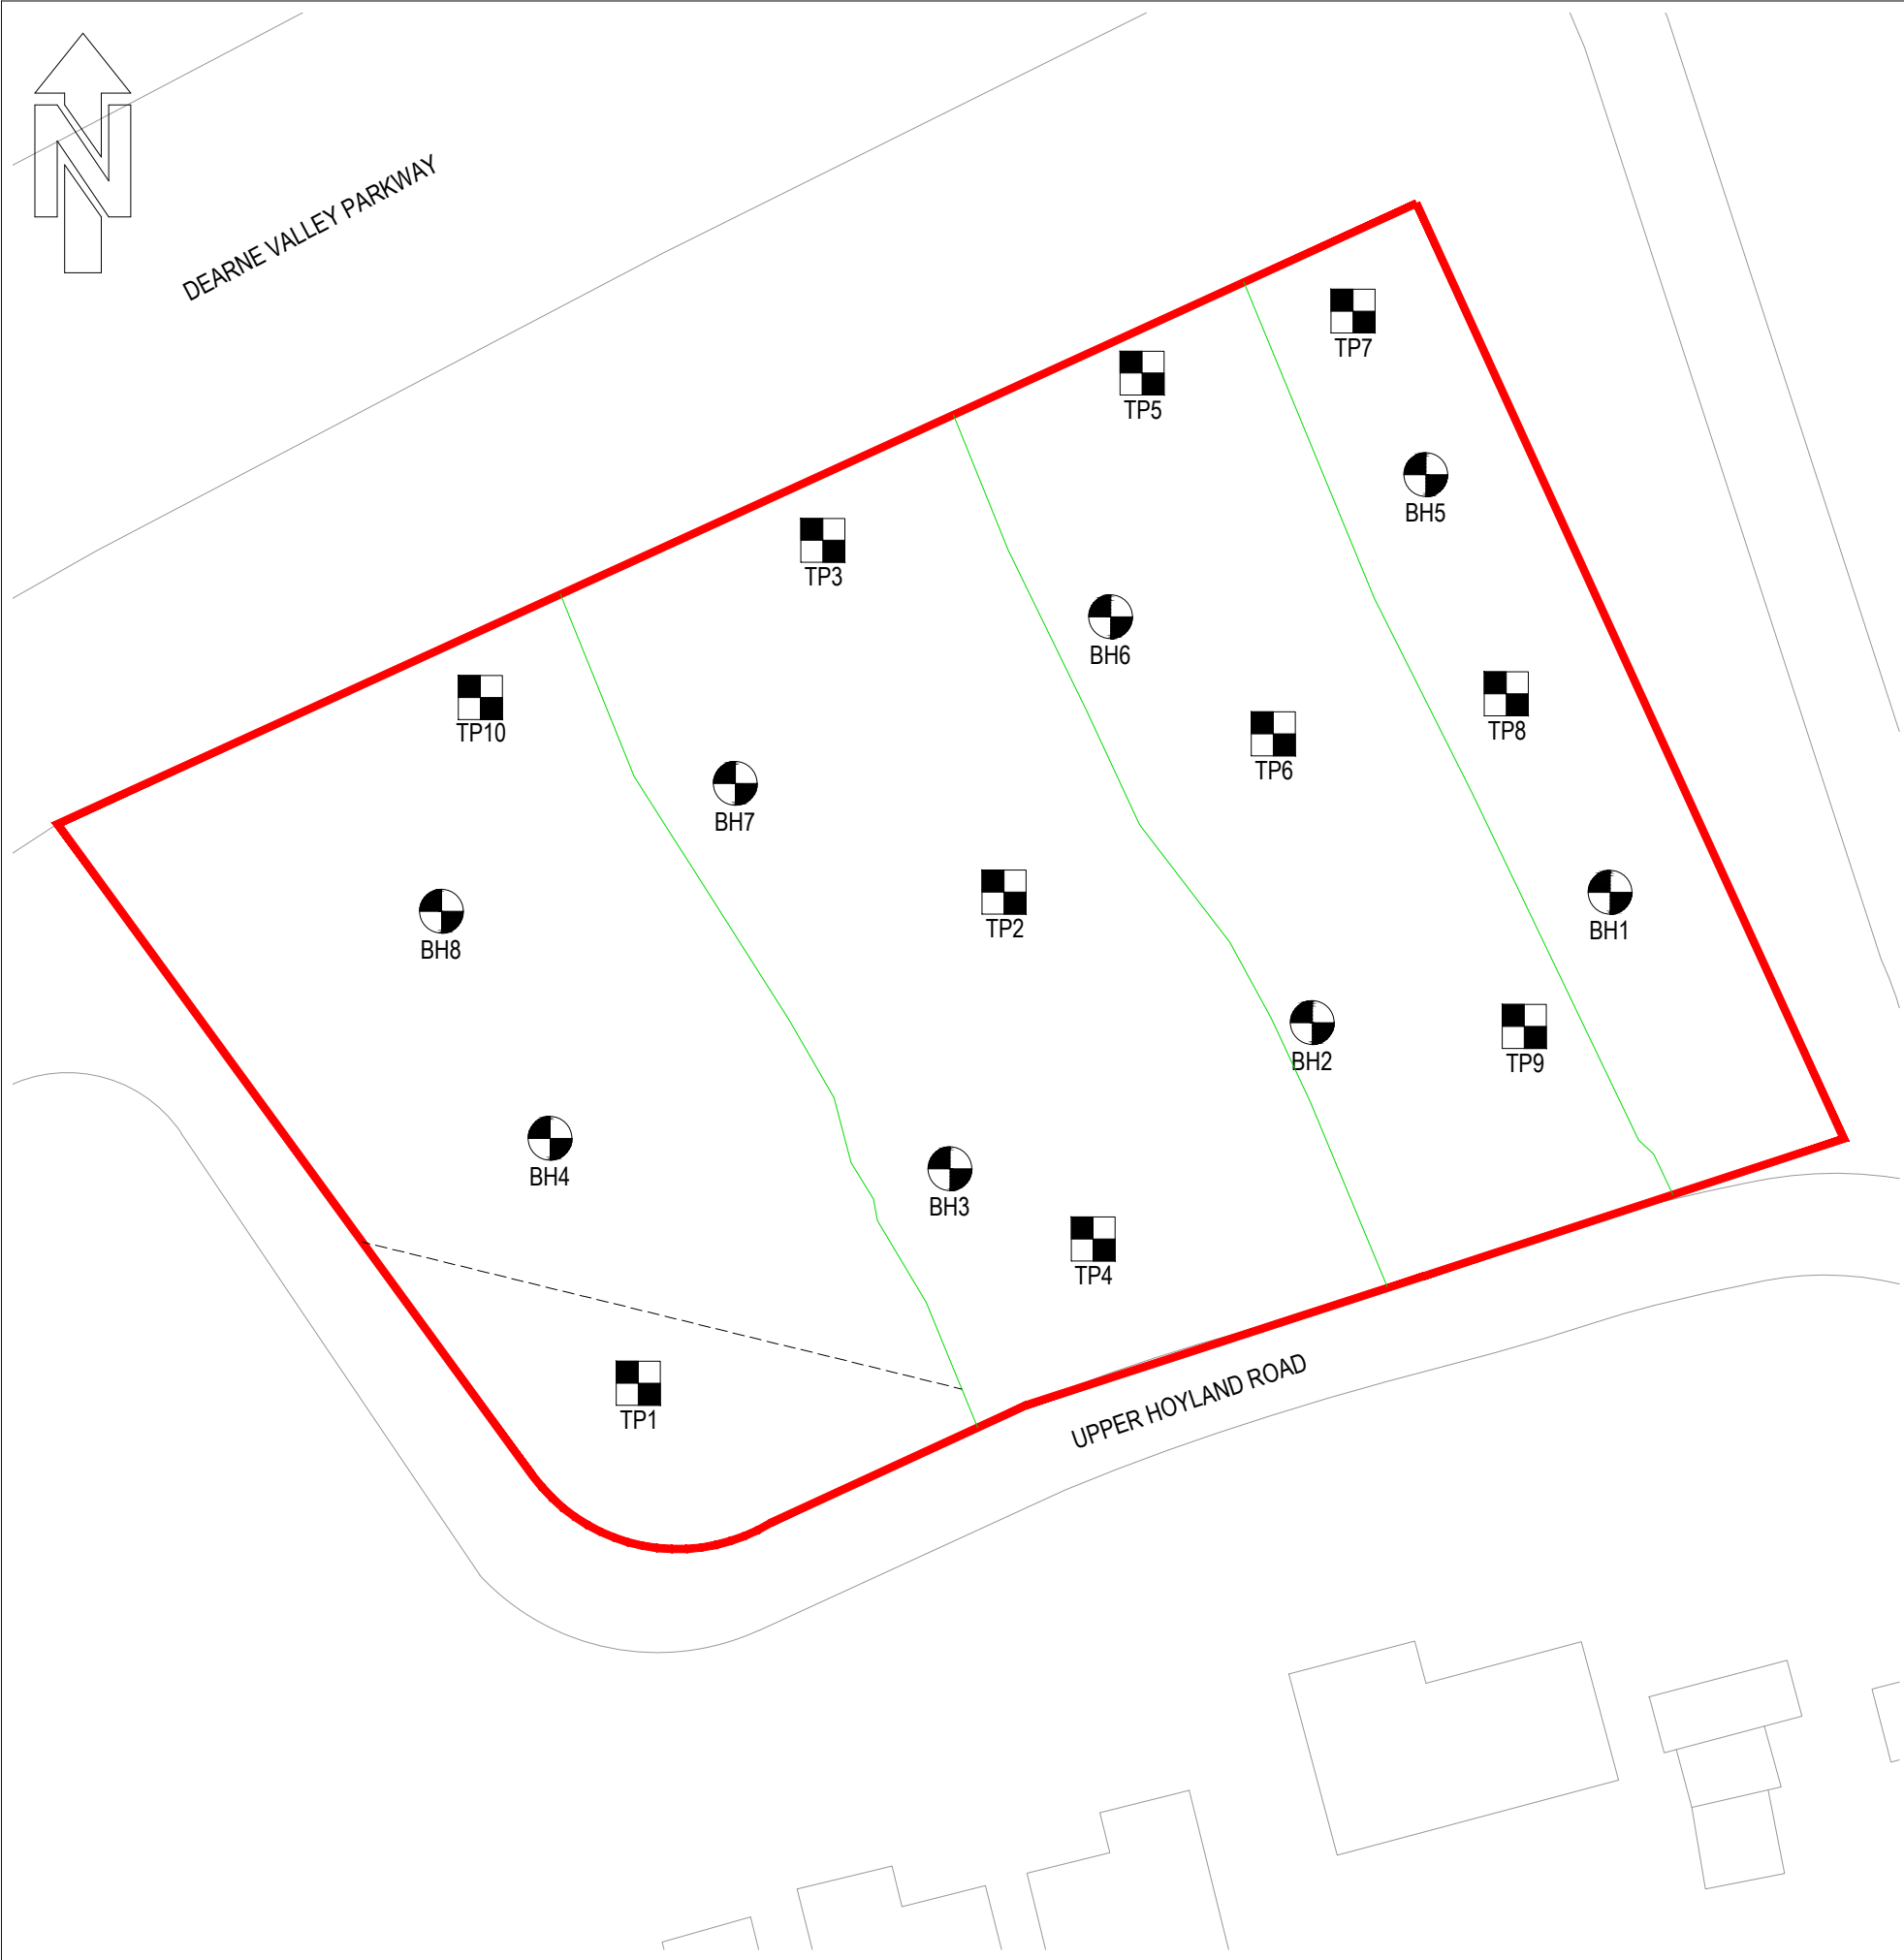
The trial pits and boreholes were positioned in order to give good site coverage. Copies of the trial pit and borehole logs are presented in Appendix 2 and their locations are shown on the Exploratory Hole Location Plan, Drawing number 41677/001 in Appendix 1.

**Appendix 1** Exploratory Hole Location Plan – Drawing 41677/001A
