Geo-Environmental Assessment

Wood Walk, Hoyland, Barnsley

Issued: August 2021

Delta-Simons Project No. 16-0406.03

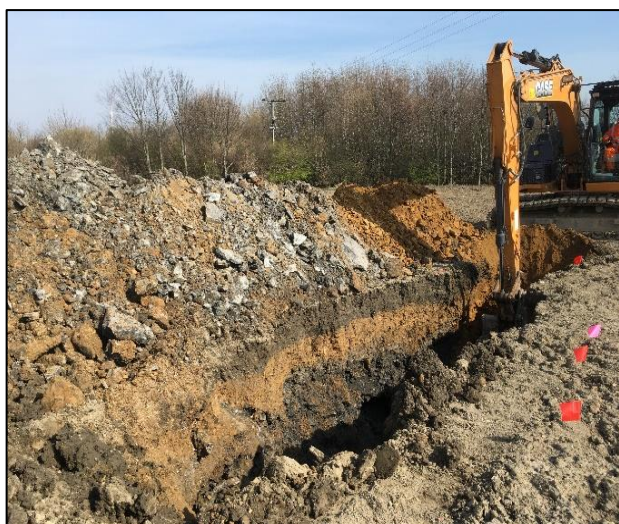
Plate A: View of TT105, with associated arisings. Facing east.

The gradient of the highwall varied between locations, with TT101 resembling a shallow slope and TT102 to TT106 showing a stepped and sloping profile. Plates A to D, below, show the edge of the former opencast and nature of the backfill.

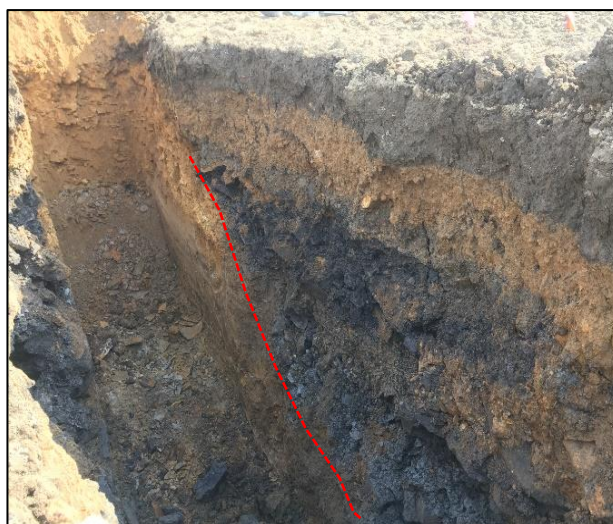
Plate B: Tapering edge of colliery spoil (dark grey) overlying a slope of weathered bedrock and sandstone cobble fill in TT105b / 105c. Facing south-east.

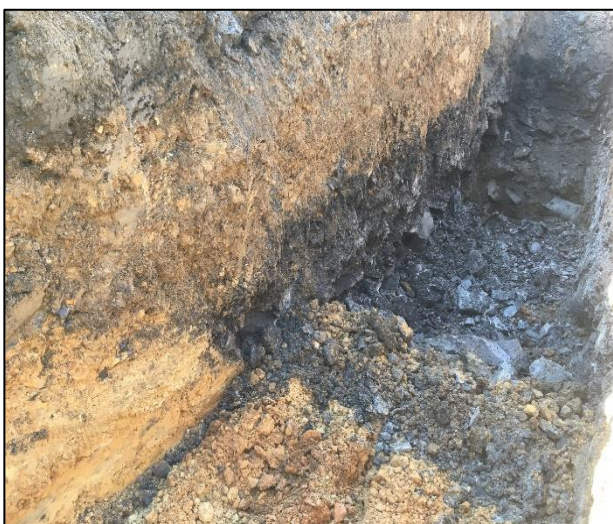
Plate D: View into TT106b/106a, from TT106c, with a transition from weathered bedrock (light orangish brown) into colliery spoil (dark grey). Facing south-west.

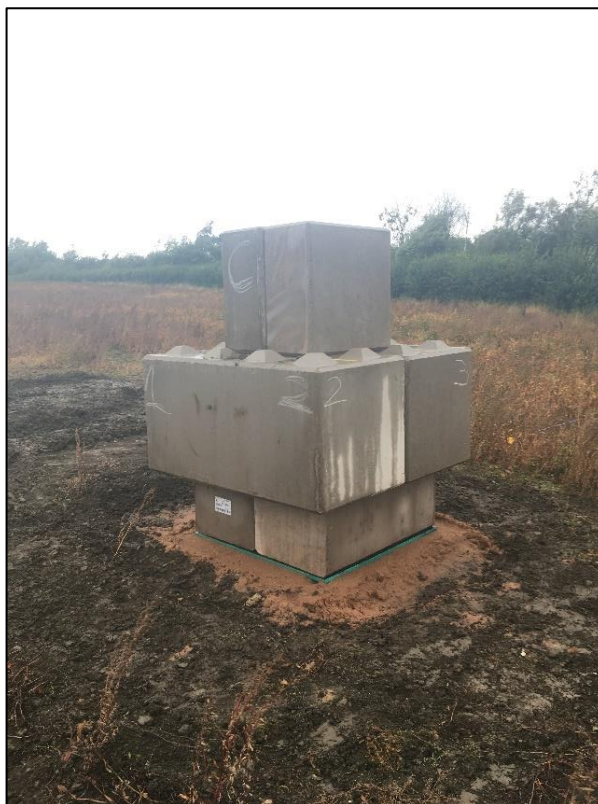
Plate F: Site example of the constructed Maintained Load Test.

- ▲ Preparation of test location by removing any topsoil to a depth of 300 mm.
- ▲ Placement of sand blinding to a depth no greater than 100 mm.
- ▲ Placement of a steel plate (1.25m x 1.25m x 25mm) onto the sand blinding; and
- ▲ Placement of 7200kg load (concrete kentledge and steel plate) to simulate at least 150 % of the anticipated design loading as provided by the engineer assuming a raft foundation.

Once the test locations were constructed, a surveyor undertook initial benchmarking of the four corners of each testing to establish GPS locations and initial elevation data in order to commence the testing.
