NETHERFIELD FARM BARN.

BAT SURVEY.

Ref No: 210838.

Date: 17th August 2021.

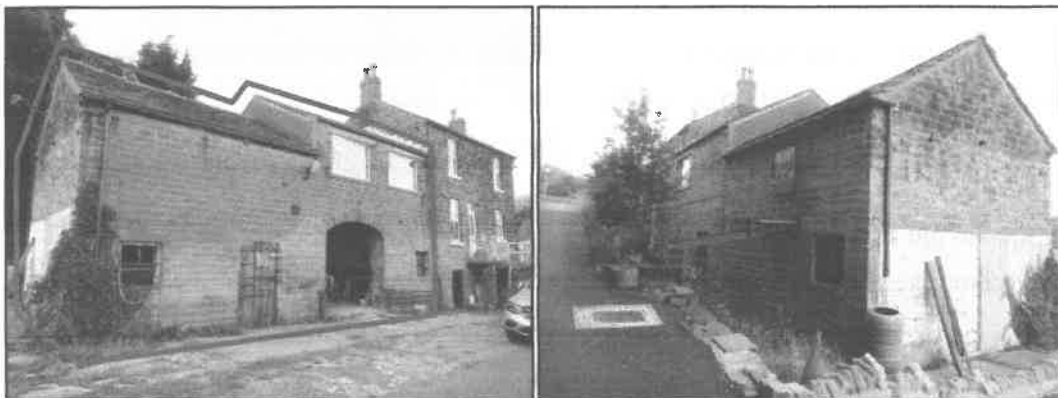
3.3.2. The left photograph below shows the southern side of surveyed barns in red with the farmhouse at the end. The right photograph below shows the northern side.

3.3.4. The barns are two storey and constructed with stone walls and pitched stone slate roofs. The ground floor of both barns has a large open arch doorway and the room extends through both barns. The first floor of the eastern barn has been converted and is part of the house. The first floor of the western barn is disused and access through a small doorway on the northern side. The floor is in poor condition and the roof is heavily covered with cobwebs with cobwebs hanging throughout the room.

3.3.5. The walls are generally in good condition and well pointed. Three holes were found in the stone walls, one on the northern side of the western barn, one on the southern side due to a broken vent and one on the southern side of the eastern barn.

3.3.6. The roof of the eastern barn is in good condition with the slates all in place and well fitted and all ridge tiles in place and well pointed. The gable end is well pointed under the slates. The wall of the gable end has a decorative finish but this is well sealed and has no gaps. This roof is lined inside with spray insulation.

3.3.7. The roof of the western barn has all slates in place but there are gaps due to slightly lifted slates. The ridge is in place and well pointed. Internally the roof is unlined and very heavily covered with cobwebs.
