Billingley View,

Bolton on Dearne

**- BS 5837:2012 Tree Survey, Arboricultural Impact
Assessment and Arboricultural Method Statement**

July 2019

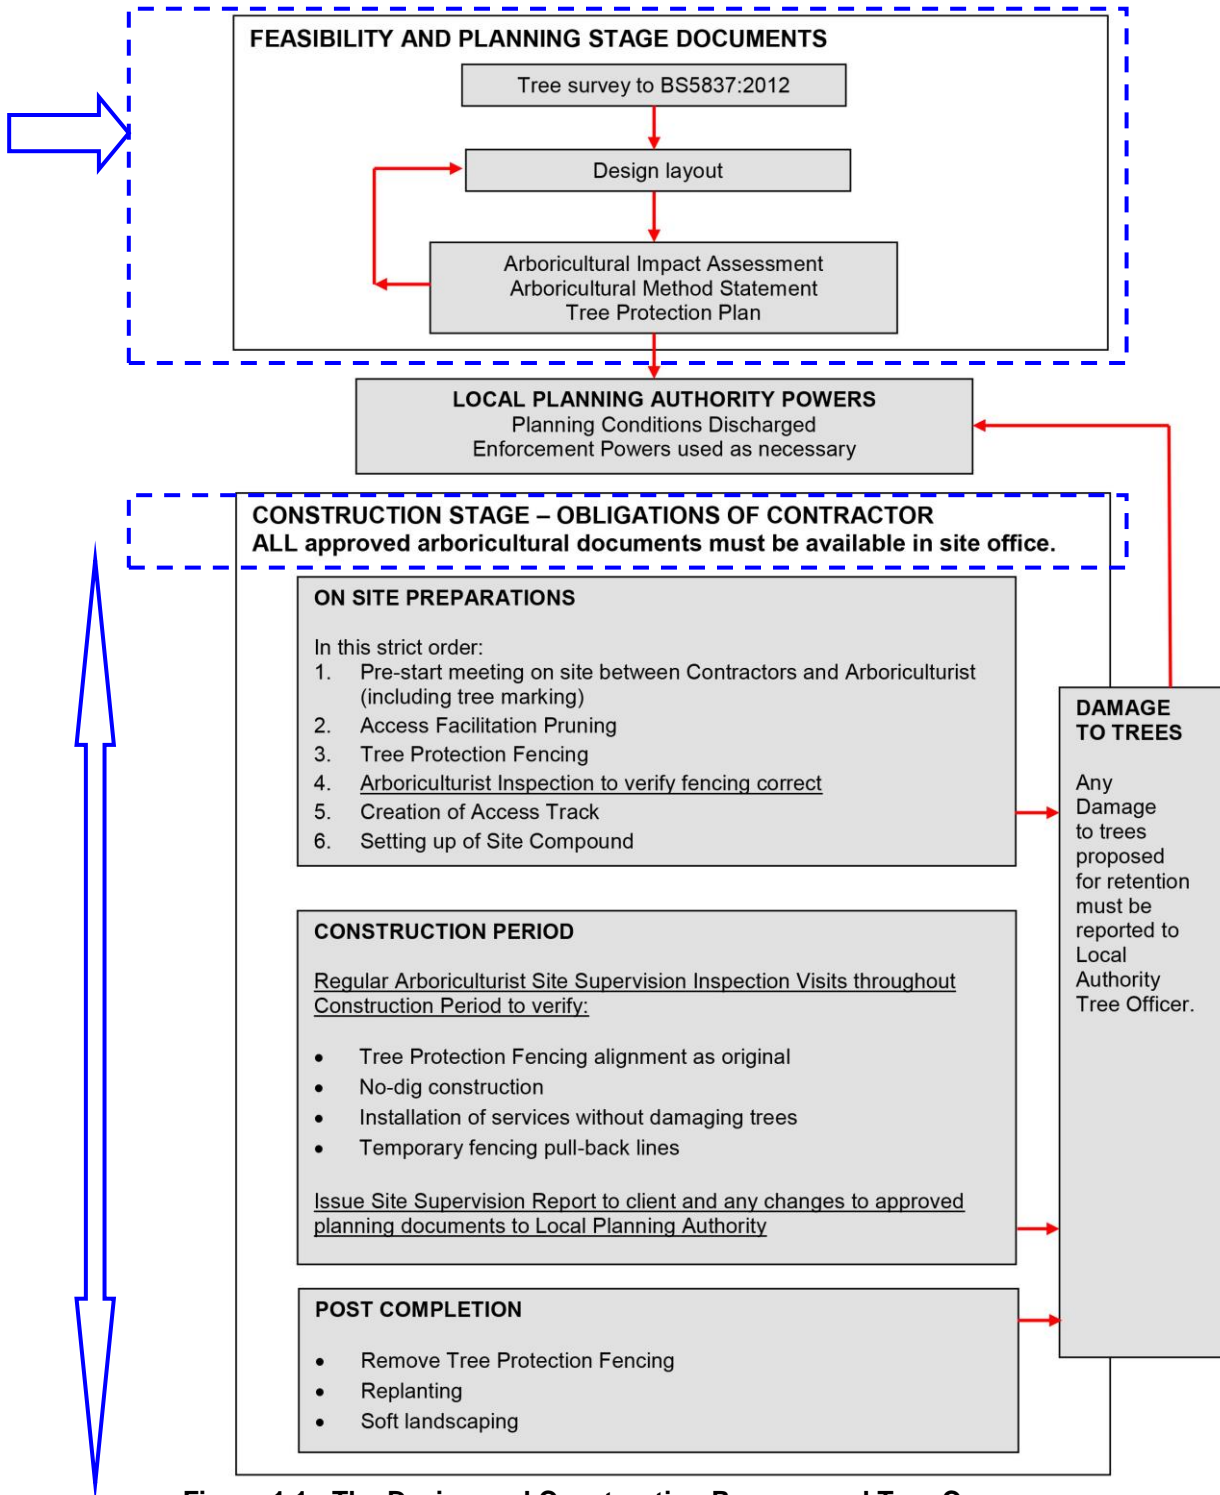
Figure 1.1 - The Design and Construction Process and Tree Care

For ready reference, Figure 1.1 (Chapter 1) is a simplified version of the 'Design and Construction Process and Tree Care' table outlined in BS 5837:2012. The table clearly identifies processes and obligations expected at the various stages of the construction project. BS 5837:2012 is considered an iterative process, and as such the project arboriculturist's advice should be ongoing.

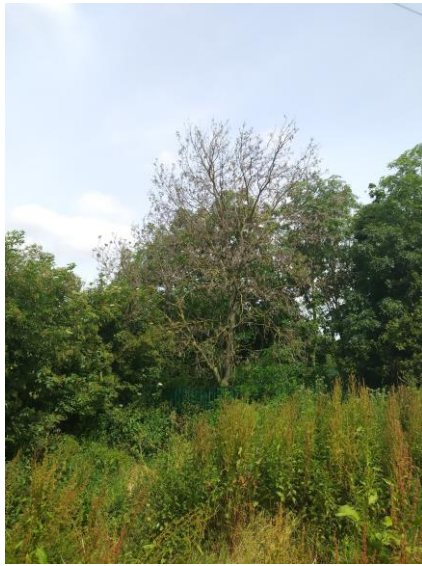
Plate 1: Dead ash tree T001

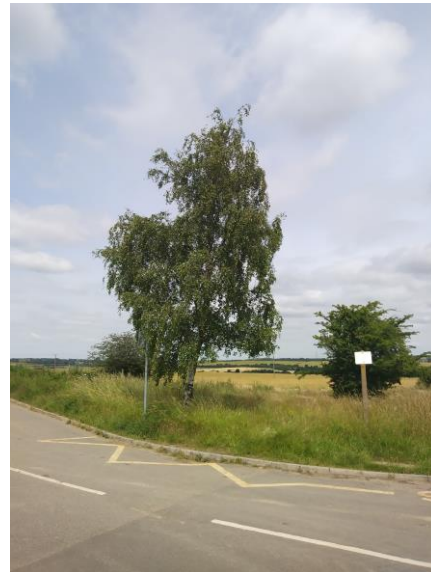
Plate 2: Silver birch T022 in the southern end of the site

- 3.2.8 T022 is a mature silver birch that is found on the southern edge of the site. It is an established tree that currently provides some interest from the highway and Lacewood primary school. Whilst it could be considered for retention it has limited remaining contribution and is not of significant arboricultural importance.

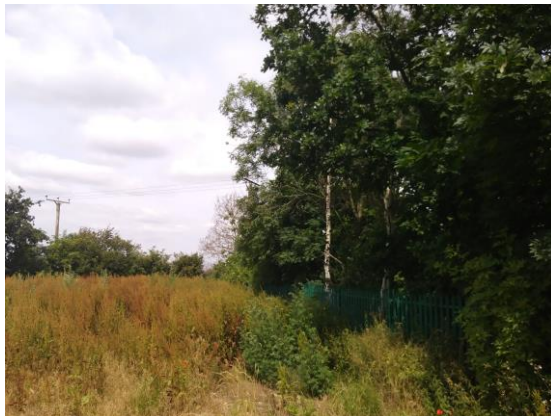
Plate 3: View looking west, showing the trees overhanging the school boundary fence.

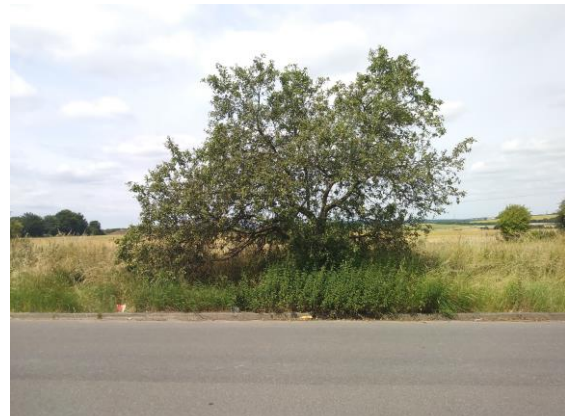
Plate 4: Large crab apple on eastern boundary.

- 3.2.6 Along the eastern boundary there are several groups and individual trees that are typical of a field edge. The species found along the boundary are mostly crab apple (*Malus sylvestris*) and hawthorn (*Crataegus monogyna*) with a single elder (T018) and a small group (G015) of goat willow (*Salix caprea*).
