# Geoenvironmental Appraisal

## Land at Goldthorpe Colliery For Countryside Properties

Report no: 1750/2A

Date: September 2019

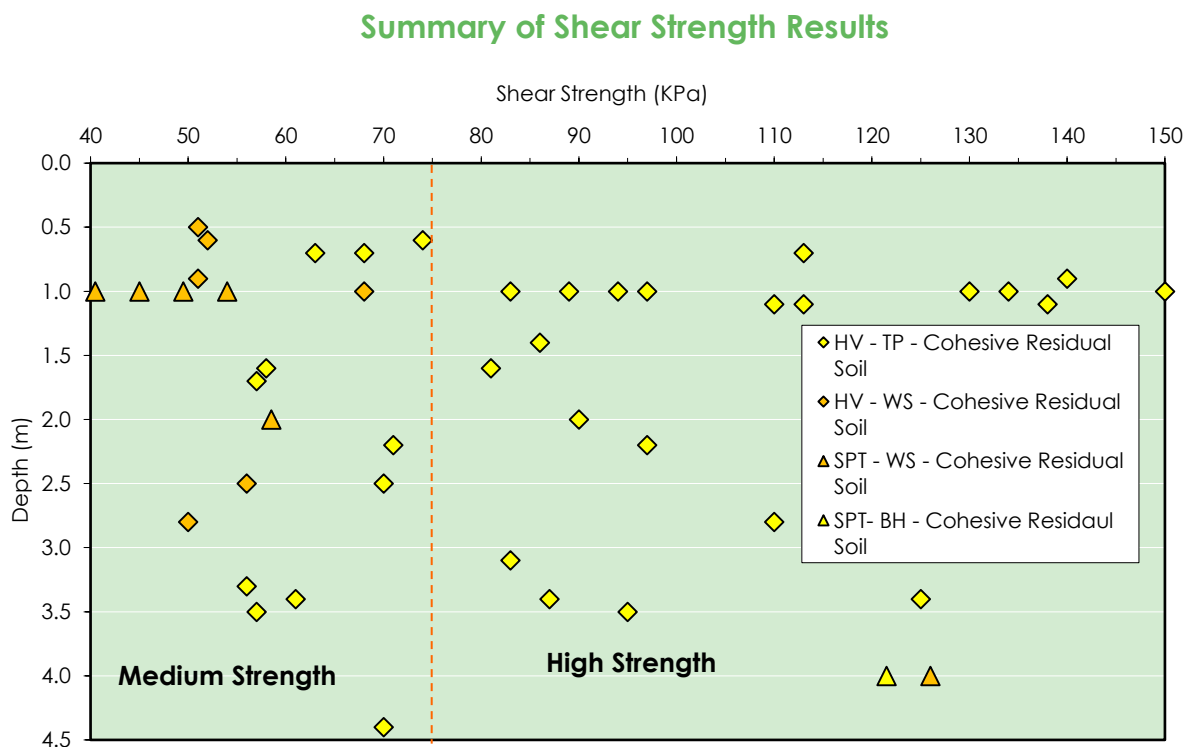
- 12.7.1 Hand shear vane testing was undertaken within trial pits in-situ to around 1m depth and from larger blocks of excavated clay below that depth.
- 12.7.2 The results are summarised within the plot below and do not typically illustrate a clear pattern. The SPT and shear vane results in the window samples are less reliable than shear vanes undertaken in-situ within trial pit walls. Below approximately 1m depth  $S_u$  is typically greater than 55kPa.
- 12.7.3 The plot below provides a summary of undrained shear strengths

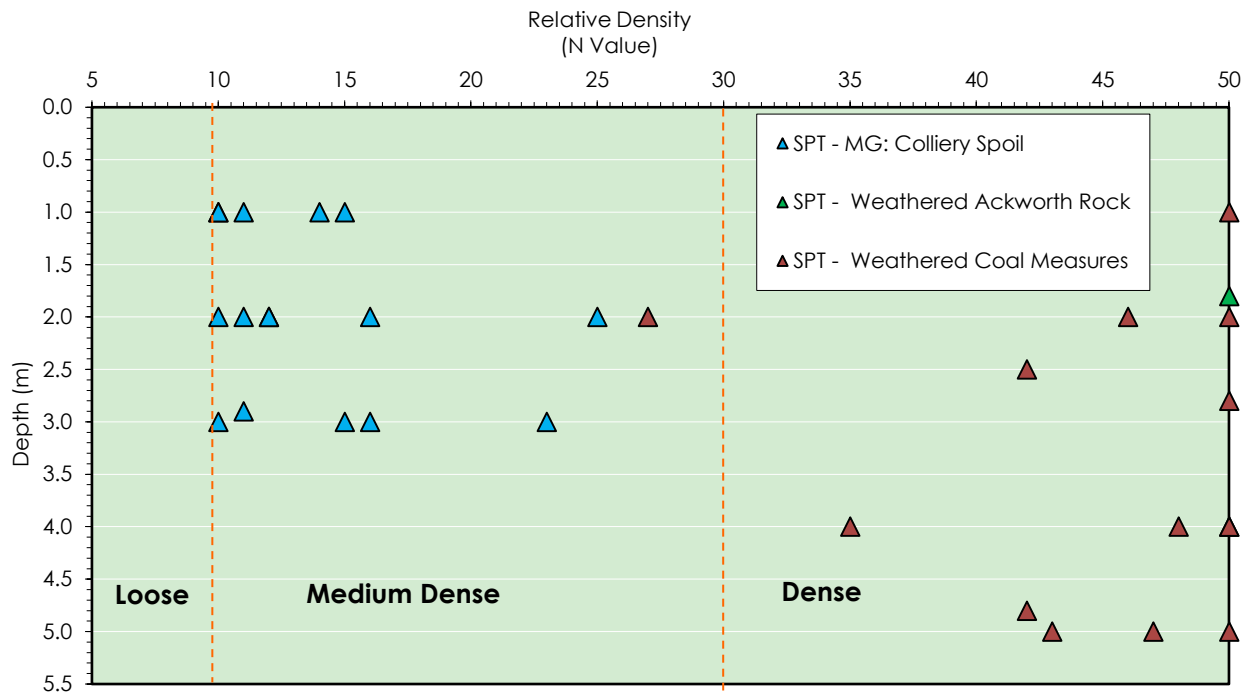
### Summary of SPT Results

- 12.8.3 The reported blow count suggests the made ground is medium dense.
- 12.8.4 The reported blow counts suggest the densities ranging from medium dense to very dense for weathered Coal Measures and weathered Ackworth Rock. Seven tests refused on bedrock between 1.8m and 2.5m (Area A) and at 5m (Area B).

- 12.8.5 The above results confirm observations made during the trial pitting, that the weathered bedrock is at least medium dense.

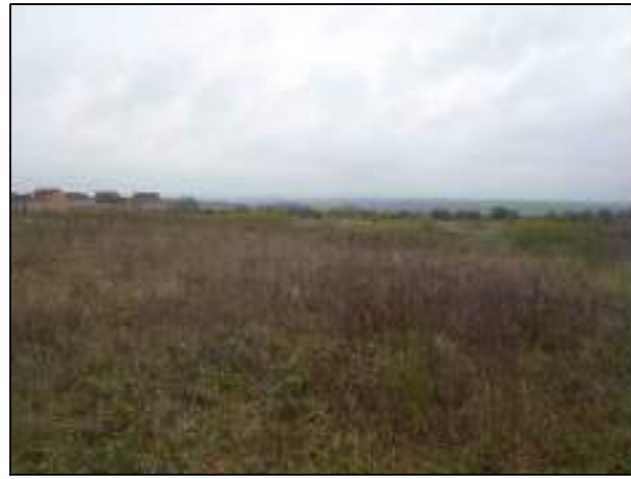
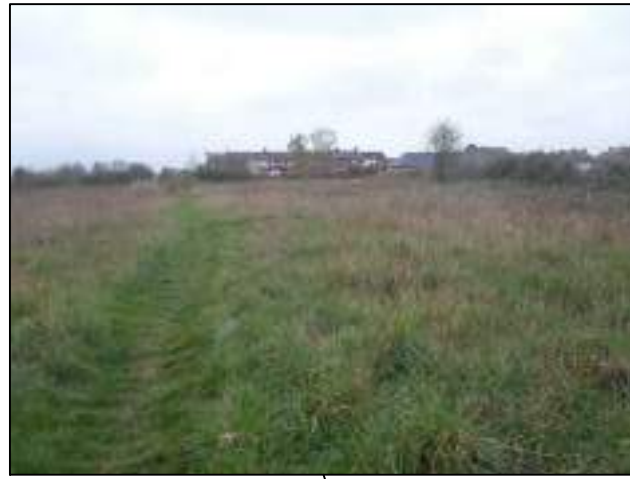
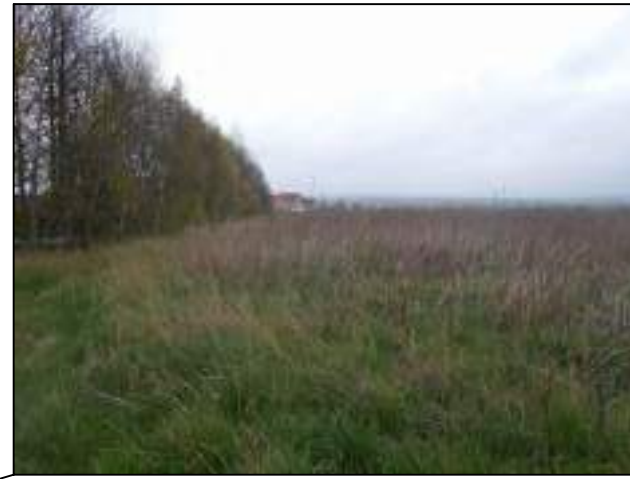
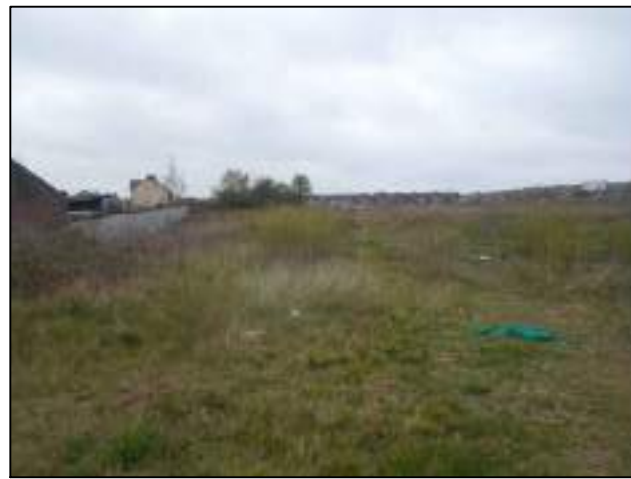
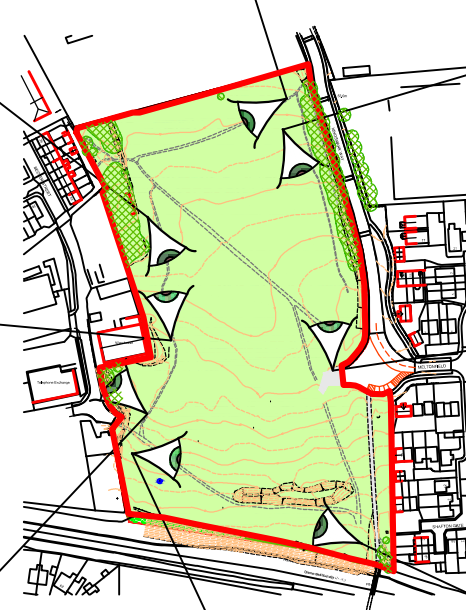
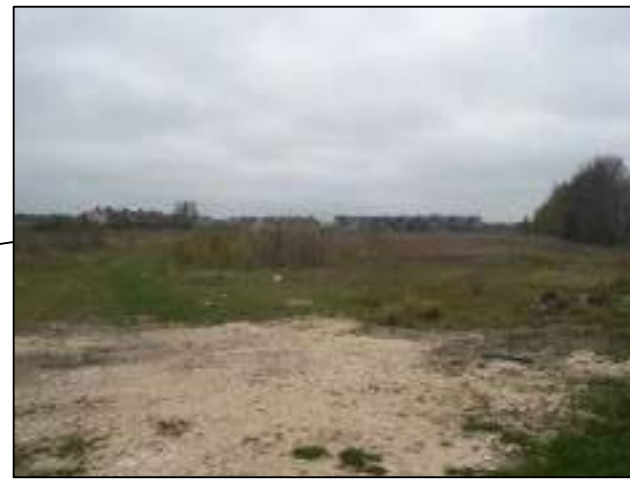
| SCALE | NOT TO SCALE | SHEET | A3 | DRAWING NO. | 1750/4 | REVISION | |

- GRASS & OVERGROWN AREAS
- TARMAC HARDSTAND
- TREES AND HEDGEROWS
- APPROXIMATE SITE BOUNDARY
- LOCATION & ORIENTATION OF PHOTOGRAPH

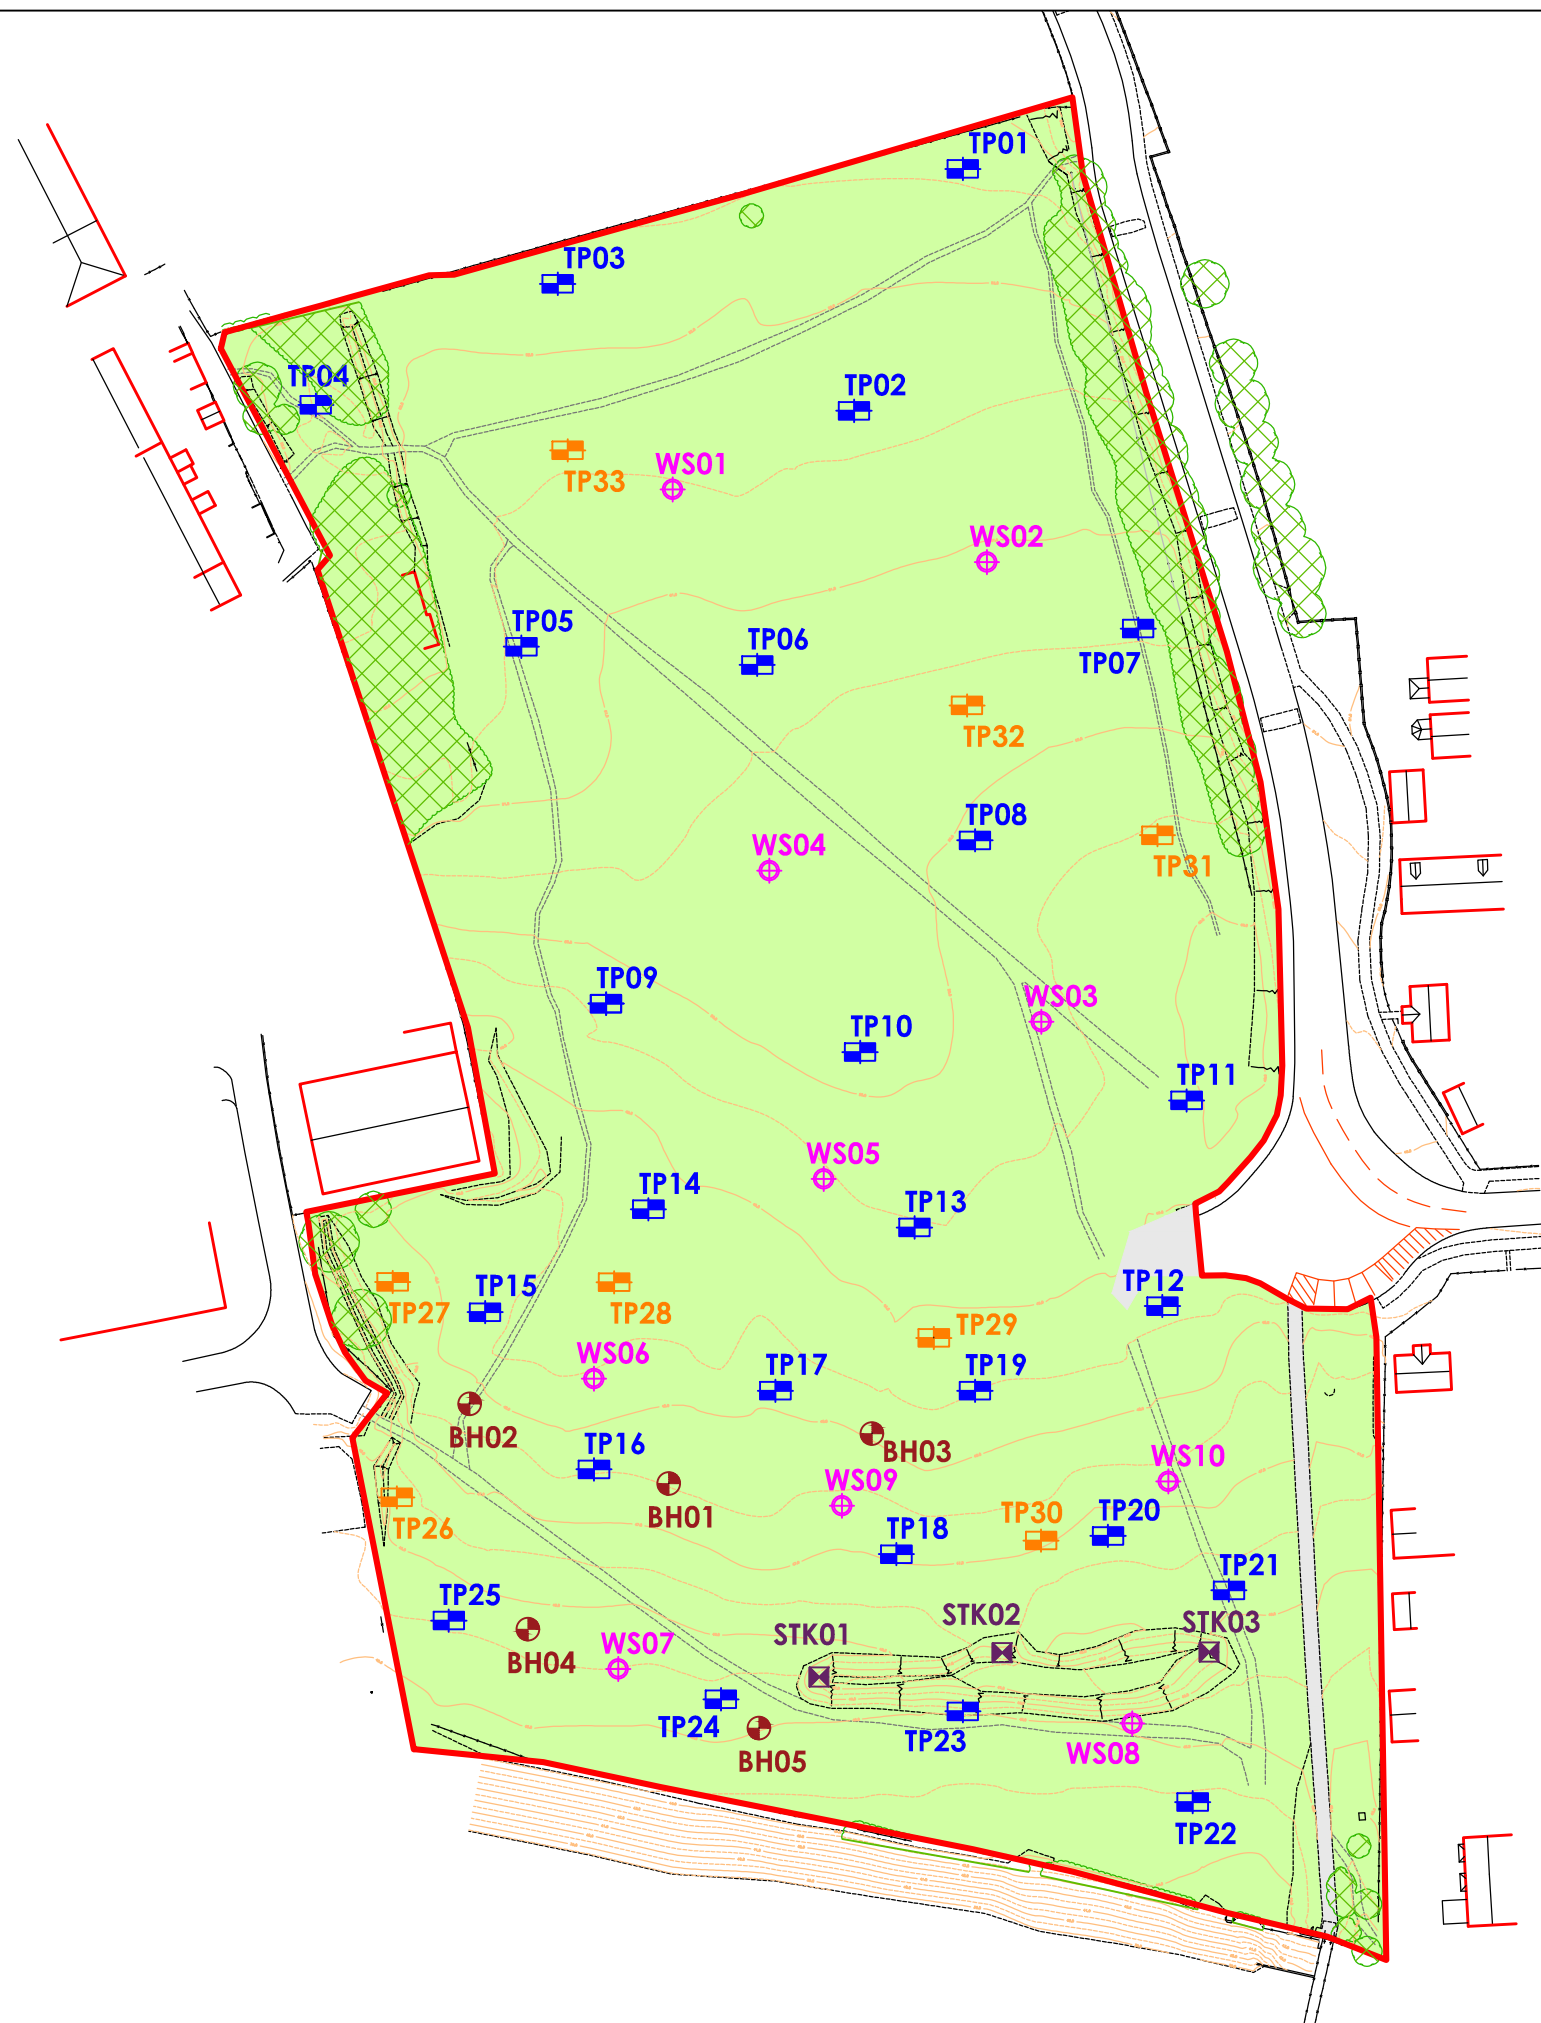
| SCALE | 1:1250 | SHEET | A3 | DRAWING NO. | 1750/6 | REVISION | A |

| NOTES | | |
|---|---|---|
| LITHOS INVESTIGATION (APRIL 2019) | | |

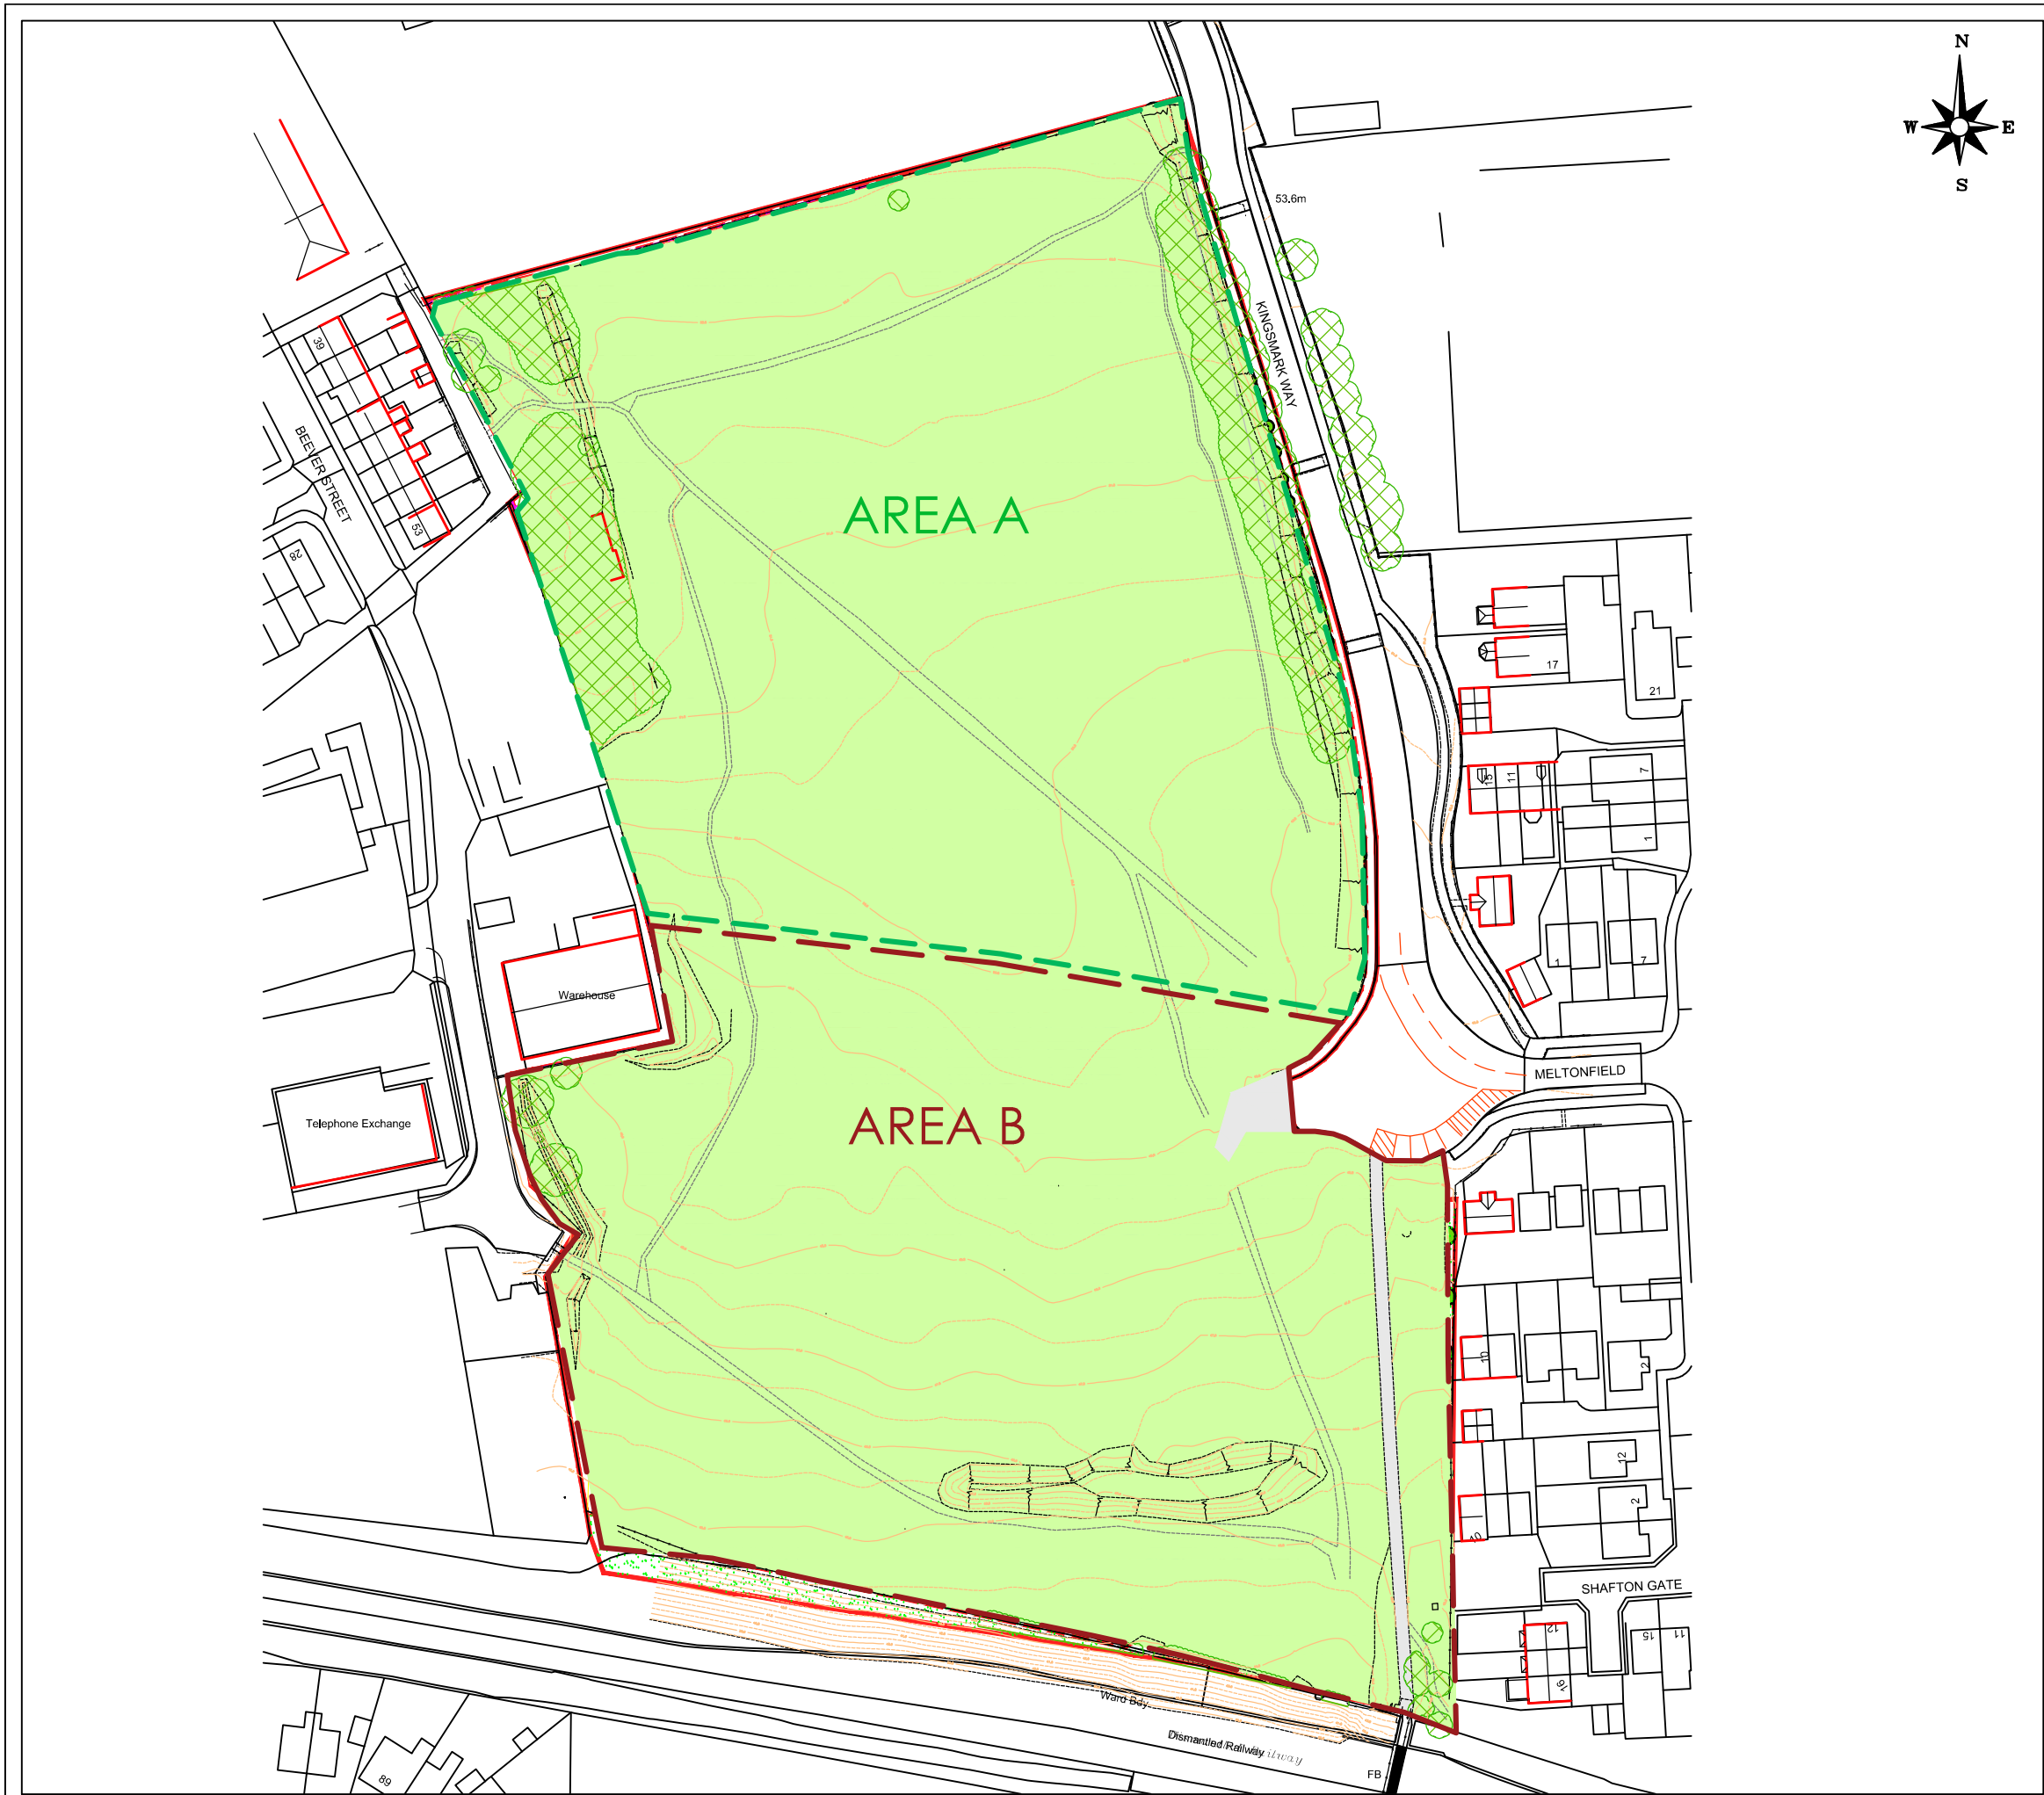
| SCALE | SHEET | DRAWING NO. | REVISION |
|---|---|---|---|
| Not to scale | A3 | 1750/8 | |

- GRASS & OVERGROWN AREAS
- TARMAC HARDSTAND
- TREES & HEDGEROWS
- APPROXIMATE SITE BOUNDARY

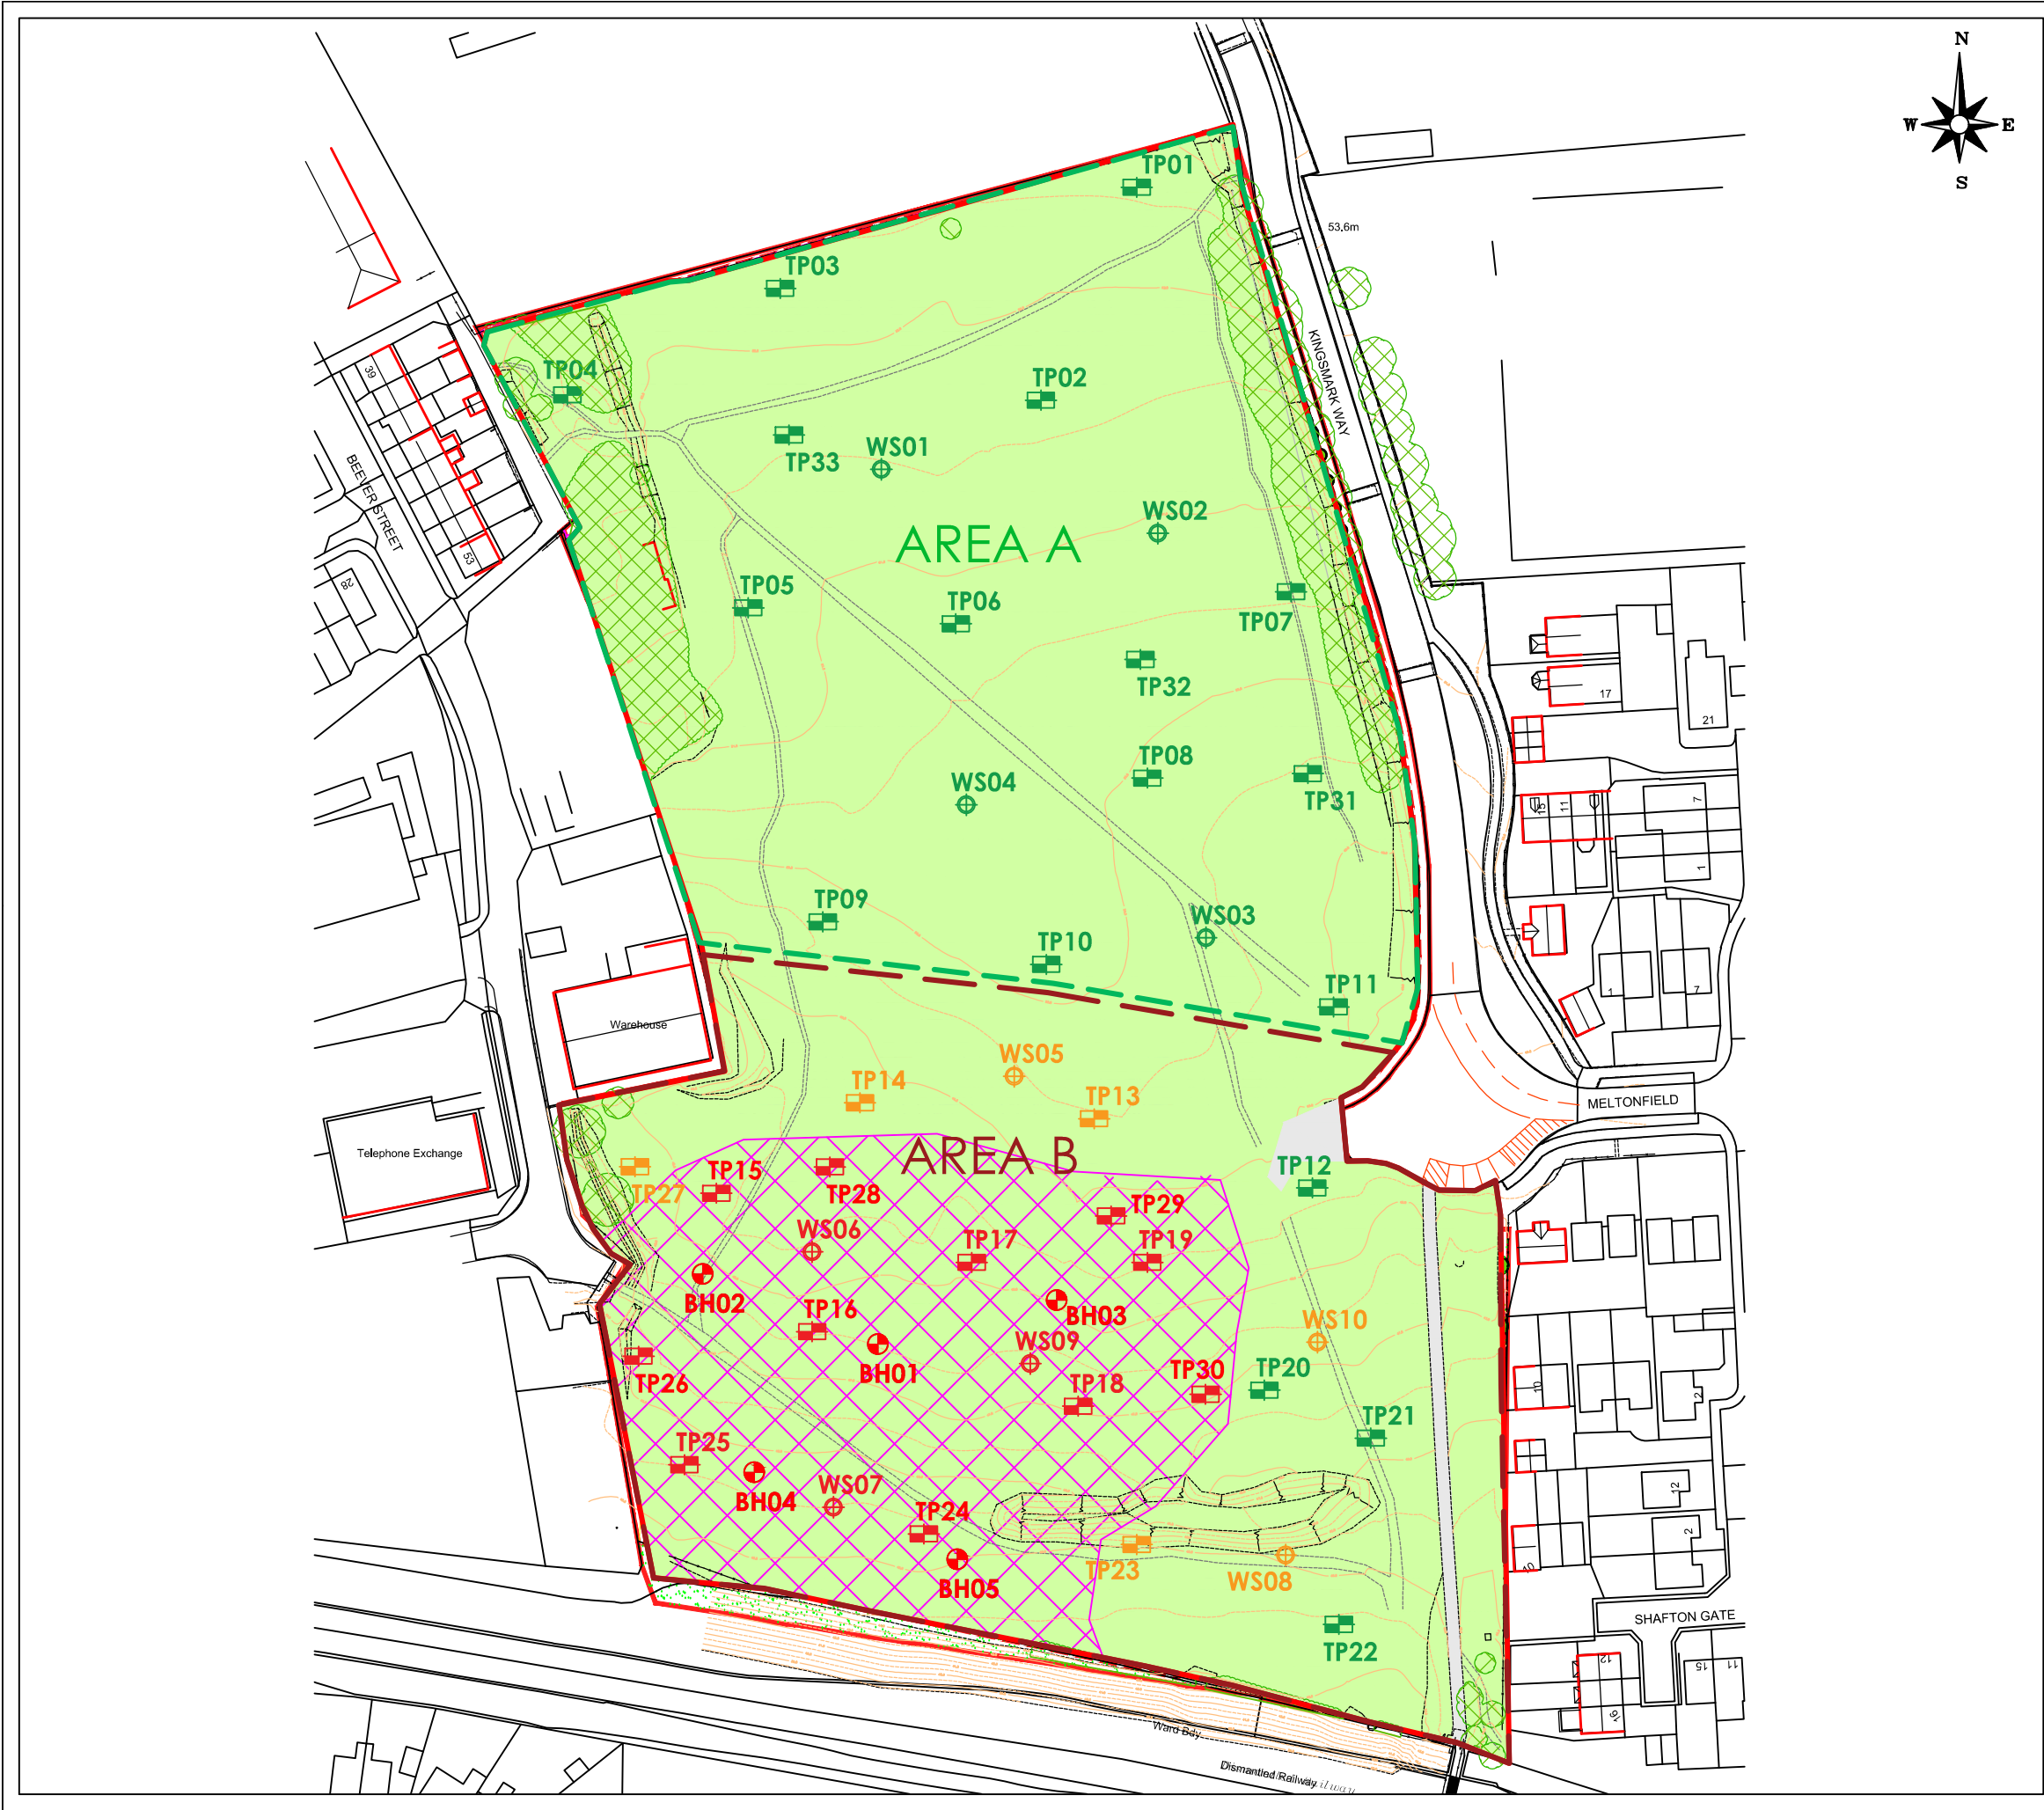
EXPLORATORY HOLE WITH NO OR LIMITED MADE GROUND (<1.0m)
