Trinity Academy, Barnsley

# Preliminary Environmental Risk Assessment and Coal Mining Risk Assessment Technical Note – Trinity Academy Temporary School

# **Trinity Academy, Barnsley – Temporary School**

## **Supplementary Geo-Environmental Assessment**

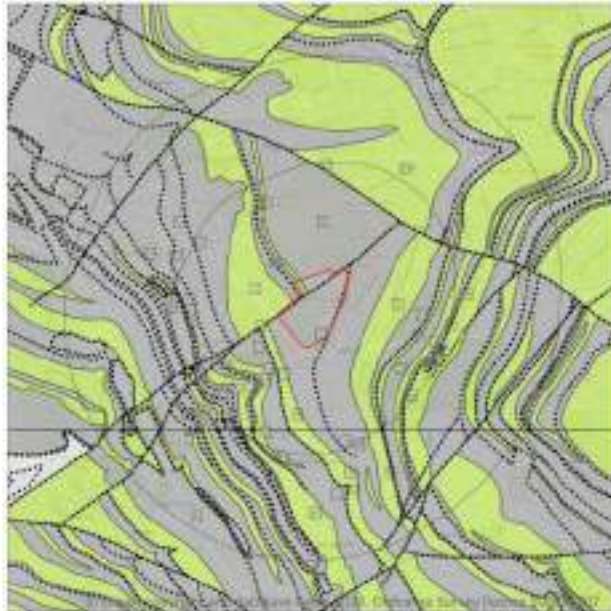
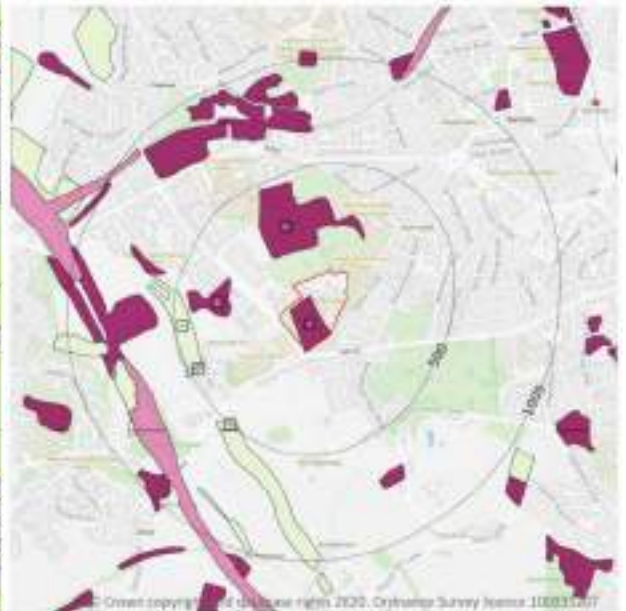
Figure 1: Geology

| ID | Description |
| 1 | Pennine Middle Coal Measures Formation - Mudstone, Siltstone And Sandstone |
| 3 | Pennine Middle Coal Measures Formation - Sandstone |

| ID | Description |
| 1 | Made Ground (Undivided) |
