**PHASE II GEO-ENVIRONMENTAL SITE ASSESSMENT**

Lee Lane  
Royston  
South Yorkshire  
S71 4RT

Report Ref: 11-604-r0  
Date Issued: February 2016

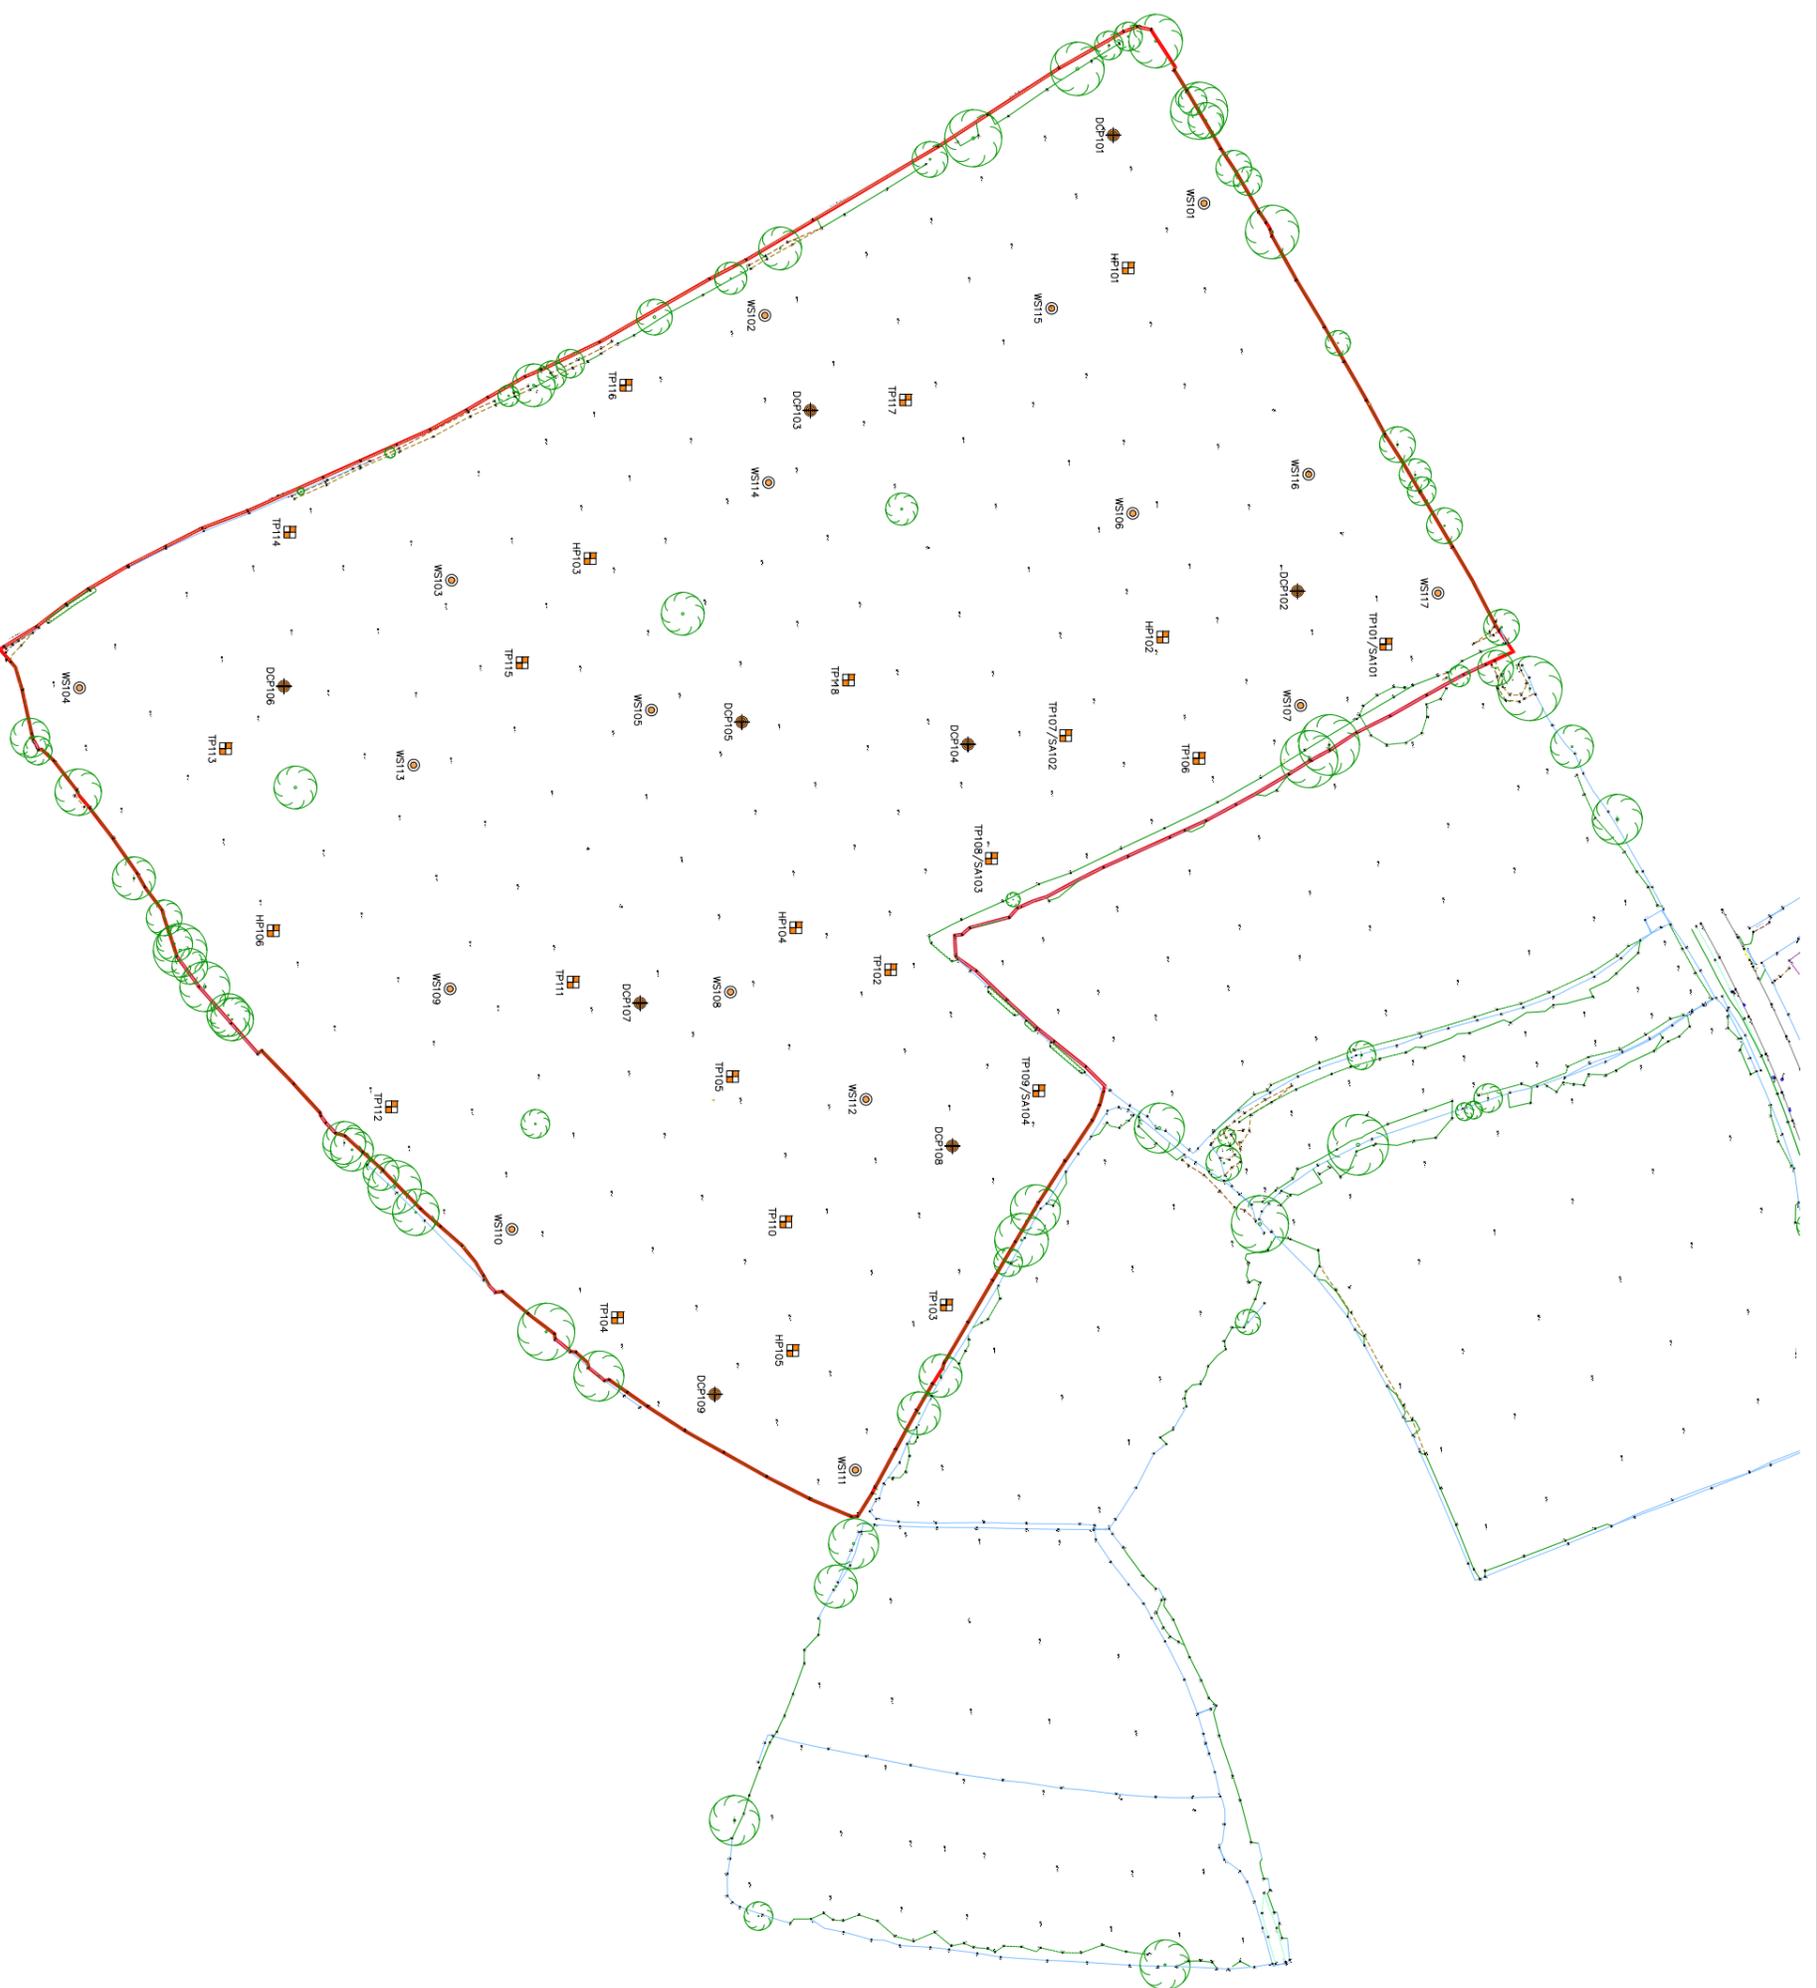
- Location Symbols**
- WS101 Proposed Window Sample Probehole Location
  - TP101 Proposed Trial Pit Location
  - SA101 Proposed Soakaway Test Location
  - Approximate Location of Gas Service

The sampling locations are illustrated in Drawing 11-604-003 (Appendix III). The ground conditions encountered are indicated on the logs which are provided in Appendix IV.

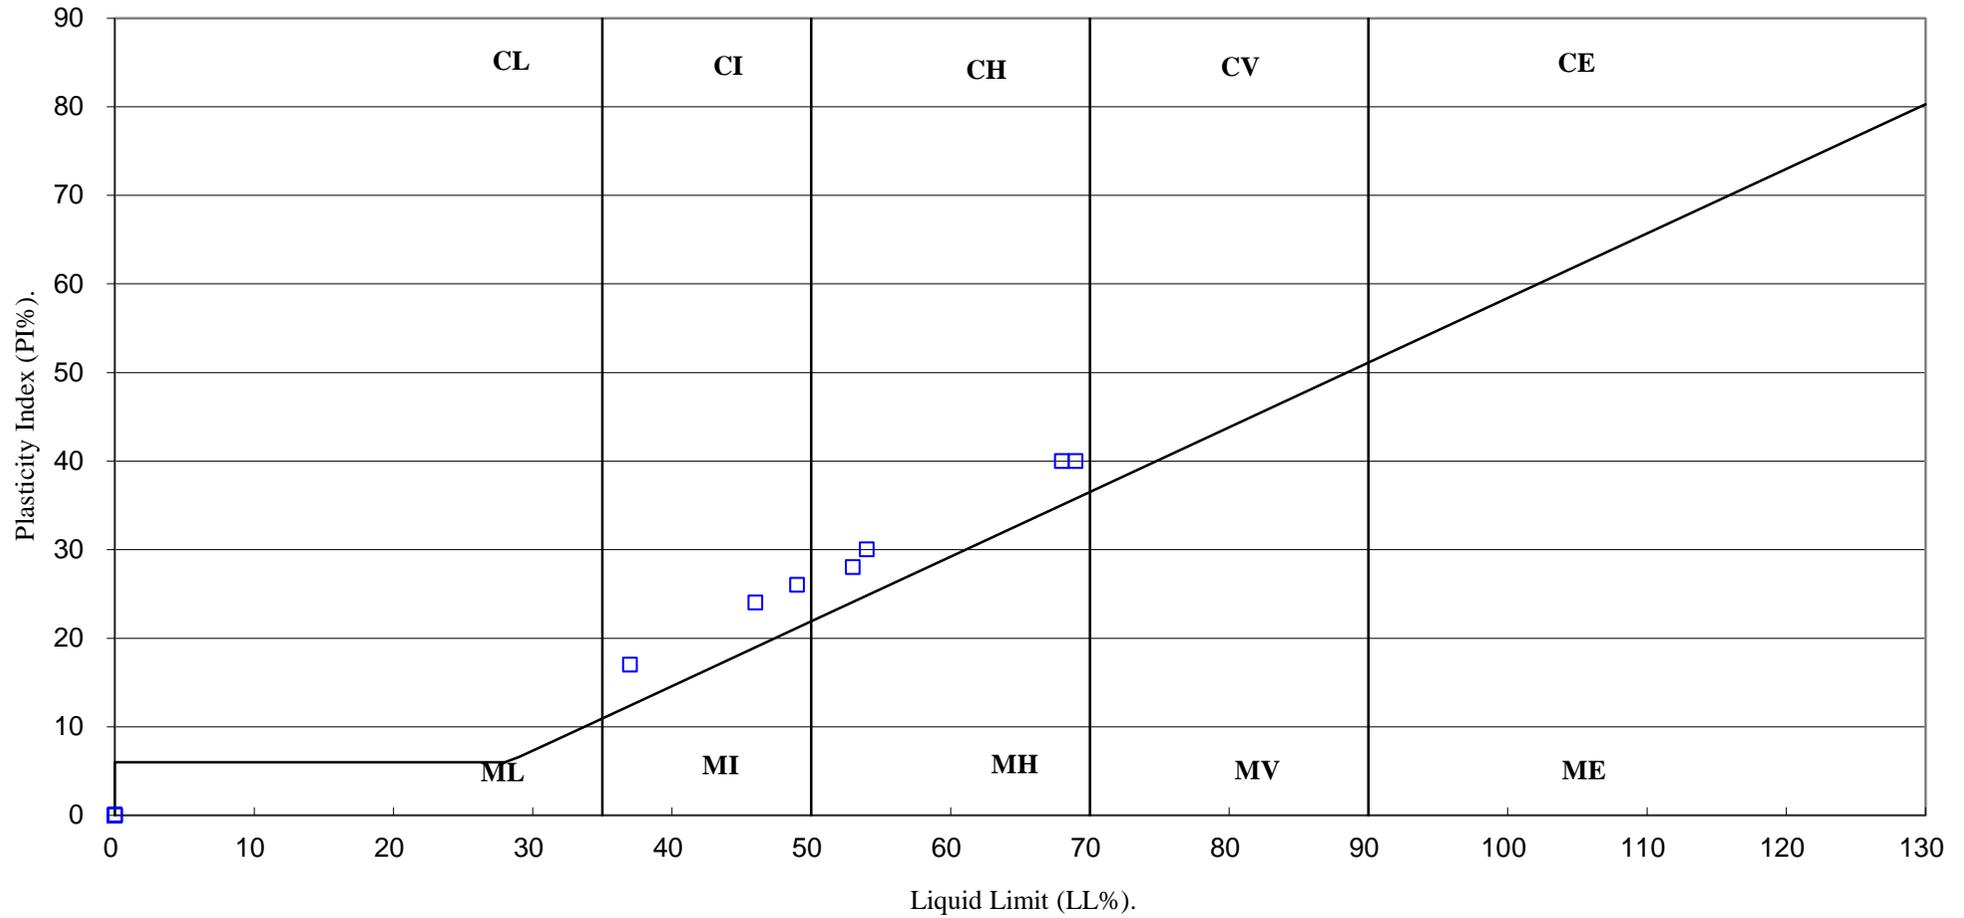
# PLASTICITY CHART FOR CASAGRANDE CLASSIFICATION.

(BS5930 :2015)

LOCATION	DEPTH (m)	NATURAL MOISTURE CONTENT (%)	PLASTIC LIMIT (%)	LIQUID LIMIT (%)	PLASTICITY INDEX (%)	PERCENTAGE PASSING 425MM SIEVE (%)	MODIFIED PLASTICITY INDEX
TP101	1.20	28	23	49	26	94	24.44
TP103	1.20	29	28	68	40	98	39.20
TP112	1.20	24	24	54	30	97	29.10
TP116	1.30	26	29	69	40	98	39.20
WS105	1.00	21	25	53	28	95	26.60
WS111	2.00	23	20	37	17	94	15.98
WS104	1.00	18	22	46	24	93	22.32

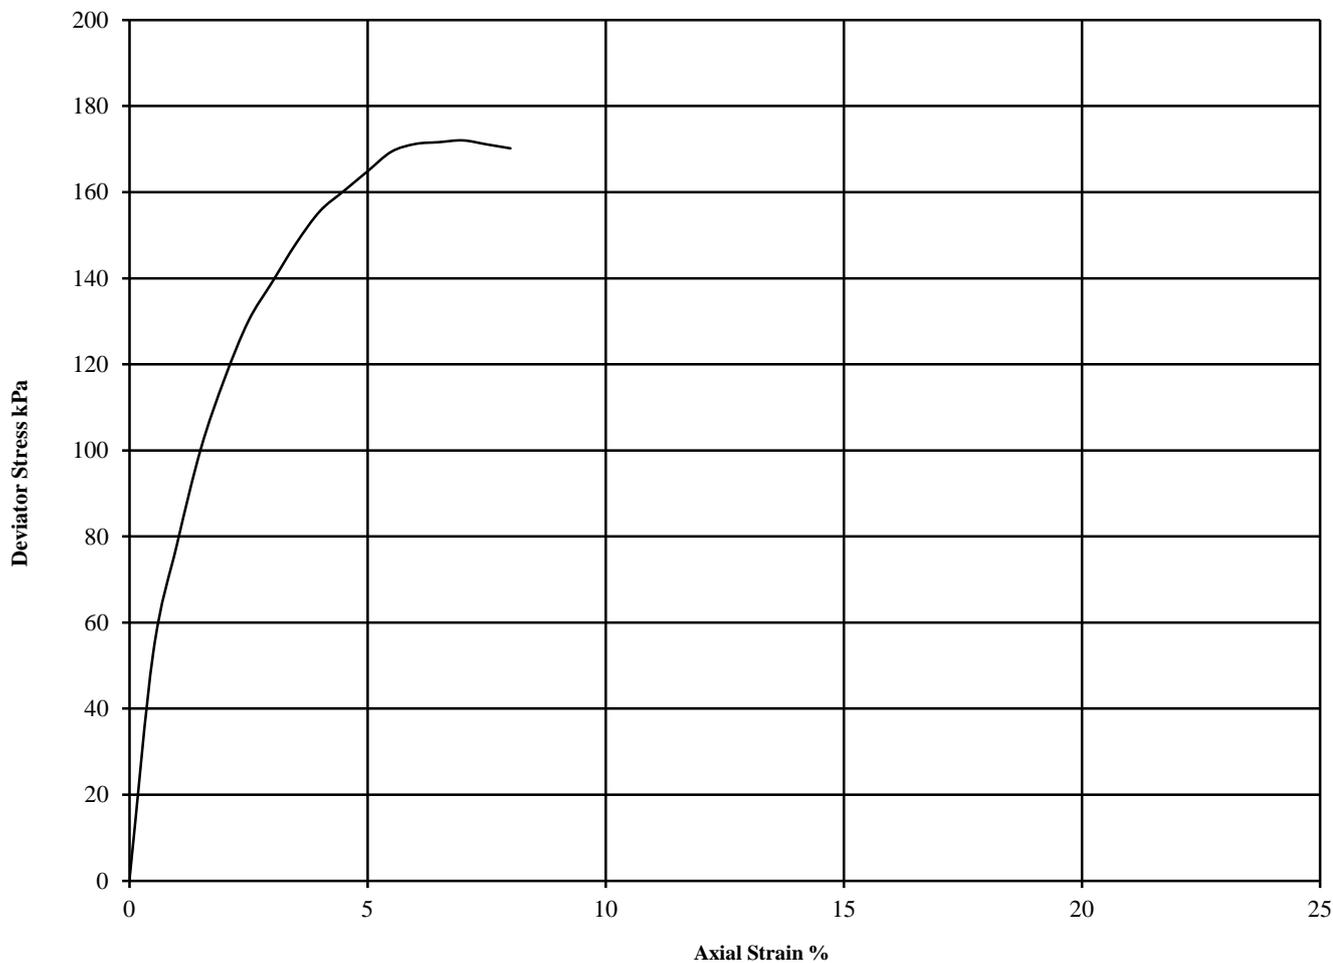
Diameter (mm):		75.0	Height (mm):			150.0	Test:	UU Single Stage		Remarks:
Specimen	Moisture Content (%)	Bulk Density (Mg/m <sup>3</sup> )	Dry Density (Mg/m <sup>3</sup> )	Cell Pressure (kPa)	Corr. Max. Deviator Stress (kPa)	Shear Strength Cu (kPa)	Failure Strain (%)	Mode of Failure	Undisturbed Sample Sample taken from top of tube Rate of strain = 2 %/min Latex Membrane used 0.2 mm thick, Correction applied 0.48 See summary of soil descriptions	
				$\theta_3$	$(\theta_1 - \theta_3)_f$	$\frac{1}{2}(\theta_1 - \theta_3)_f$				
1	28	1.99	1.56	30	172	86	7.0	Plastic

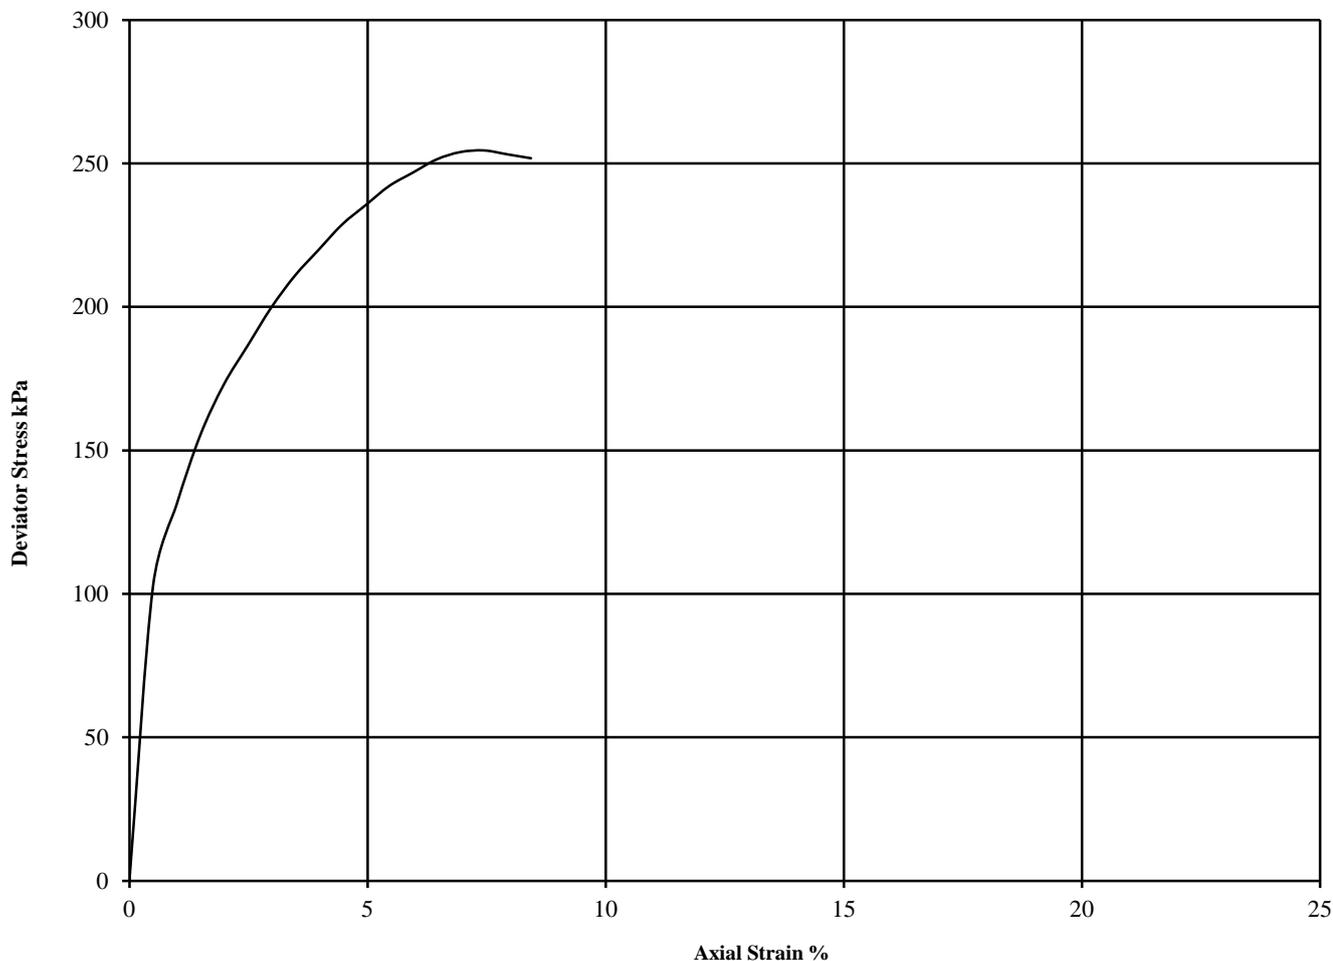
Diameter (mm):		62.0	Height (mm):		125.0	Test:	UU Single Stage		Remarks:
Specimen	Moisture Content (%)	Bulk Density (Mg/m3)	Dry Density (Mg/m3)	Cell Pressure (kPa)	Corr. Max. Deviator Stress (kPa)	Shear Strength Cu (kPa)	Failure Strain (%)	Mode of Failure	Undisturbed Sample Sample taken from top of tube Rate of strain = 2 %/min Latex Membrane used 0.2 mm thick, Correction applied 0.57 See summary of soil descriptions
			$\theta_3$	$(\theta_1 - \theta_3)_f$	$\frac{1}{2}(\theta_1 - \theta_3)_f$				
1	26	1.91	1.52	50	255	127	7.4	Plastic

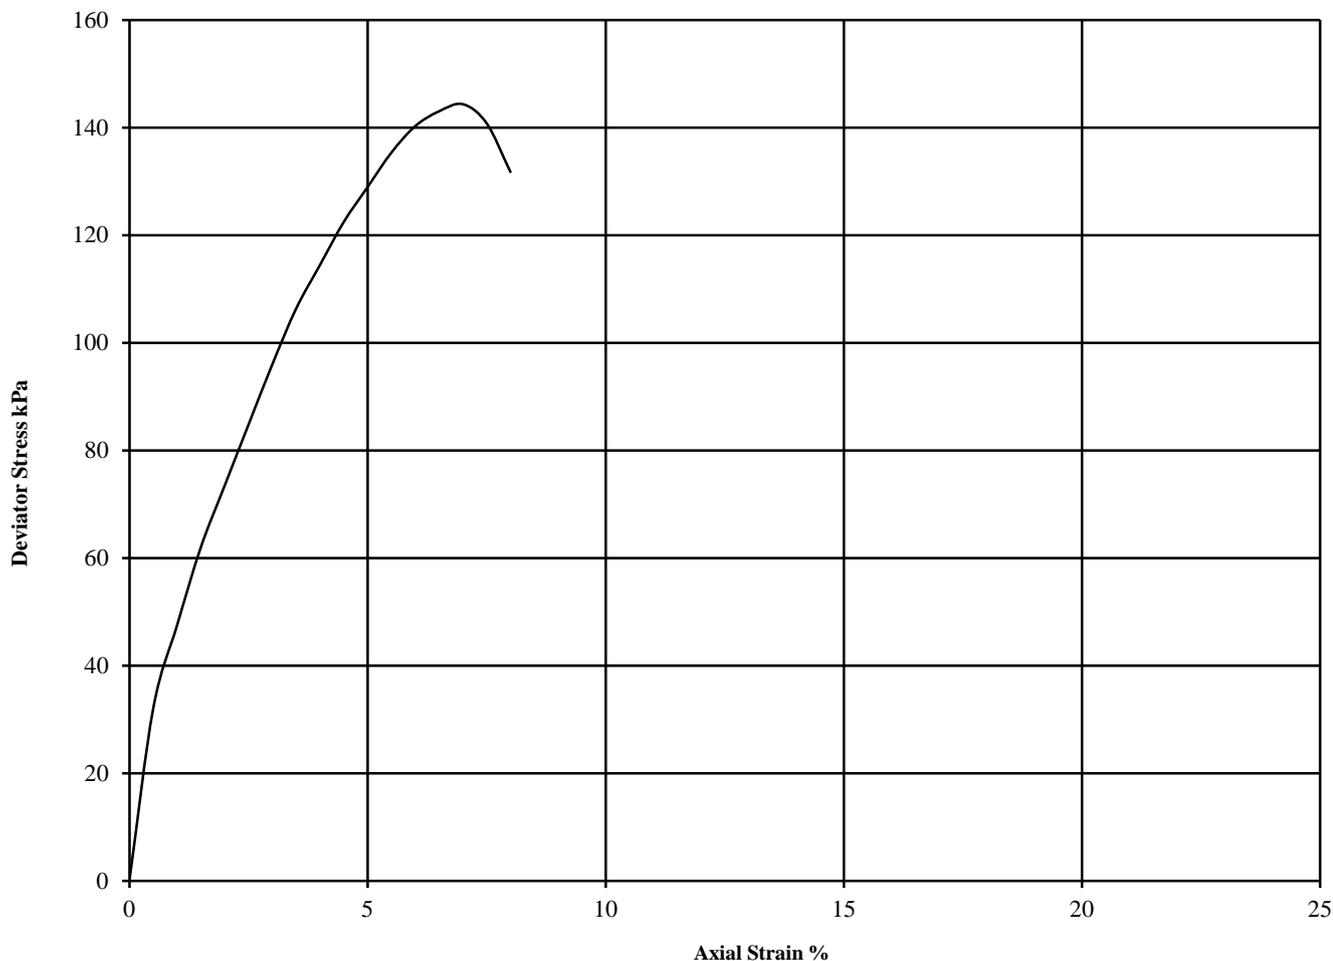
Diameter (mm):		82.0	Height (mm):		164.0	Test:	UU Single Stage		Remarks:
Specimen	Moisture Content (%)	Bulk Density (Mg/m <sup>3</sup> )	Dry Density (Mg/m <sup>3</sup> )	Cell Pressure (kPa)	Corr. Max. Deviator Stress (kPa)	Shear Strength Cu (kPa)	Failure Strain (%)	Mode of Failure	Undisturbed Sample Sample taken from top of tube Rate of strain = 2 %/min Latex Membrane used 0.2 mm thick, Correction applied 0.44 See summary of soil descriptions
			$\theta_3$	$(\theta_1 - \theta_3)_f$	$\frac{1}{2}(\theta_1 - \theta_3)_f$				
1	20	2.17	1.81	10	144	72	7.0	Brittle

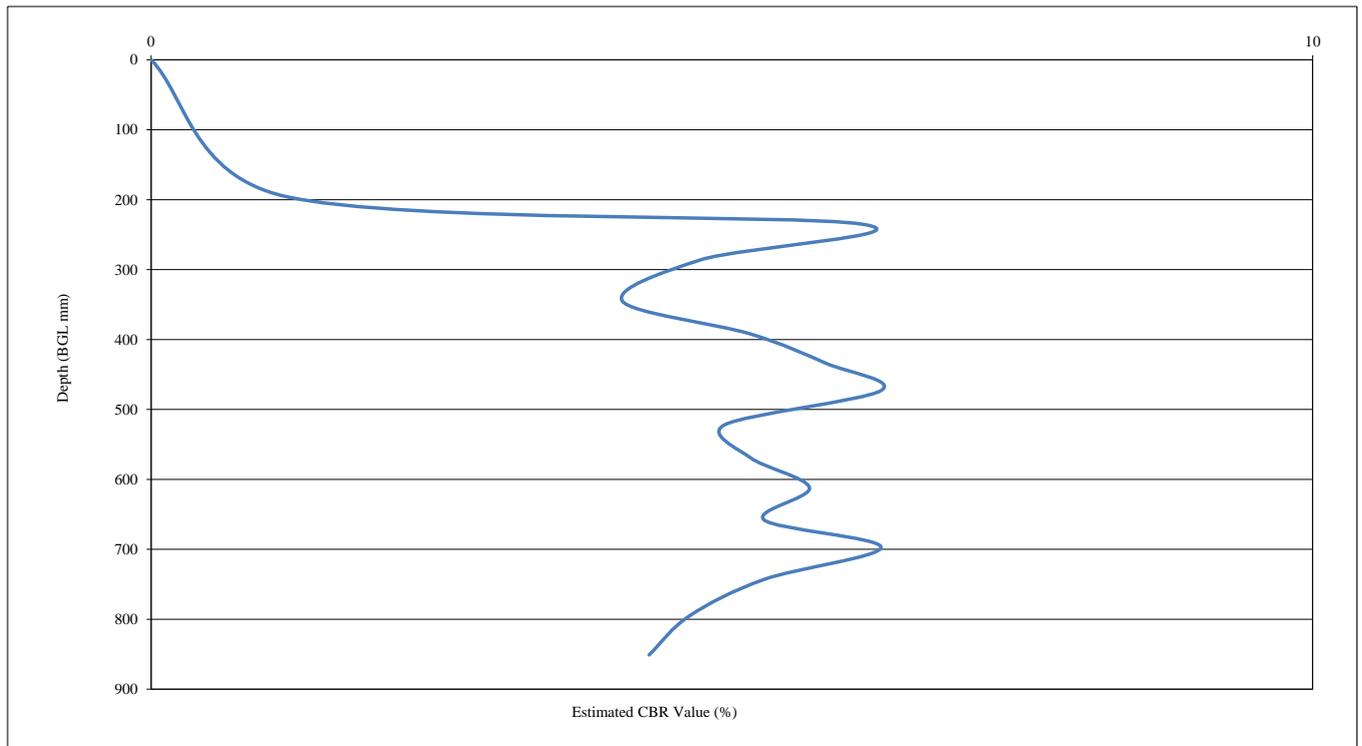
Estimated California Bearing Ratio Graph

**Determination of Dynamic Cone Penetrometer - Estimated CBR Value (%)**

Start Depth (mm) BGL	Finish Depth (mm) BGL	No. of Blows	Blows Per Layer	DCP mm/Blows	Ave Estimated Layer (CBR %)
0	195	1	1	195.00	1.15
195	286	3	2	45.50	5.34
286	345	4	1	59.00	4.06
345	697	12	8	44.00	5.53
697	851	15	3	51.33	4.70

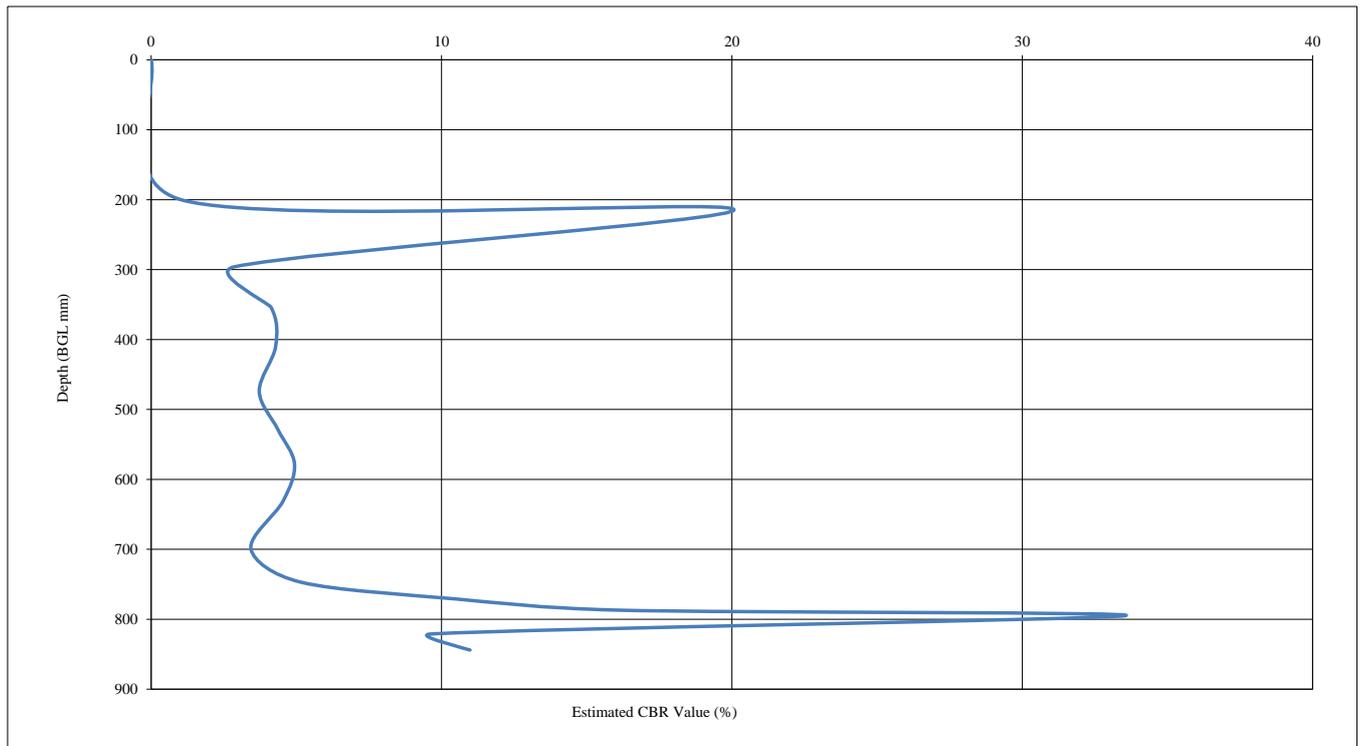
Estimated California Bearing Ratio Graph

**Determination of Dynamic Cone Penetrometer - Estimated CBR Value (%)**

Start Depth (mm) BGL	Finish Depth (mm) BGL	No. of Blows	Blows Per Layer	DCP mm/Blows	Ave Estimated Layer (CBR %)
0	214	2	2	107.00	2.16
214	296	3	1	82.00	2.86
296	700	10	7	57.71	4.15
700	795	14	4	23.75	10.62
795	844	16	2	24.50	10.27

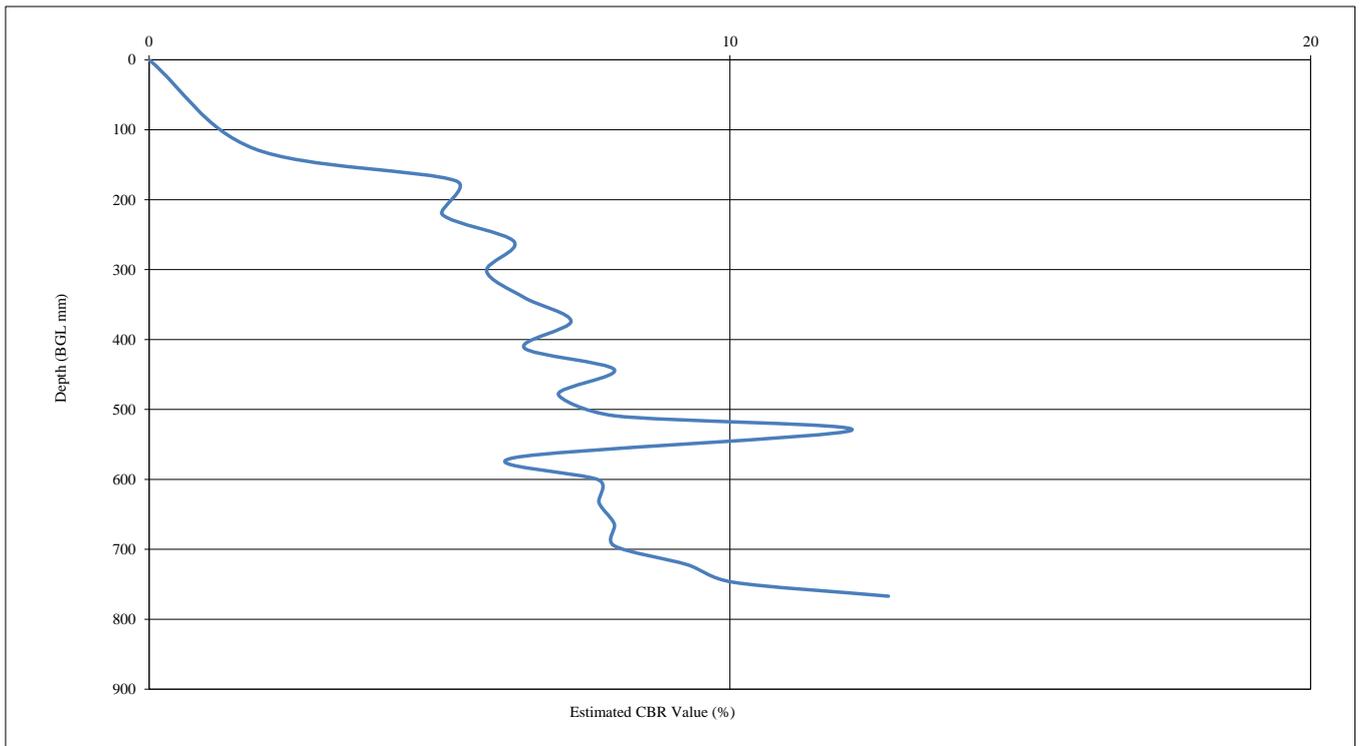
Estimated California Bearing Ratio Graph

**Determination of Dynamic Cone Penetrometer - Estimated CBR Value (%)**

Start Depth (mm) BGL	Finish Depth (mm) BGL	No. of Blows	Blows Per Layer	DCP mm/Blows	Ave Estimated Layer (CBR %)
0	173	2	2	86.50	2.71
173	478	10	8	38.13	6.44
478	530	12	2	26.00	9.65
530	601	14	2	35.50	6.94
601	767	20	6	27.67	9.03

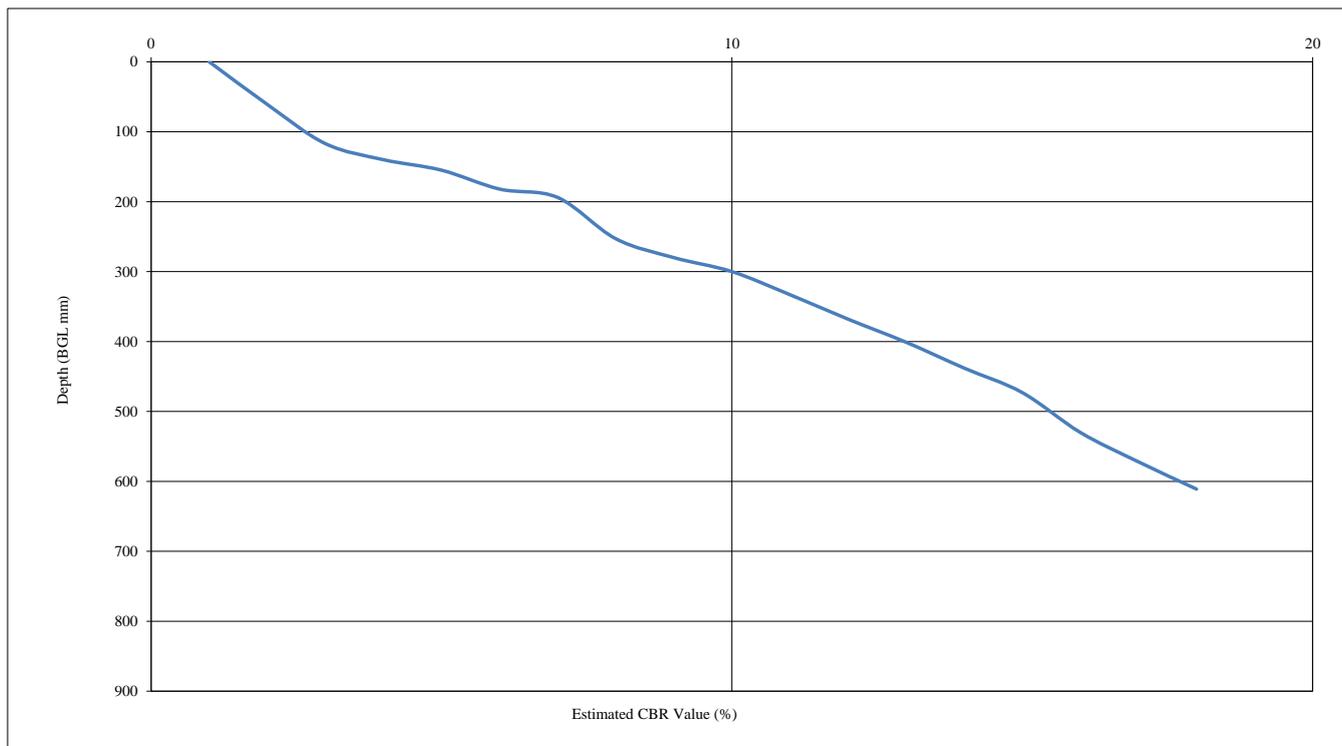
**Estimated California Bearing Ratio Graph**

<b>Site Name</b>	Lee Lane	<b>Test Date:</b>	02/02/2017
<b>Site Ref</b>	11-604	<b>Test Location:</b>	Royston
<b>Test No.:</b>	DCP104	<b>Easting:</b>	-
<b>Initial Depth (mm BGL):</b>	0	<b>Northing:</b>	-
<b>Final Depth (mm BGL):</b>	962

Start Depth (mm) BGL	Finish Depth (mm) BGL	No. of Blows	Blows Per Layer	DCP mm/Blows	Ave Estimated Layer (CBR %)
0	117	2	2	58.50	4.09
117	194	7	5	15.40	16.78
194	611	19	12	34.75	7.10

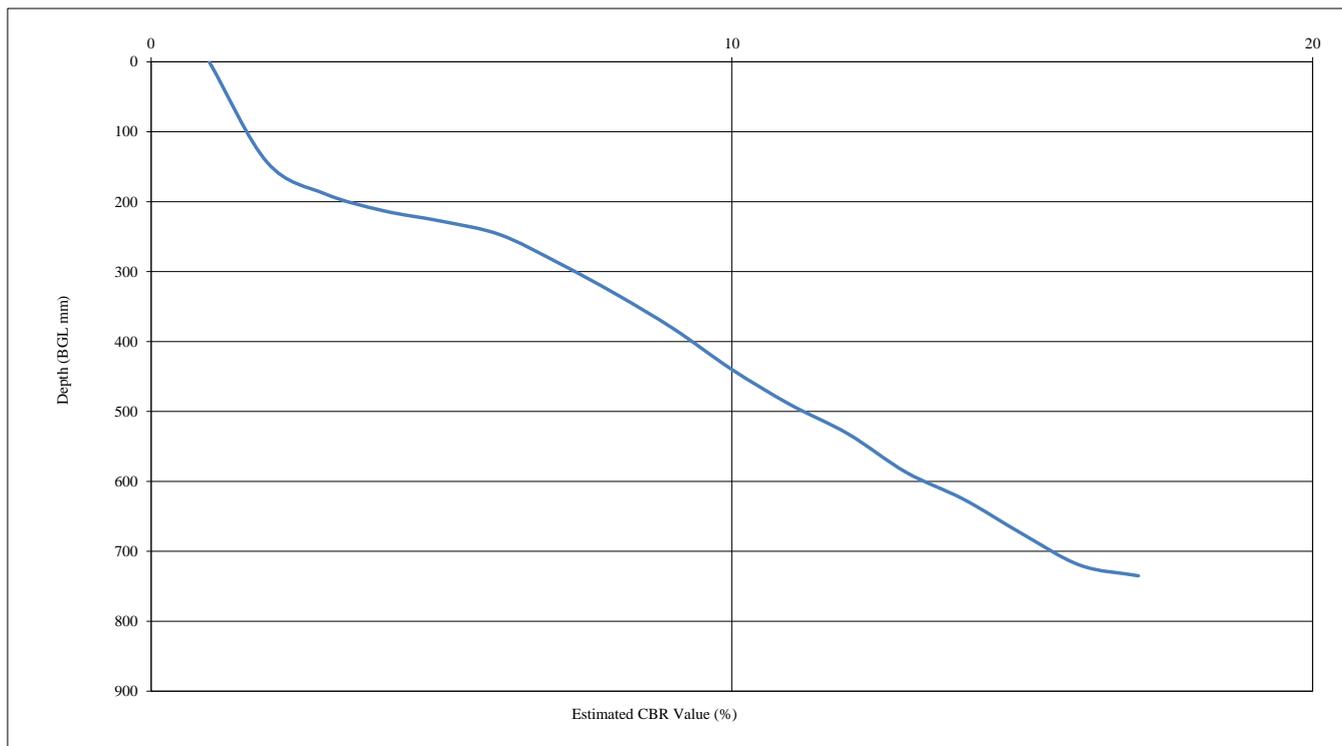
Estimated California Bearing Ratio Graph

<b>Site Name</b>	Lee Lane	<b>Test Date:</b>	02/02/2017
<b>Site Ref</b>	11-604	<b>Test Location:</b>	Royston
<b>Test No.:</b>	DCP105	<b>Easting:</b>	-
<b>Initial Depth (mm BGL):</b>	0	<b>Northing:</b>	-
<b>Final Depth (mm BGL):</b>	967

Start Depth (mm) BGL	Finish Depth (mm) BGL	No. of Blows	Blows Per Layer	DCP mm/Blows	Ave Estimated Layer (CBR %)
0	144	1	1	144.00	1.58
144	247	5	4	25.75	9.75
247	735	16	11	44.36	5.48

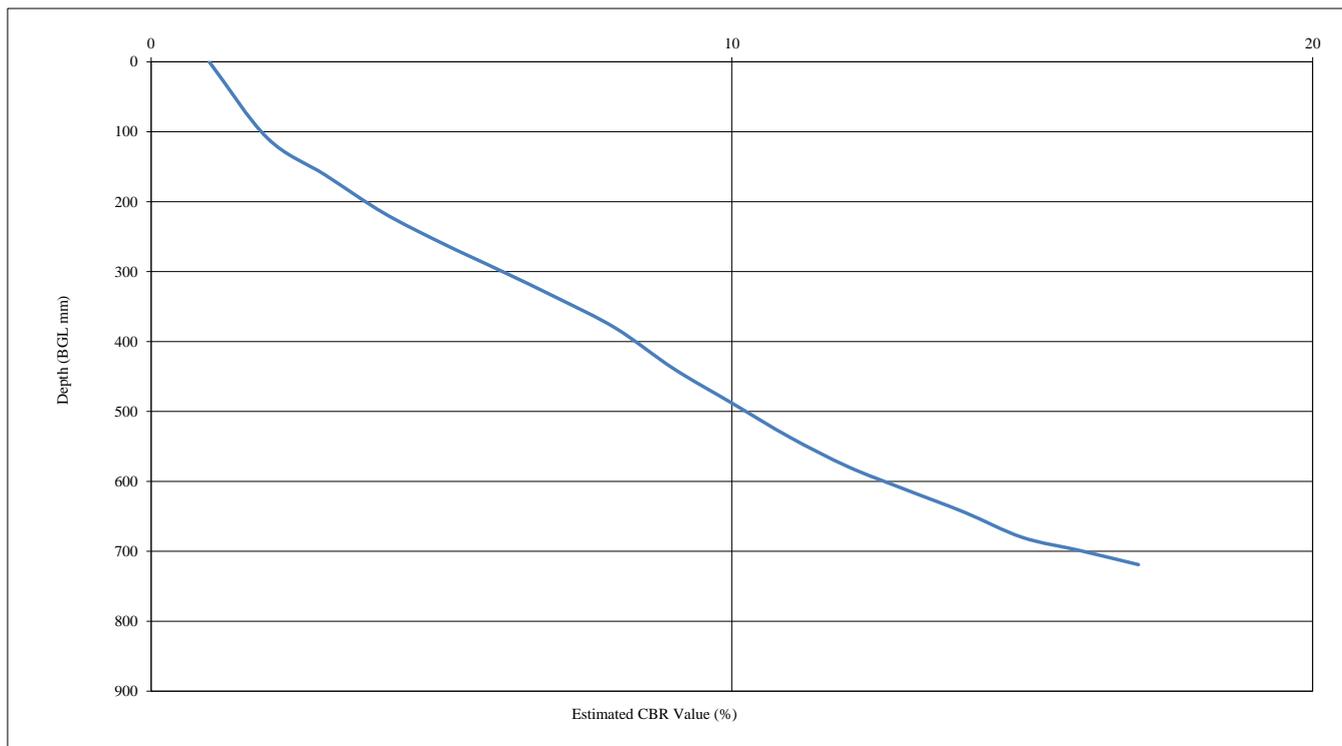
Estimated California Bearing Ratio Graph

<b>Site Name</b>	Lee Lane	<b>Test Date:</b>	02/02/2017
<b>Site Ref</b>	11-604	<b>Test Location:</b>	Royston
<b>Test No.:</b>	DCP106	<b>Easting:</b>	-
<b>Initial Depth (mm BGL):</b>	0	<b>Northing:</b>	-
<b>Final Depth (mm BGL):</b>	952

Start Depth (mm) BGL	Finish Depth (mm) BGL	No. of Blows	Blows Per Layer	DCP mm/Blows	Ave Estimated Layer (CBR %)
0	109	1	1	109.00	2.12
109	719	16	15	40.67	6.01

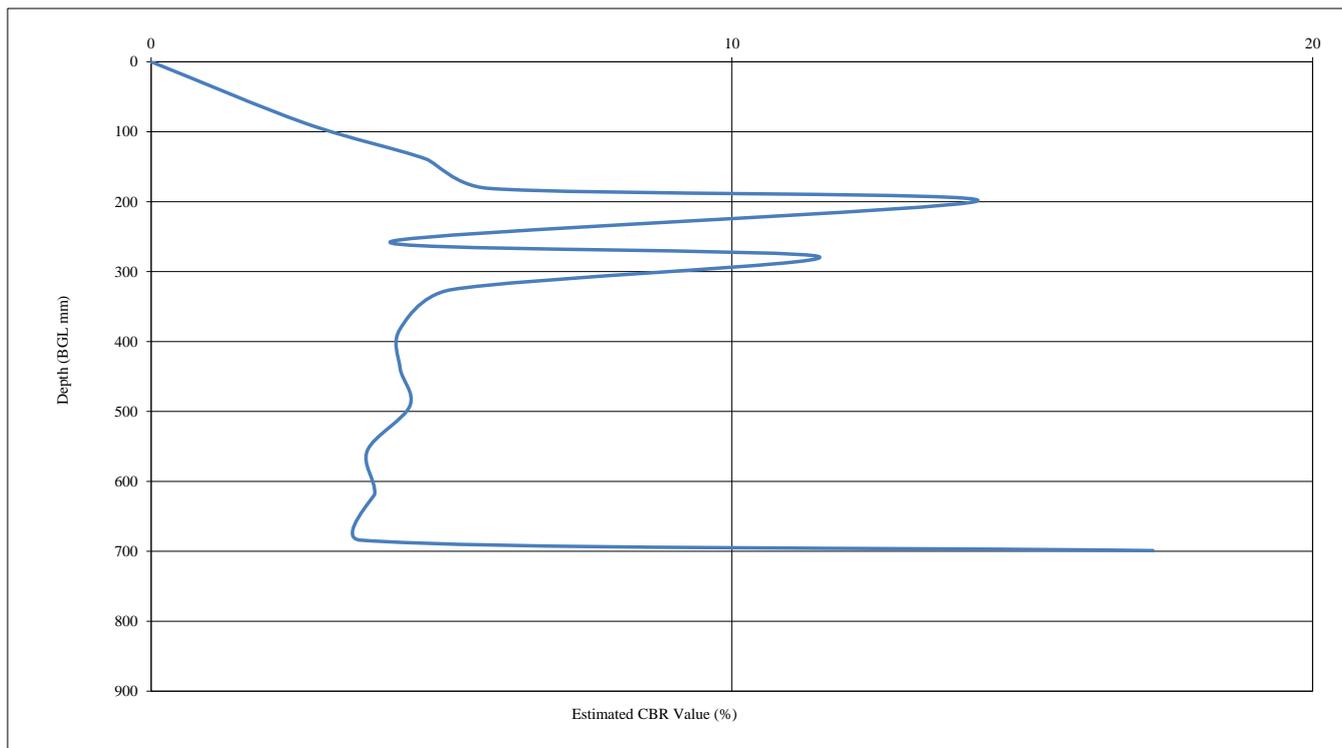
Estimated California Bearing Ratio Graph

<b>Site Name</b>	Lee Lane	<b>Test Date:</b>	02/02/2017
<b>Site Ref</b>	11-604	<b>Test Location:</b>	Royston
<b>Test No.:</b>	DCP107	<b>Easting:</b>	-
<b>Initial Depth (mm BGL):</b>	0	<b>Northing:</b>	-
<b>Final Depth (mm BGL):</b>	951

Start Depth (mm) BGL	Finish Depth (mm) BGL	No. of Blows	Blows Per Layer	DCP mm/Blows	Ave Estimated Layer (CBR %)
0	139	2	2	69.50	3.41
139	199	4	2	30.00	8.29
199	326	7	3	42.33	5.76
326	382	8	1	56.00	4.29
382	699	14	6	52.83	4.56

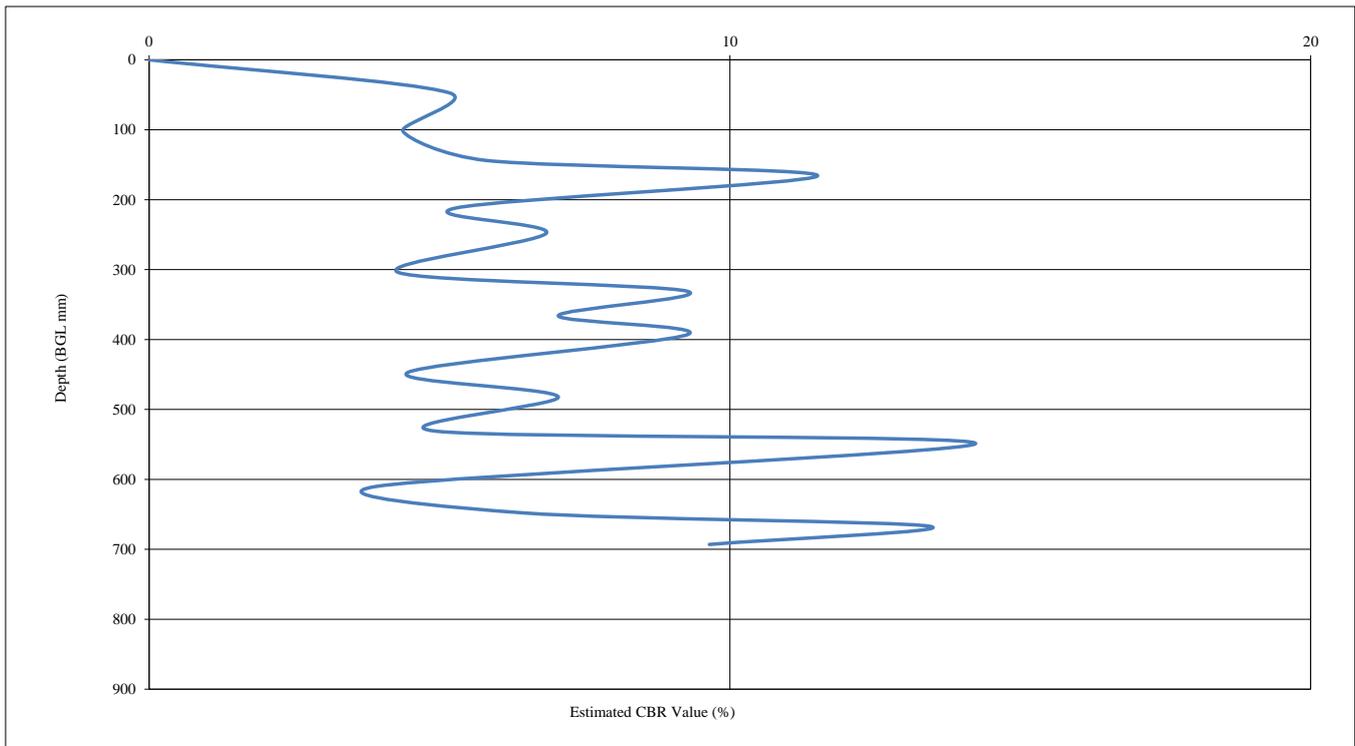
Estimated California Bearing Ratio Graph

**Determination of Dynamic Cone Penetrometer - Estimated CBR Value (%)**

Start Depth (mm) BGL	Finish Depth (mm) BGL	No. of Blows	Blows Per Layer	DCP mm/Blows	Ave Estimated Layer (CBR %)
0	102	2	2	51.00	4.73
102	166	4	2	32.00	7.75
166	304	7	3	46.00	5.28
304	549	14	7	35.00	7.05
549	693	18	4	36.00	6.84

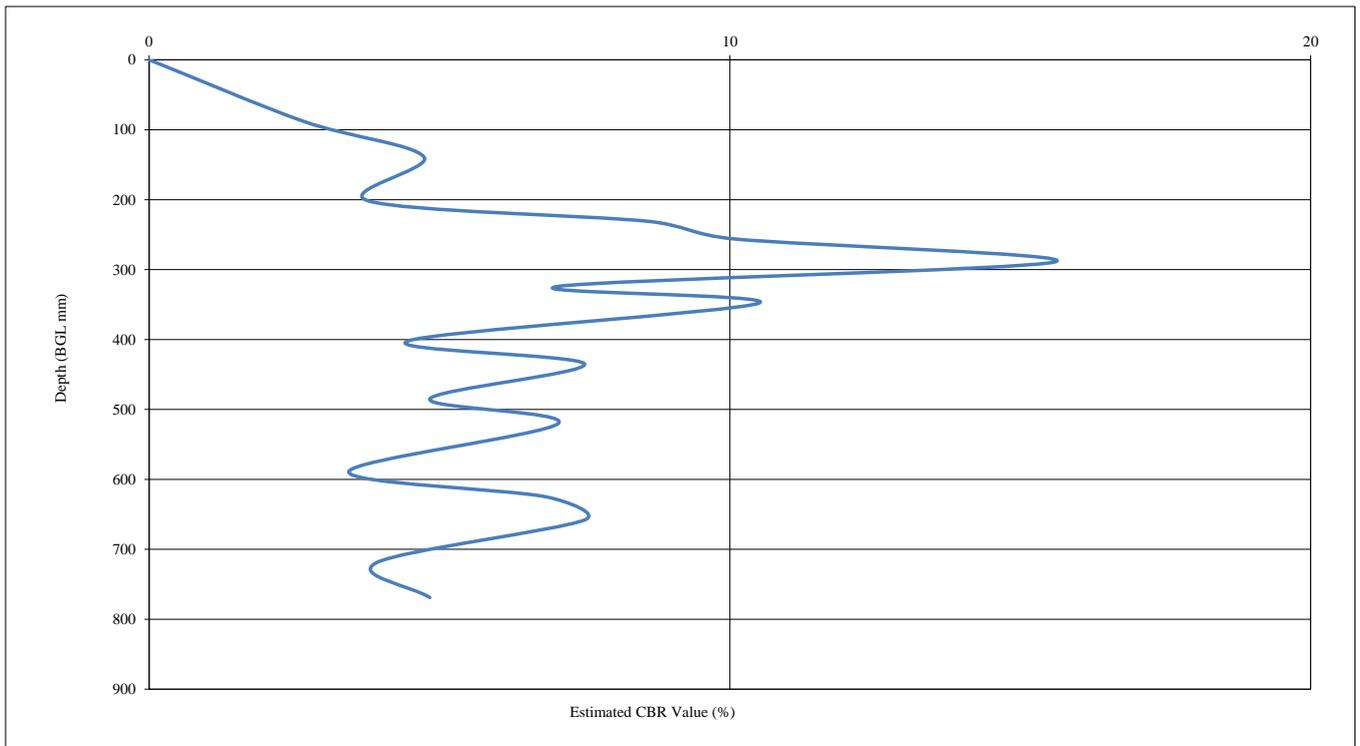
Estimated California Bearing Ratio Graph

**Determination of Dynamic Cone Penetrometer - Estimated CBR Value (%)**

Start Depth (mm) BGL	Finish Depth (mm) BGL	No. of Blows	Blows Per Layer	DCP mm/Blows	Ave Estimated Layer (CBR %)
0	202	3	3	67.33	3.53
202	289	7	4	21.75	11.65
289	324	8	1	35.00	7.05
342	719	17	9	41.89	5.83
719	769	18	1	50.00	4.83
